Deterioration mechanisms of the compact clay-bearing limestone of Tournai used in the Romanesque portals of the Tournai Cathedral (Belgium)

Laurent Fontaine¹ · Roel Hendrickx¹ · Hilde De Clercq¹

Received: 6 November 2014 / Accepted: 26 March 2015 / Published online: 7 April 2015
© Springer-Verlag Berlin Heidelberg 2015

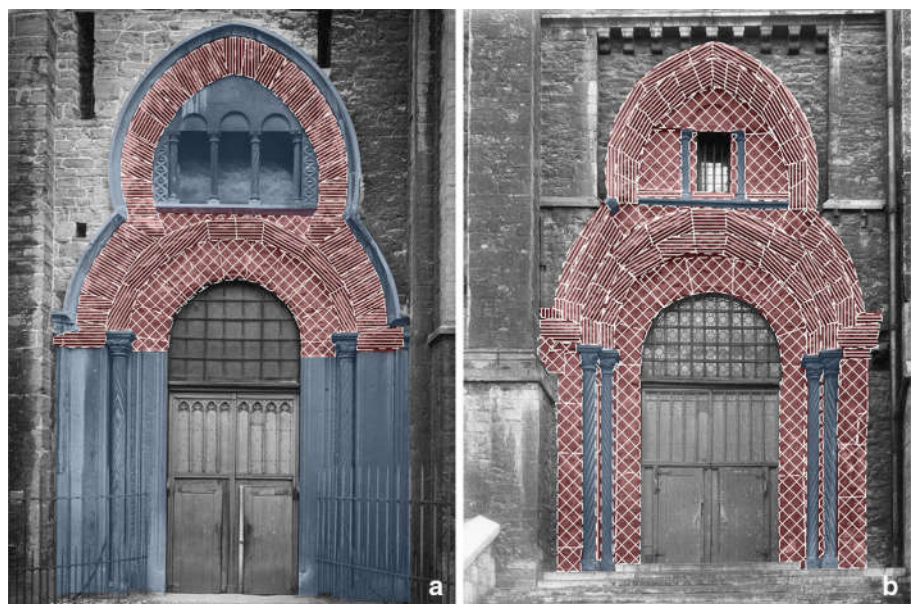
Generally speaking, the deterioration pattern of the Tournai stone consists of multiple delamination [i.e. detachments of flakes parallel to the bedding plane (ICOMOS-ISCS 2008)]. The bedding direction of the original blocks in both portals is represented in Fig. 2.

Fig. 2 Cartography of the bedding direction of the original stone blocks in the Capitole (a) and Mantile (b) portals. Hatching underlines the stone bedding, while crosshatching is used for face-bedded blocks. Blue-coloured zones correspond to restoration works in *Petit Granit* dating from the second half of the nineteenth century © KIK-IRPA (Stone Sculpture Workshop)

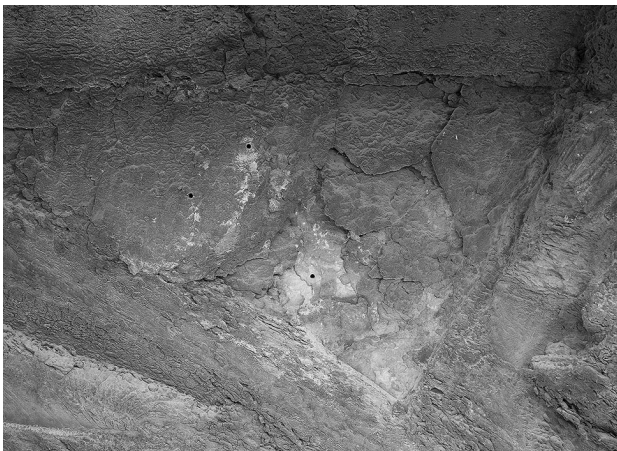
In the case of natural-bedded and edge-bedded stone blocks, the delamination process has caused an intense fragmentation in the outer edges; their schist-like appearance suggests a higher clay content compared to the compact stone core (Fig. 3). Face-bedded blocks suffer from material loss up to a few centimetres depth and, this to such a degree, that lots of sculpted reliefs are hardly readable (Fig. 4).

Fig. 4 Face-bedded block showing multiple delamination (Capitole portal, spandrel at the right side) © KIK-IRPA (Monuments Laboratory)

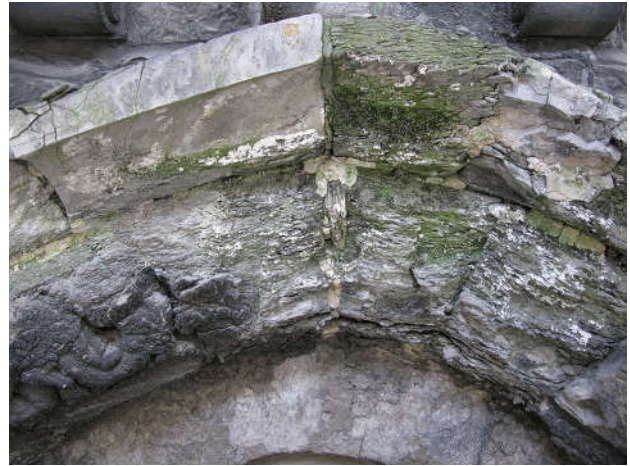
Thanks to its northeast orientation, the Mantile portal is protected from wind and has little direct solar radiation. However, its location in an urban environment has led to extensive development of black crusts (Fig. 5). The severely damaged dripstone has stimulated rainwater running-off and hence biological colonization (green algae, mosses and lichens).

Fig. 5 Summit of the Mantile portal. Black crusts (thick deposits), green algae, mosses and lichens can be identified © KIK-IRPA (Monuments Laboratory)

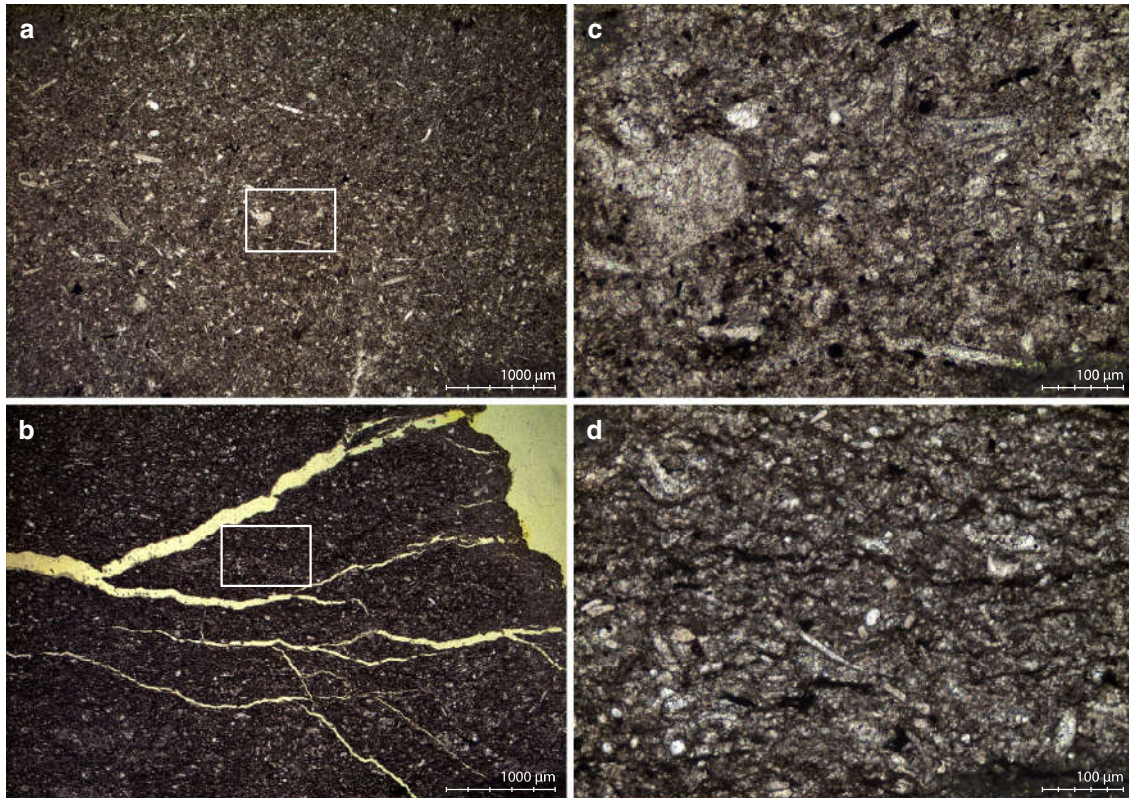
($\leq 100 \mu\text{m}$) (Fig. 6b), careful examination reveals a more prominent presence of small clay laminae in these outer edges (Fig. 6d) which are almost absent in the stone core (Fig. 6c). The clay laminae impart a laminated structure to the outer edges of the stone.

While from microscopic investigation of the thin section of a compact stone core, no deterioration can be observed; the outer edges show the presence of numerous micro-cracks (width up to $250 \mu\text{m}$) following the direction of the bedding or according to an angle up to 45° with it. This network of micro-cracks gives rise to a considerable fracture porosity, which was not present in the original rock material.

The spatial correlation between the clay laminae and the occurrence of micro-cracks suggests a strong causal link. Moreover, the pattern of micro-cracks is typical for stress-induced fractures in anisotropic materials, characterized by an alternation of zones with different elastic moduli (in this case: the calcitic groundmass versus the clay laminae).

Fig. 6 Thin-section photomicrographs of *black* Tournai limestone from the portals. **a** General view in a compact stone core; **b** general view in an outer edge showing micro-cracks (*yellow*); **c** zoom in

compact stone core (disseminated opaque grains correspond to pyrite); **d** zoom in outer edge (note the fine clay laminae in *black*) © KIK-IRPA (Monuments Laboratory)

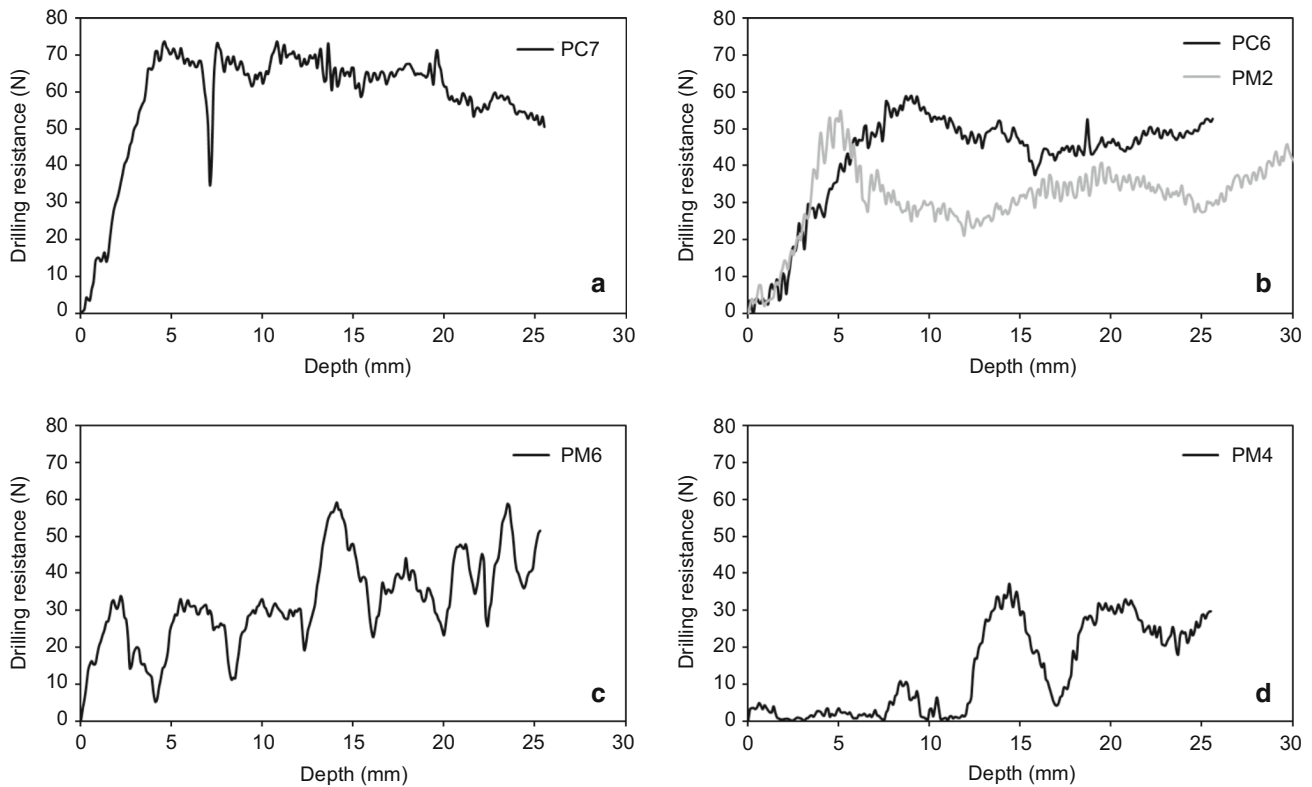
weathering, with occasionally lower mechanical resistance zones (Fig. 7a); (2) significantly lower resistance and deeper weathering are noticed on slightly deteriorated outer edges (e.g. drill hole PC6), while the hardness of severely deteriorated outer edges (e.g. hole PM2) is reduced to 50 % and characterized by a pronounced noise reflecting a large number of micro-cracks (Fig. 7b); (3) face-bedded blocks present saw-tooth profiles corresponding to flakes and cracks (Fig. 7c); (4) thick black crusts have a lower drilling resistance than the underlying stone and can contain harder inclusions, corresponding to embedded stone fragments (Fig. 7d).

Fig. 7 Hardness profiles obtained on site by DRMS: **a** compact stone core (lower resistance at 7 mm); **b** deteriorated outer edges; **c** face-bedded block (note an increase of the hardness with depth); **d** edge-

bedded block covered by a thick black crust up to 12 mm depth, then successively stone flake (12–17 mm) and deteriorated stone (from 17 mm) © KIK-IRPA (Monuments Laboratory)

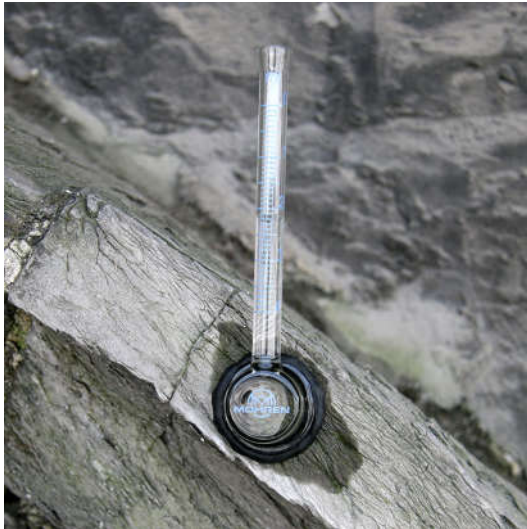
Figure 8 illustrates a typical water absorption test executed parallel to the bedding (the bedding of the stone is

Fig. 8 Example of the formation of a wetted zone which is stretched to an ellipse shape in the direction of the bedding (dripstone of the Mantile portal) © KIK-IRPA (Monuments Laboratory)

perpendicular to the surface). Wetting occurs according to the orientation of the bedding. It can be assumed that the wet front does not have a hemispherical shape, as is expected in isotropic materials, but a half ellipsoid one with a long axis parallel to the bedding and a short one perpendicular to it. Absorption coefficients calculated from the results vary between 4 and 8 $\text{g/m}^2\text{s}^{0.5}$ for slightly deteriorated stones, while they can increase by a factor of ten for severely deteriorated ones ($84 \text{ g/m}^2\text{s}^{0.5}$) (Table 2).

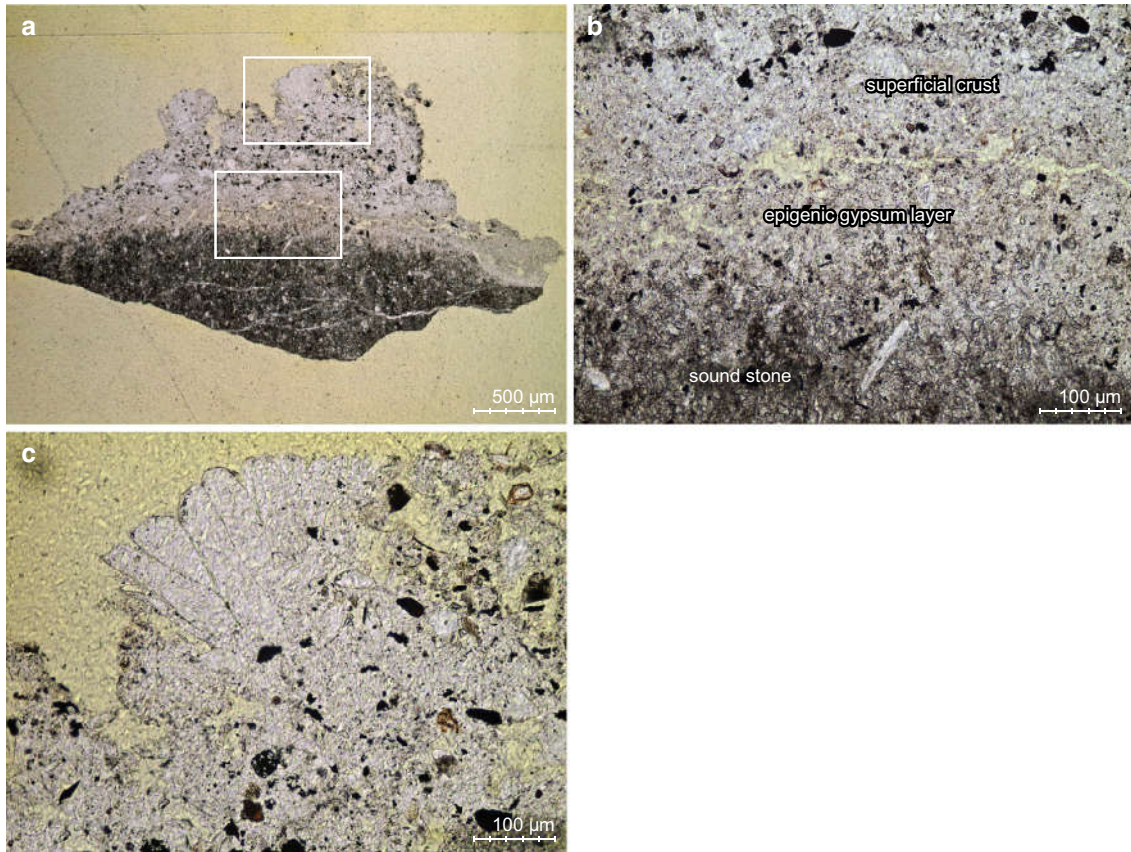
micro-cracks can be observed (Fig. 14a). On the other hand, when the crusts have the form of thick deposits, the stone support is always more or less fragmented (Fig. 15). In case of pronounced fragmentation (Fig. 16), gypsum is regularly found between stone flakes where it acts as a micro-crack infill material.

The transition zone is very thin ($<250 \mu\text{m}$) in the case of films and shows a replacement of the micritic matrix of the stone by gypsum, with the preservation of the original stone fabric (Fig. 14b). Although the lower boundary of the transition zone is diffuse, the upper boundary is characterized by a lack of adhesion, which might correspond to the original stone surface. The mentioned features point out that the stone has been locally transformed into gypsum. Since this replacement of calcite by gypsum has occurred after the initial formation of the stone (genesis), the resulting layer is frequently denominated as “epigen(et)ic” by experts (Bromblet and Vergès-Belmin 1996; Vergès-Belmin and Dignard 2003).

The superficial crust corresponds to an indurated gypsum layer (Figs. 14c, 15), with entrapped airborne particles, such as fly ashes and very fine quartz grains ($<100 \mu\text{m}$). The thickness of the superficial crust does not exceed 1 (films) or 2 mm (thick deposits).

Fig. 14 Thin-section photomicrographs of a film: **a** thin-section overview; **b** zoom on sound stone/epigenic gypsum layer/superficial crust interfaces [*upper marked zone* in **(a)**]; **c** zoom on superficial

crust showing opaque particles (fly ashes) and quartz grains embedded in well-developed gypsum crystals [*lower marked zone* in **(a)**] © KIK-IRPA (Monuments Laboratory)

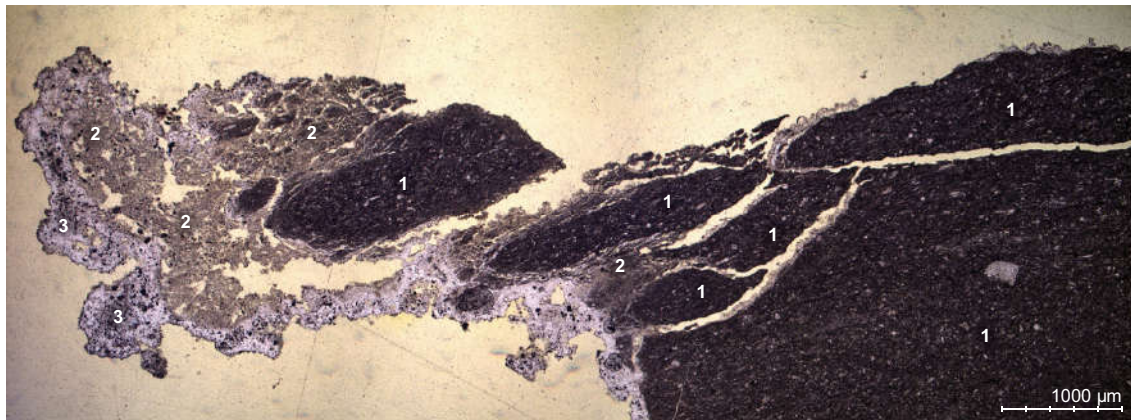
As opposed to the case of films, the transition zone within thick deposits is much thicker: up to several millimetres. It consists of unweathered stone remnants embedded in a weakly cohesive weathered material. Due to the strong fragmentation, the original stone surface is lost.

Fig. 15 Sequence of thin-section photomicrographs of thick deposits showing (from the *right* to the *left*): **1** fragmented stone support, **2** weathered stone with stone remnants, and **3** superficial crust © KIK-IRPA (Monuments Laboratory)

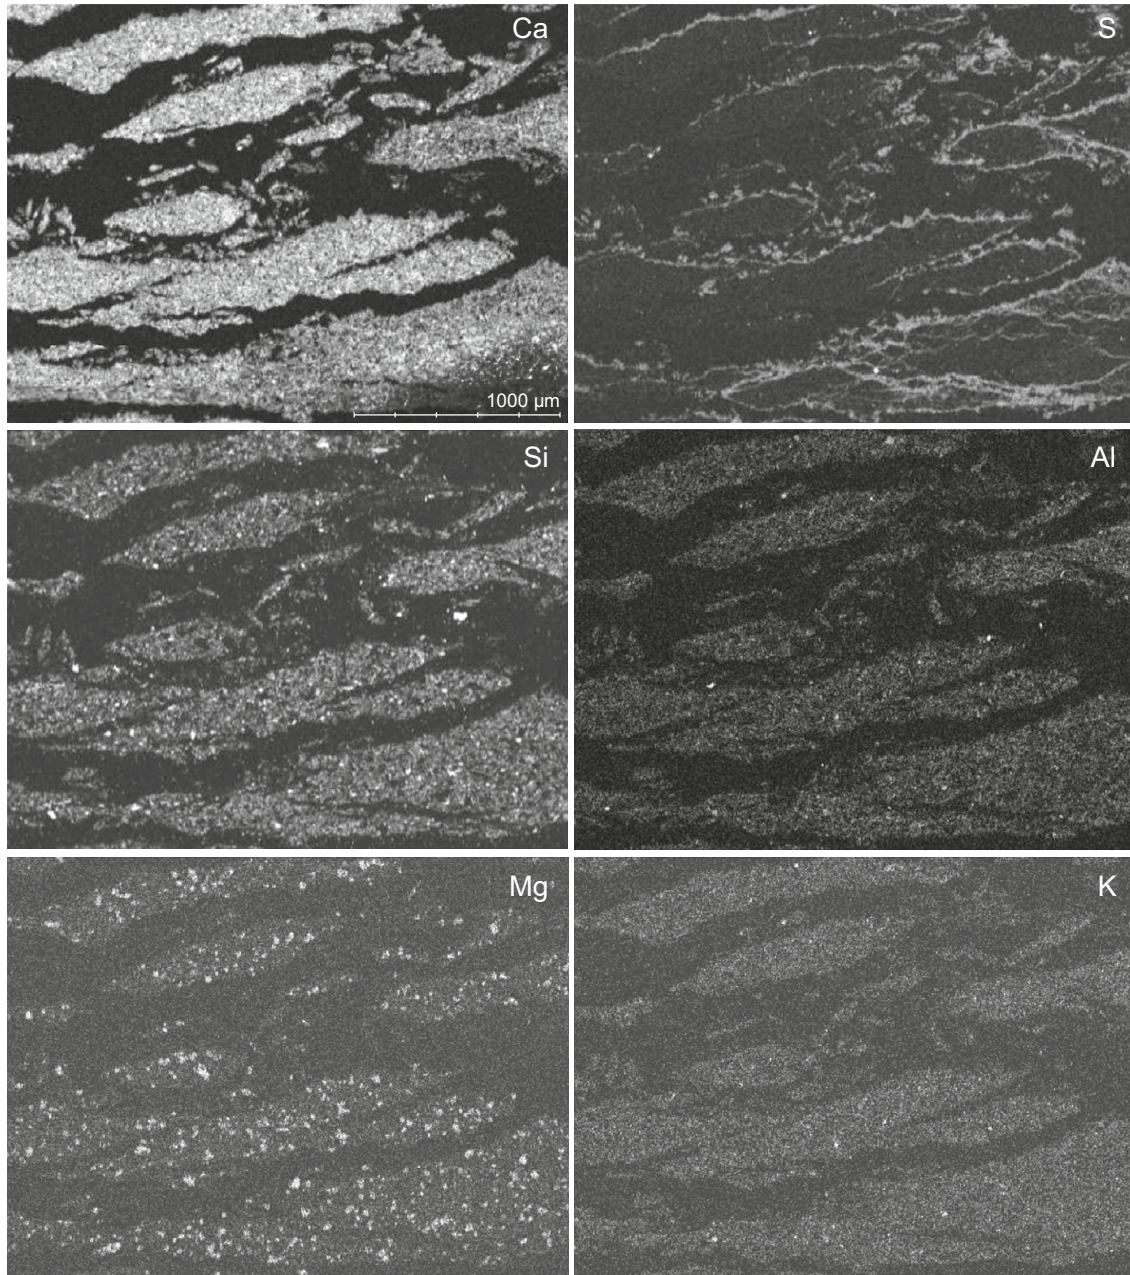
Fig. 16 SEM-EDX mappings of main elements in fragmented stone support. The mapping of calcium gives an overview of the stone flakes, while the one of sulphur indicates that flakes are rimmed with

gypsum deposits. The stone flakes are mainly composed of calcite (Ca) and grains of dolomite (Mg–Ca), silica (Si) and illite (Si–Al–K) © KIK-IRPA (Monuments Laboratory)

Although, gypsum formation cannot be considered as the primary cause of the deterioration, its presence as infill material in-between micro-cracks is not without consequences. Indeed, as it is the case for ice formation, gypsum crystallization exerts pressures that accelerate the deterioration mechanism (Charola et al. 2007). Gypsum infillings, however, might fix the flakes to the stone support which would otherwise have been detached from it.
