# Paper 4: Mechanical Properties of Bricks of the Coudenberg Archaeological Site in View of a Proper Conservation Strategy

HILDE DE CLERCQ, LAURENT FONTAINE, ROALD HAYEN,  
and SEBASTIAAN GODTS

*Royal Institute for Cultural Heritage (KIK-IRPA), Belgium*

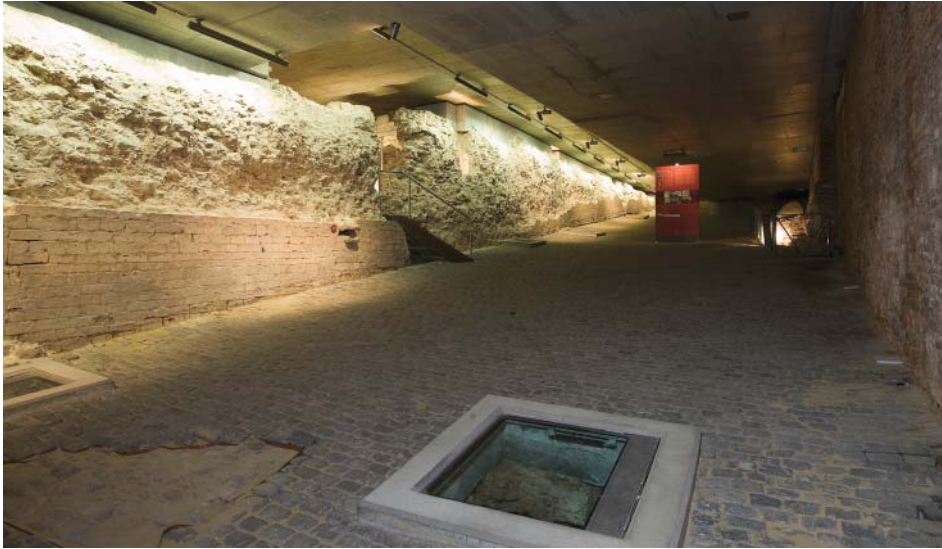
Figure 1 presents the areas submitted to the investigation of the mechanical properties and which are subject of the discussion in this paper. The first area is a part of the wall in brickwork masonry of the *Isabella Street* (Figures 2 and 3: zone a in Figure 1). This wall is quite dry and shows local damage in the form of powdering

FIGURE 2 Upper end of Isabella Street.

of the brick. The salt contamination (see Paper 3 this issue), comprises mainly gypsum, sodium chloride, and sulphate. The evaluation of the crystallization behaviour was determined by means of the environmental control of salts (ECOS) program. The prediction of the crystallization sequence is based on the principle of the thermodynamic behaviour of salt mixtures. The ECOS output of the experimentally determined ion mixture, revealed that the salts crystallize within a broad range of relative humidity (RH), between 40 and 95%. This range of RH corresponds to the climatic variations recorded in the Isabella Street (see Paper 2 this issue). Hence, the conditions of the surrounding environment cause recurrent cycles of crystallization and dissolution within the porous structure of the bricks resulting in their powdering (Figure 3). The hardness profile obtained by means of the DRMS-device illustrates that the brick as such is very soft, having a resistance up to 3 N (Figure 4). The outer 16 mm shows an even lower cohesion that gradually increases with depth. This pattern is quite typical for building materials contaminated with salts situated in an environment of which the hygrometric conditions favour cycles of crystallization/deliquescence. In conditions of RH above the transition point of the salts, the salts absorb moisture from the surrounding environment and dissolve (deliquescence). A descending of the RH across the transition point will result in a re-crystallization of the salts. The crystallization of salts consists of nucleation and crystal growth that might exert crystallization pressures on confined pores resulting in mechanical damage, as confirmed through hardness profiles.

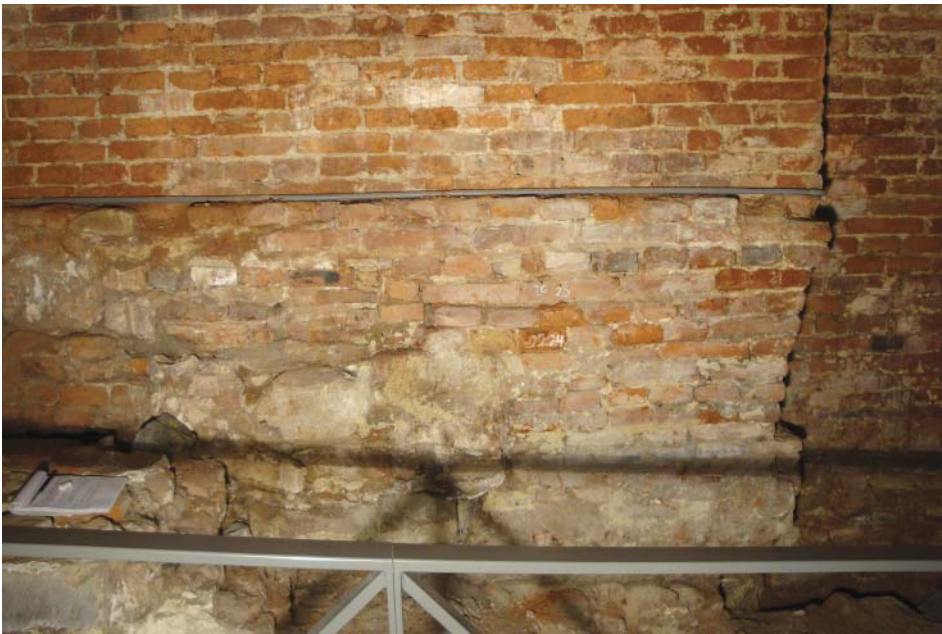
FIGURE 3 Detail of brickwork along Isabella Street.

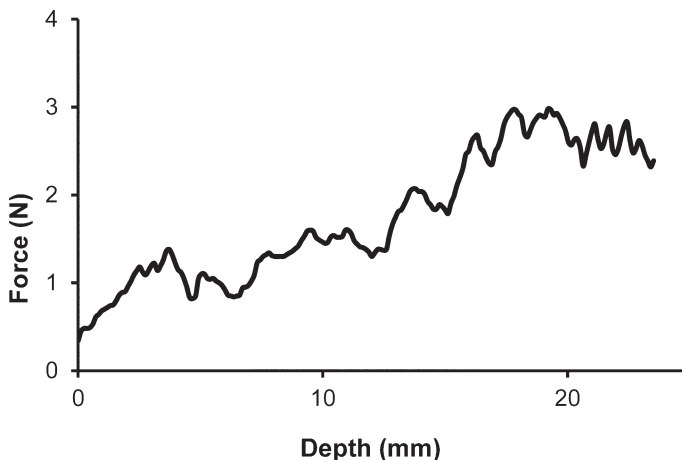
FIGURE 4 Hardness profile of a brick from zone a (Isabella Street).

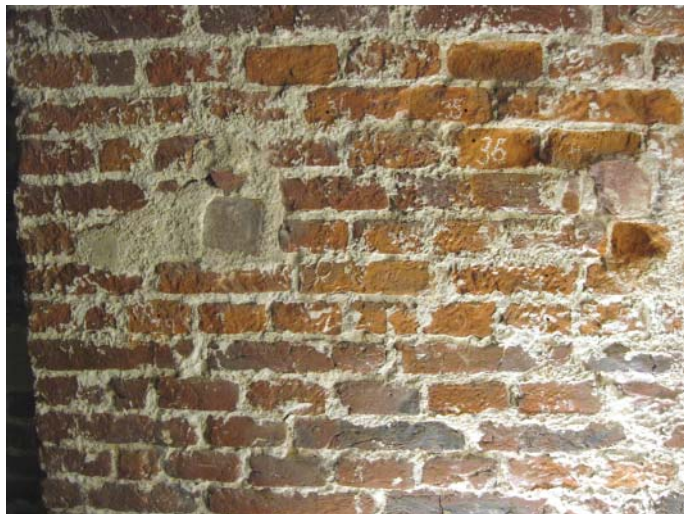
The building materials of zones b (Figure 5) and c, situated further down the descending Isabella Street (Figure 1), are again quite dry but contain especially sodium salts, partly linked to carbonates in the form of trona ( $\text{Na}_3\text{H}(\text{CO}_3)_2 \cdot 2\text{H}_2\text{O}$ ). The salt crystallization sequence of the remaining ion mixture of the first centimetre of the mortar revealed that crystallization occurs within quite a narrow range of RH, i.e. between 60 and 66%, out of which sodium nitrate is the major salt. A high nitrate contamination is also detected in the surface layer of the brick. In conditions of descending RH, especially potassium nitrate and darapskite ( $\text{Na}_3\text{NO}_3\text{SO}_4 \cdot \text{H}_2\text{O}$ ) will crystallize between 70 and 63% RH. At around 45% RH, darapskite re-dissolves and

FIGURE 5 Detail of the brickwork on the lower part of Isabella Street.

thenardite ( $\text{Na}_2\text{SO}_4$ ) crystallizes. According to the actual climate conditions, sequences involving the darapskite-thenardite transformation occur in spring (April–May) and autumn (October) as the RH fluctuates regularly between 40 and 50%. Sequences of crystallization of sodium and potassium nitrate and darapskite will preferentially occur during the summer (from June till mid-October). Hence, the current climate conditions stimulate cycles of crystallization/deliquescence resulting in powdering of the brick (Figure 5). The loss of cohesion resulting from the exerted crystallization pressures is confirmed by the hardness profiles, illustrated in Figure 6. The weathering depth varies from 11 mm (zone c, Figure 6a) to 22 mm (zone b, Figure 6b). Again, it concerns bricks which are originally characterized by low mechanical properties, probably due to a low firing temperature which is quite typical for the Middle Ages.

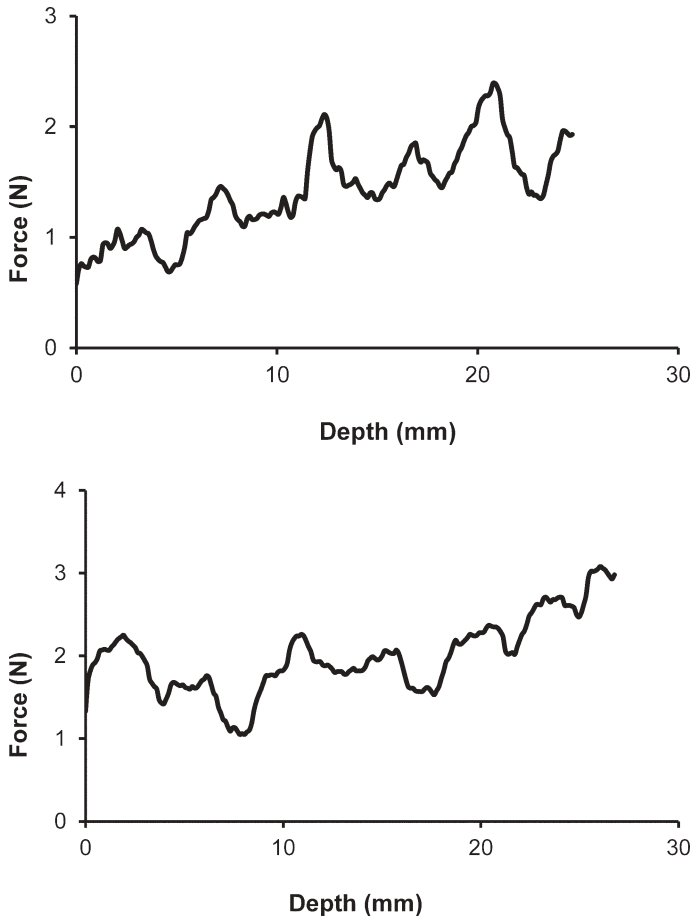
FIGURE 6 Hardness profile of bricks from zone c (top) and zone b (bottom).

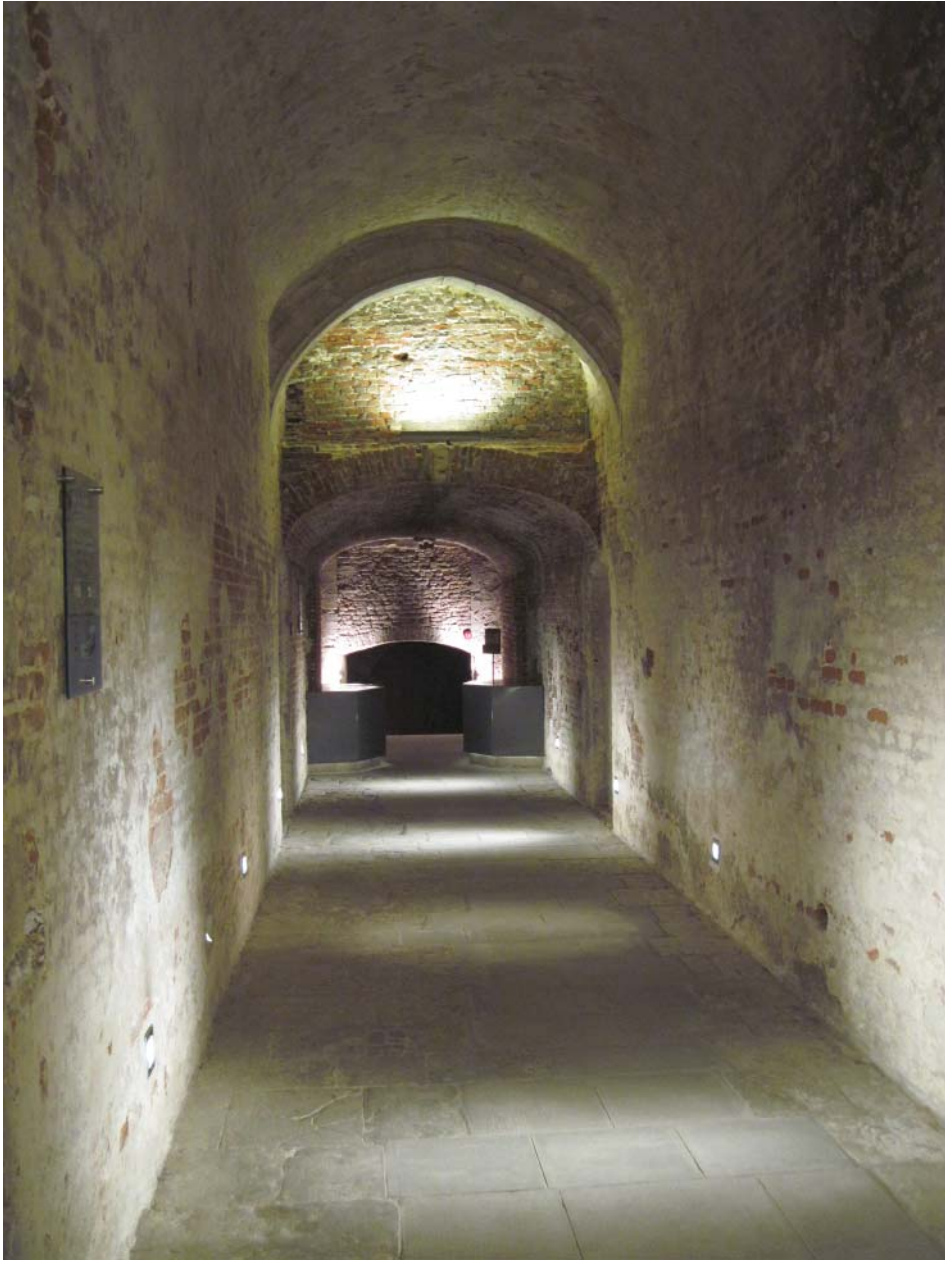
The mortar of zone d, situated in the basement level of the **Chapel** that was built in the sixteenth century (Figures 1 and 7), is wet having a moisture content up to 22 w% partially due to the hygroscopic properties for the hygroscopic moisture content reaches values up to 52 w%. The salt load of the building materials is characterized by an excess of sodium indicative for the presence of sodium carbonates, such as trona, which was also detected in the efflorescence. The crystallization sequence, as predicted by means of the ECOS model, of the remaining ion mixture is such that in conditions of descending RH salts crystallize from a RH of 60%. The environment of this zone, situated close to the inlet of outdoor air, is characterized by strong RH fluctuations (see Paper 2 this issue). In winter, cold air is blown inwards and heated up to 20° C resulting in a dramatic decrease of the RH in the Chapel down to 18%. In these dry conditions, all detected salts are continuously crystallized. From June until mid-November, frequent fluctuations of RH between 40 and 80% RH are recorded. Again, frequent transitions of deliquescence/crystallization of the present salts will result in salt damage, which was experimentally determined by means of DRMS-measurements. This soft brick shows an overall hardness of about 3 N and a weathered surface layer of 10 mm (Figure 8).

FIGURE 7 The Chapel.

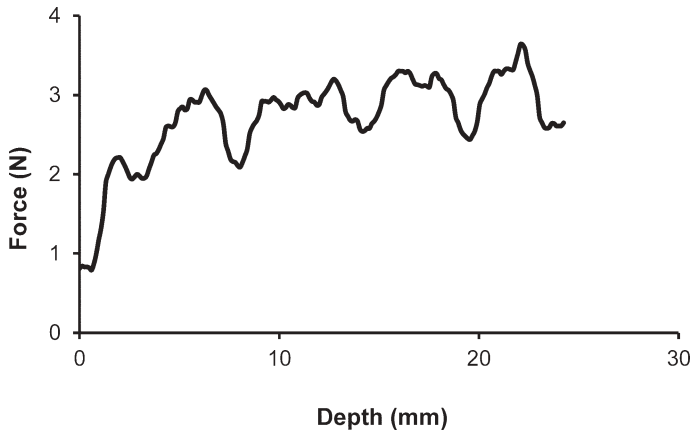
FIGURE 8 Hardness profile of the brick from zone d (Chapel).

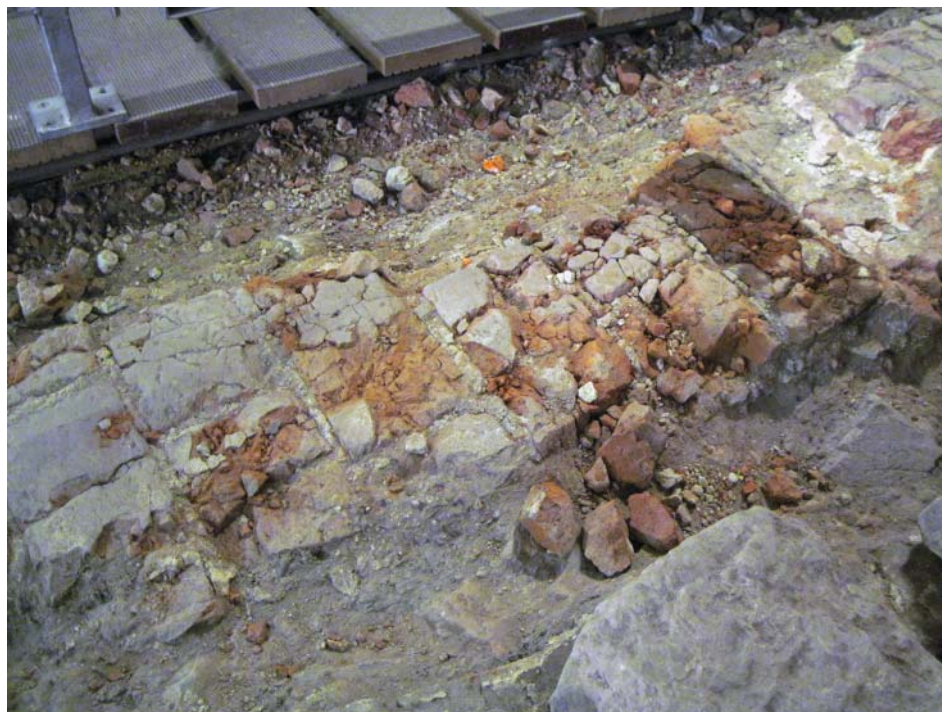
What remains of the Aula Magna (Figure 9), the previous palace's banqueting hall, are cellars located directly underneath the Royal Square. This level housed kitchens and storage rooms of the fifteenth-century palace. The bricks of the Aula Magna (zone e) are generally characterized by a complex fissure pattern (Figure 10). The presence of several fissures leads to an irregular hardness profile (Figure 11). Fissures are detected at a depth of at least 2 cm.

From a detailed visual monitoring on site, it was noticed that the process of fissure formation was still active. The microscopic investigation of thin sections of the brick revealed a general heterogeneous composition and that the clay was not fully mixed prior to the firing of the brick (see Paper 6, this issue). Hence a low quality of the brick used for the construction of the Aula Magna, and this right from the beginning, is concluded. Despite the low quality of the brick being identified, the phenomena activating the process of fissuration remained unknown. Within this investigation, following possible mechanisms were examined:

FIGURE 10 The severely fissured bricks of the Aula Magna.

Finally, the problems related to the vibrations caused by the passage of the tram and heavy vehicles on Royal Square, above the Aula Magna, remain the only plausible explanation for the damage process of the bricks. The vibrations — felt on-site — could not be quantified at present. A methodology was set up to consolidate the fissured bricks by means of a grouting mortar. The results are discussed in (see Paper 6 this issue).

fire, and consequently collapse of walls, in 1731 initiated the process of crack formation. Today, microcracks formed further develop as a consequence of the vibrations induced by the passage of the tram and heavy vehicles on the Royal Square above the Aula Magna.

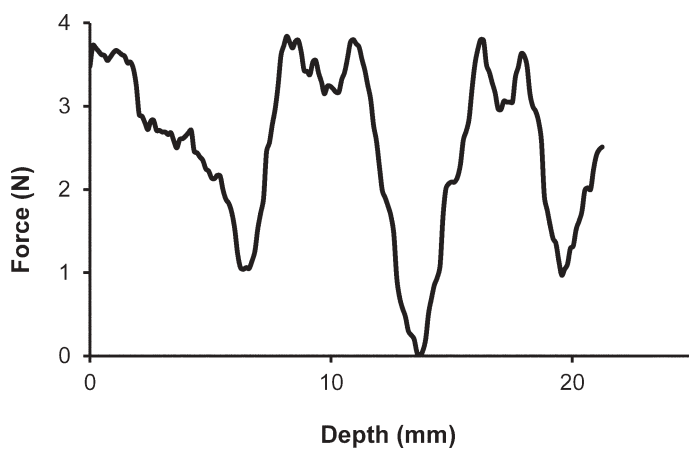
FIGURE 11 Hardness profile of a brick from the Aula Magna (zone e).

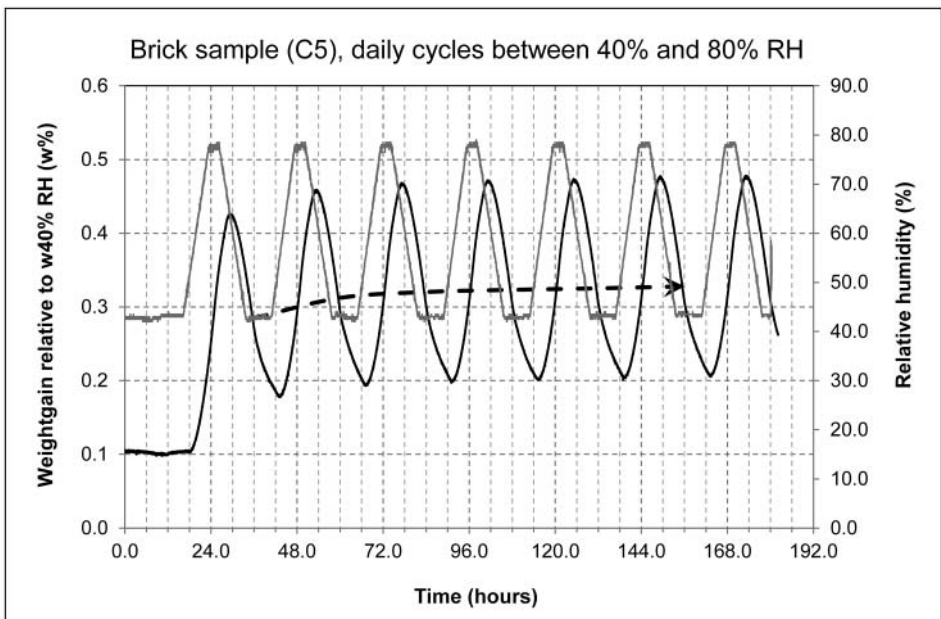
It is known that clays, characterized by a lamellar structure, are very sensitive to variations of RH. In conditions of high RH, some clays absorb ambient moisture in their lamellar structure resulting in swelling phenomena while in conditions of low RH moisture will desorb from their lamellar structure. Frequent cycles of swelling-shrinkage might cause damage to clay containing building materials (Scherer & Jimenez Gonzalez, 2005: 51–61; Jimenez, et al., 2002: 21–27). Therefore, a severely damaged brick lifted from the masonry of the Aula Magna was submitted to variations of RH. At first, the brick, pre-conditioned at 80% RH, was conditioned at 40% during which its weight was recorded continuously. After 4 days, equilibrium was reached resulting in a weight decrease of 0.8 w%. Further, the brick was submitted to cycles of RH of alternately 40 and 80% during which its weight was followed up. Figure 12 illustrates that the pattern of the weight evolution is quite similar to the one of the RH, with a delay of 6 hours. The maximum difference in weight was up to 0.3 w%,

FIGURE 12 Weight evolution of the brick of the Aula Magna submitted to 24 hours cycles of RH of alternately 40 and 80% (black, solid line). The curve presenting the evolution of the RH is presented by a grey solid line. The black dotted curve is the trend of the weight increase of the brick.

which is less than half the value obtained in case of conditioning during 4 days. The weight variations resulting from the moisture absorption-desorption process provoked by cycles of changing RH were considered too low to explain the procedure of fissure formation.

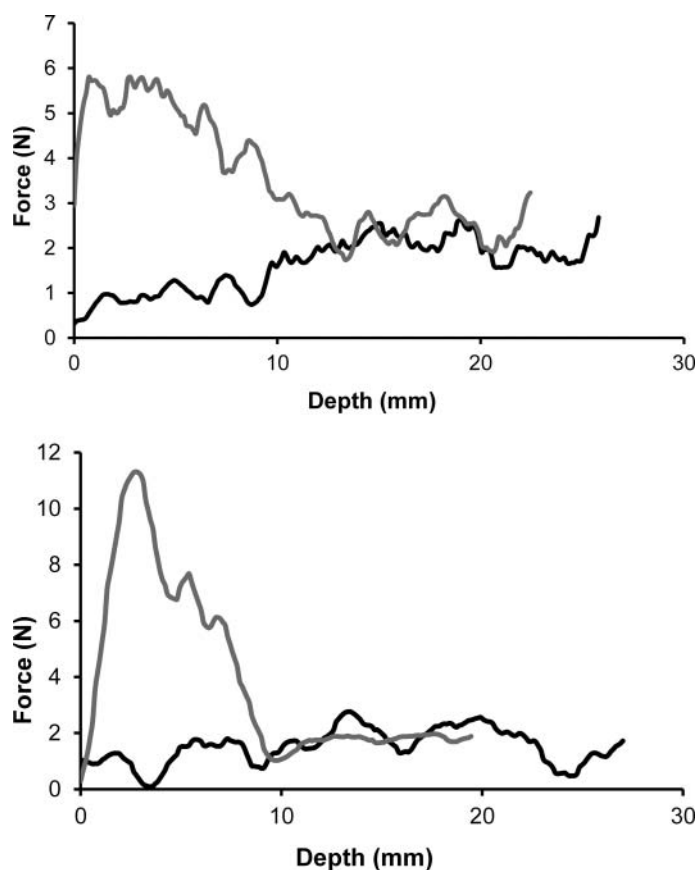
Several zones revealing surface weathering due to salt damage were treated with TEOS. One month after the application, the strengthening effect was evaluated by means of DRMS-measurements. Figure 13 illustrates the hardness profiles before and after two applications with TEOS. The consumption corresponds to about  $4 \text{ l.m}^{-2}$ . An over-consolidation was generally noticed, i.e. the hardness of the weathered zone is after treatment higher than the underlying brick material. It was concluded that one application with TEOS is sufficient to increase the cohesion of the weathered zone to an acceptable level.

FIGURE 13 Hardness profile before (black solid line) and after (grey solid line) 2 applications with TEOS of brick of zone a (upper part Isabella Street) (top) and b (lower part Isabella street) (bottom). The consumption is about  $4 \text{ l.m}^{-2}$ .

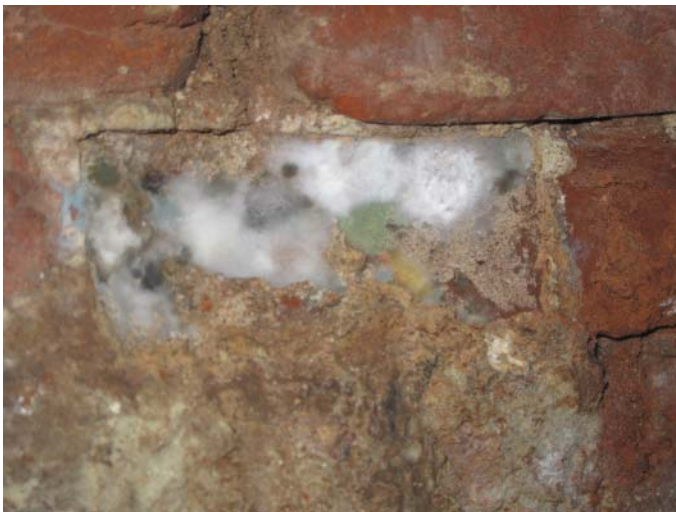
A general problem related to archaeological sites is related to humid conservation conditions and the presence of moulds. Moulds present in building materials, as such considered as uncomfortable for visitors, are activated through the application of water based restoration products as well as organic products. Figure 14 shows a detail of the zone a of the Isabella Street, four weeks after the treatment with TEOS. Severe mould growth is noticed being incompatible with health regulations. A further treatment with a biocide based on quaternary ammonium salts was capable of reducing the mould appearance significantly.

FIGURE 14 Detail of the zone a of Isabella Street, 4 weeks after the treatment with TEOS. A severe mould growth can be seen.
