# DIGITAL MAPPING AS A TOOL FOR ASSESSING THE CONSERVATION STATE OF THE ROMANESQUE PORTALS OF THE CATHEDRAL OF OUR LADY IN TOURNAI, BELGIUM

J. De Roy<sup>1\*</sup>, S. Huysmans<sup>1</sup>, L. Hoornaert<sup>1</sup>, L. Fontaine<sup>2</sup> and N. Verhulst<sup>1</sup>

In the framework of the conservation of the Cathedral of Our Lady in Tournai (Belgium), the Royal Institute for Cultural Heritage (KIK-IRPA, Brussels) was called upon in 2012 to carry out a preliminary study of two Romanesque portals called the *Mantile* and *Capitole* portals. The aim of this study was to understand the deterioration mechanisms of the stone and to propose a conservation strategy. Both portals are constructed from the local black Tournai stone, with the exception of the 19th century restoration in Belgian bluestone. Due to the strongly deteriorated state and the large size of the portals, a detailed visual inspection survey of each stone block was necessary to obtain an overview of the actual state of conservation and to develop an adapted conservation strategy. The deterioration patterns were digitally mapped with the Metigo *MAP* software (fokus GmbH), using rectified photographs as a template. The

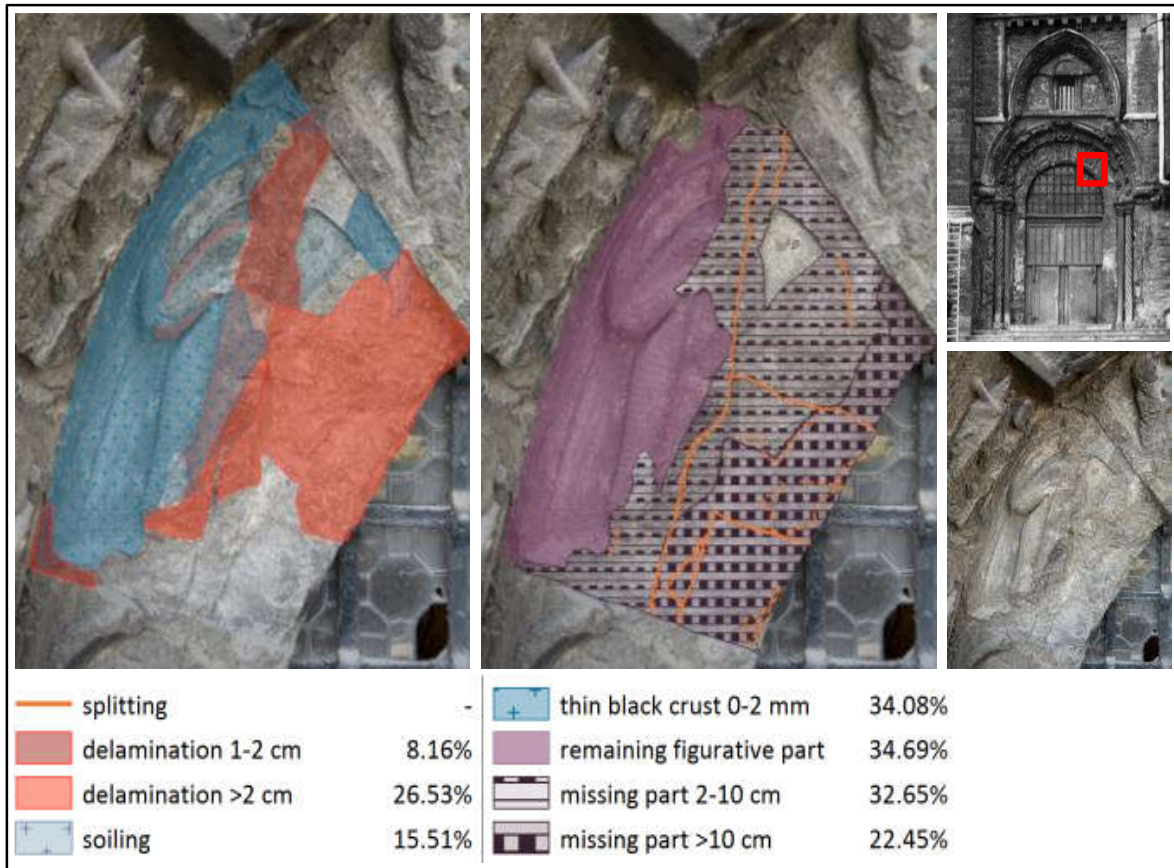
The following deterioration patterns were observed on both portals: detachment/delamination, cracks, black crusts in various thicknesses, soiling, biological colonization, blistering and efflorescence.

For quantitatively important deterioration patterns, namely black crusts and delamination, sub-categories were made to indicate the degree of the deterioration.

*Fig. 2: Detailed mapping of block BC2 (Bandeau Cintré 2) of the Mantile portal. © KIK-IRPA, Brussels.*

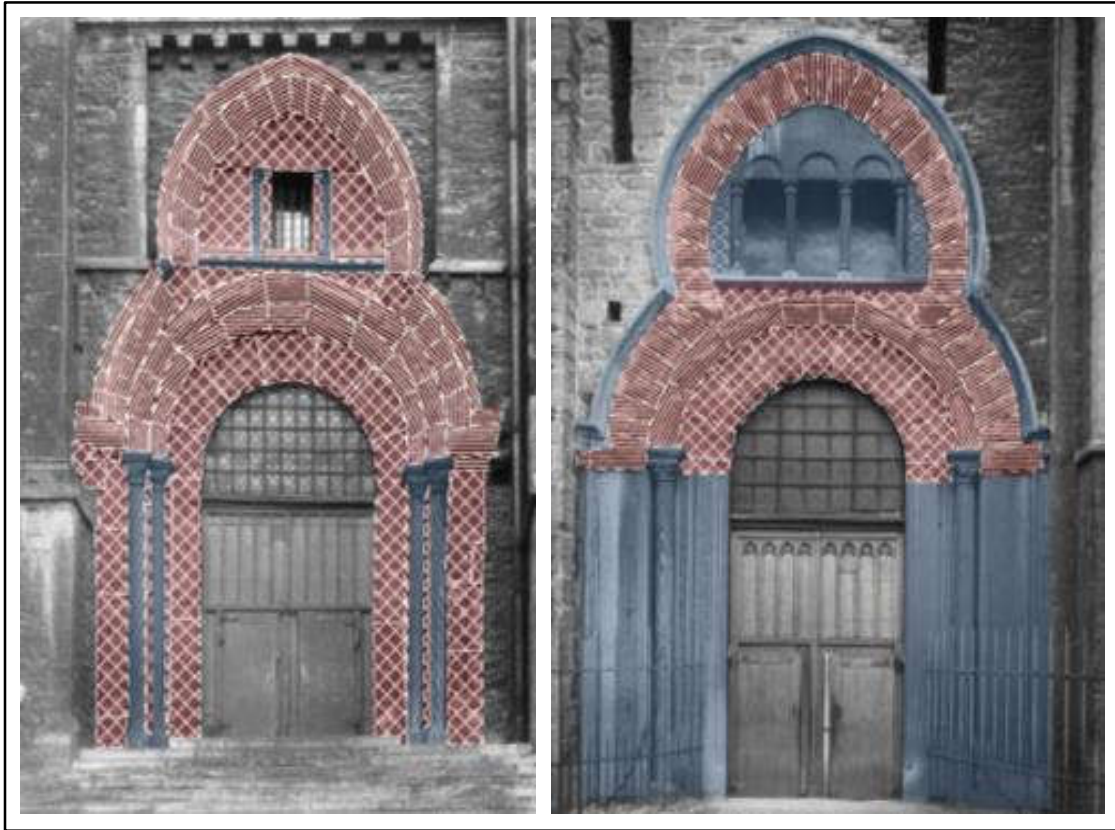
The mapping of the bedding planes of the Tournai stone proves that the construction of both portals is similar. Although the positioning of each block was not random (Fig. 3), the bedding planes were not taken into account during the construction of the portals. The blocks were positioned in three different directions, namely natural-bedded, edge-bedded and face-bedded. The latter blocks suffer from material loss due to their weaker and fragmented schist-like outer edge positioned parallel to the surface. This loss continues to a few centimeters depth, making a lot of sculpted reliefs hardly readable or even leading to their total loss.

From the identical positioning of the stone blocks in both portals we can derive that the lower part of the *Capitole* portal was very likely face-bedded. This would explain why that part would have suffered substantial material loss and was replaced with Belgian bluestone in the 19<sup>th</sup> century.

*Fig. 3: Mapping of the bedding planes of the original stone blocks in the Mantile (left) and Capitole portal (right). Hatchings underlines the bedding planes, while crosshatching is used for face-bedded blocks. Blue-coloured zones correspond to the 19th century restoration with Belgian bluestone ©KIK-IRPA, Brussels.*

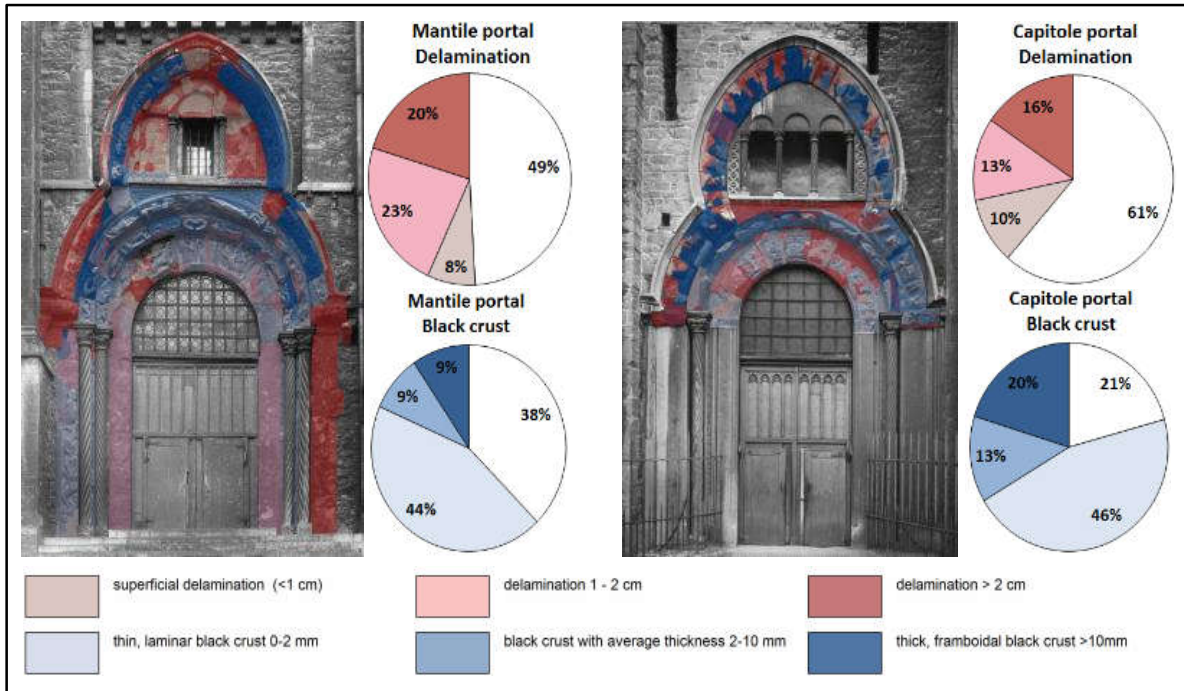
From the detailed mappings an overview can be deduced of the different degradation phenomena and their distribution on the portals (Fig. 4). Detachment is a common phenomenon of the original Tournai stone and was found on 51% of the original surface of the *Mantile* portal and on 39% of the *Capitole* portal. Black crusts were omnipresent as well: on 62% of the *Mantile* portal and on 79% of the *Capitole* portal. These phenomena are divided in different subcategories according to their degree of degradation. Other deterioration patterns such as biological colonisation, blistering and efflorescence were less common and will thus have less impact on the conservation treatment.

Fig. 4: Mappings and diagrams of the delamination and black crusts on the Mantile (left) and Capitoile portal (right) © KIK-IRPA, Brussels.

The results of these measurements in combination with additional scientific research and the data from the mappings revealed that the specific degradation of the Tournai stone is caused by intrinsic as well as extrinsic factors. These were studied by the monuments and monumental decoration lab of the KIK-IRPA. The presence of numerous clay laminae in the schist-like outer edges of each stone block constitutes an intrinsic factor for the degradation of the stone. This schist-like ‘crust’ makes the stone unsuitable for use as a building stone and must ideally be removed before use in an outdoor context. The core of these blocks is, however, in good condition. The cracks in the outer edges follow the bedding plane of the stone block. This leads to a high amount of material loss by detachment when the blocks are face-bedded.

Furthermore also extrinsic factors such as climatic conditions (temperature, humidity, precipitation) and a malfunctioning of the rainwater drainage system are significant for the degradation of the portals. Hydric dilatation is the main driving force of this degradation but hygric and thermic dilatation also play an important role (for further details see Fontaine L. *et al.*, 2015).

The principal aim of the study of the two Romanesque portals was to develop a conservation treatment based on a representative test area. The area chosen for this pilot conservation had to include all the different deterioration phenomena. A representative area was selected on the basis of the mappings. Furthermore the main focus of the conservation, namely the stabilization of the detachment, could be deduced from the mappings. With this in mind, an injection mortar was designed and tested in the lab. During the pilot conservation all the different steps of the treatment were executed onsite, starting with injecting an ethyl silicate-based mortar and followed by the removal of the soiling and the black crusts. The latter was carried out with compresses in combination with micro-abrasion for the crusts with a thickness of more than 2 mm and by a mechanical elimination followed by a soft micro-abrasion cleaning for the thinner films (for further details see De

Roy J. *et al.*, in press). During the removal of the crusts thicker than 2 mm, additional injections turned out to be necessary due to the thicker transition zone of the outer stone layer with very limited cohesion (Fontaine L. *et al.*, 2015). This is in contrast with the thin film-like crusts where the underlying stone support appears in relatively good condition.

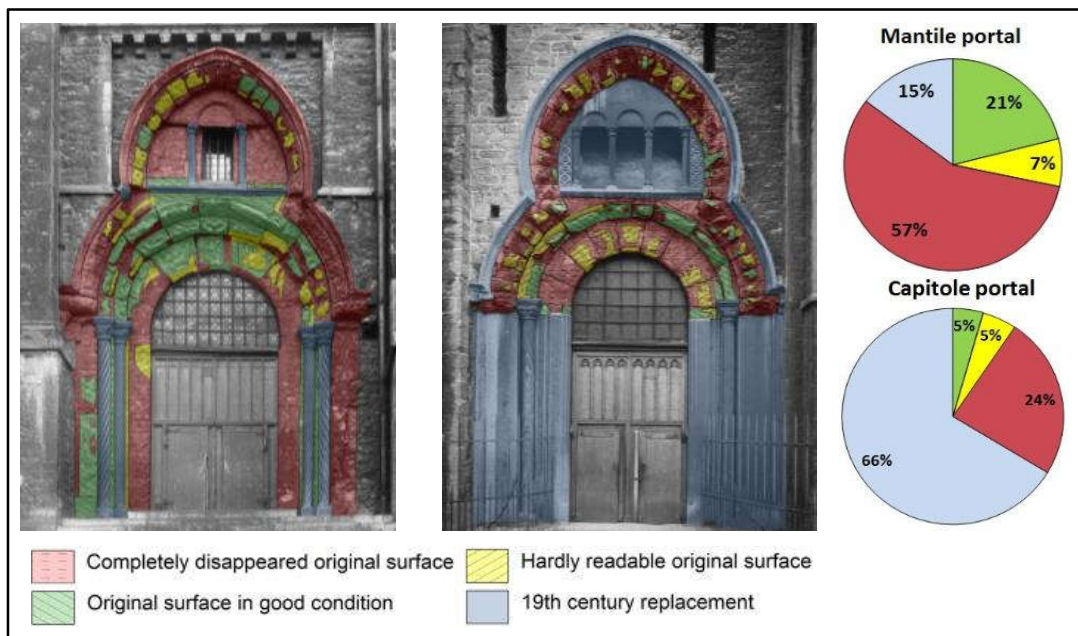
A general mapping describing the state of the sculpted surface comprises four different categories: first of all sculptures with an original surface in good condition, secondly stone blocks with an original surface that is hardly readable, thirdly original stone surfaces that have completely disappeared and lastly 19th-century replacements (Fig. 5).

Fig. 5: General mapping and diagrams of the state of conservation of the sculpted surface. Mantile portal (left) and Capitoile portal (right) © KIK-IRPA, Brussels.

Unfortunately hardly 5% of the finely detailed Romanesque sculptures remains for the *Capitole* portal and 21% for the *Mantile* portal. In total 66% of the *Capitole* portal and 15% of the *Mantile* portal was replaced by Belgian bluestone in the 19th century, leaving only around a third of the original stone of the *Capitole* portal while the *Mantile* portal still contains 85% of its original stone volumes.

From the mappings it became furthermore clear that orientation of a portal has an influence on its conservation state. Due to its southwest orientation, corresponding to the direction of prevailing winds and ample exposure to the sun, the *Capitole* portal is more deteriorated than the *Mantile* portal, as we can read out of the mappings.
