INVESTIGATION OF THE DEGRADATION PHENOMENA OF THE LUXEMBOURG SANDSTONE IN THE ROYAL MUSEUM FOR CENTRAL AFRICA (BELGIUM)

Hilde De Clercq¹, Laurent Fontaine¹, Sebastiaan Godts¹, Roald Hayen¹, Michiel Dusar²
and Marleen De Ceukelaire²

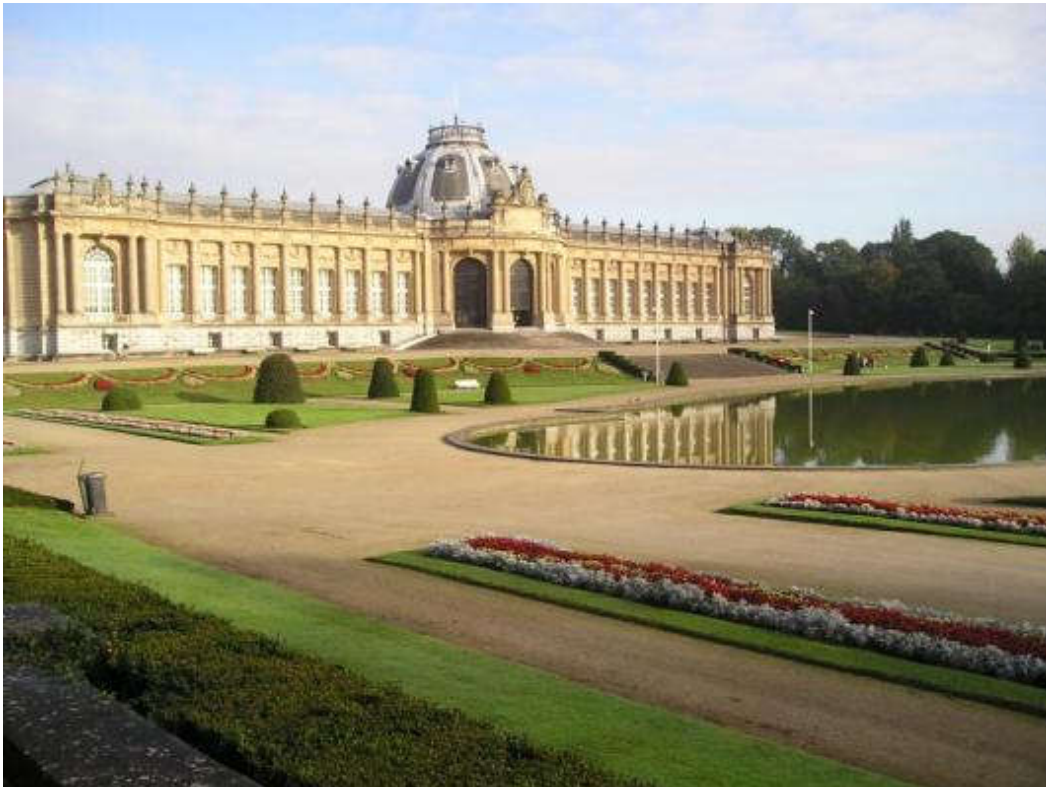
Figure 1. Royal Museum for Central Africa at Tervuren.

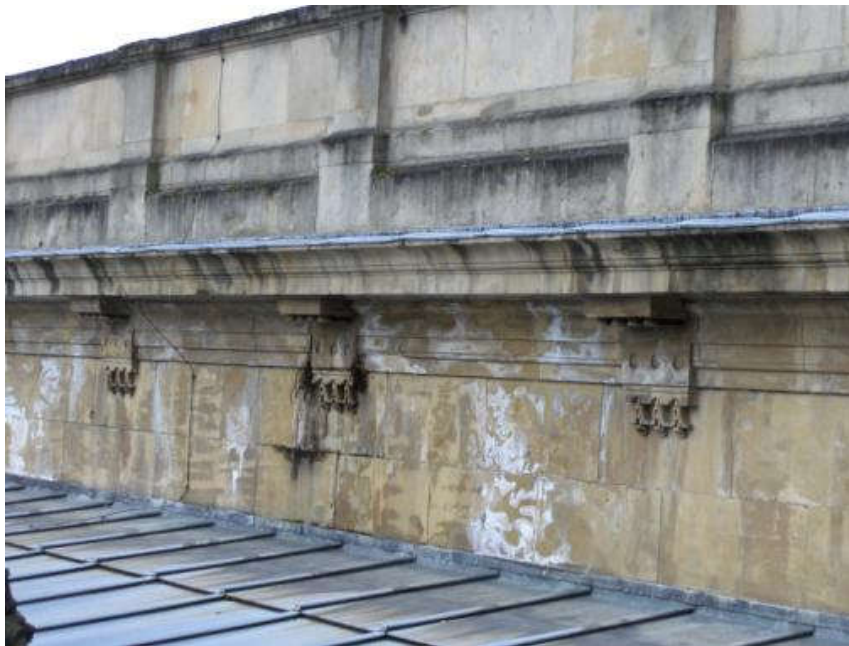
Figure 2. (Salt) staining underneath the cornice where the water evacuation system is hidden behind the wall. Two varieties of the Luxembourg sandstone can be seen: a warm yellow coloured variety below the cornice and a light grayish one above it.

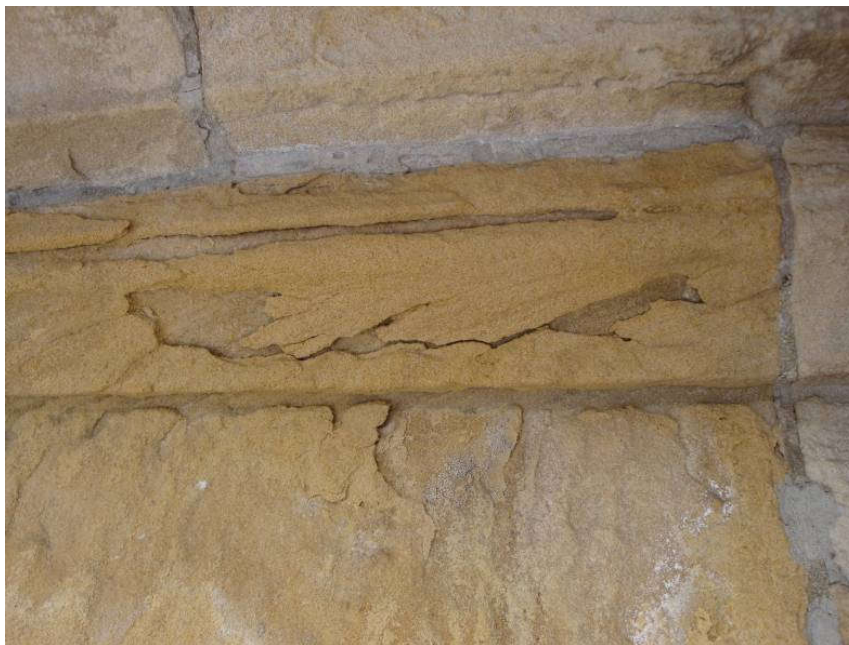
Figure 3. Scaling of the calcareous sandstone blocks underneath the cornice.

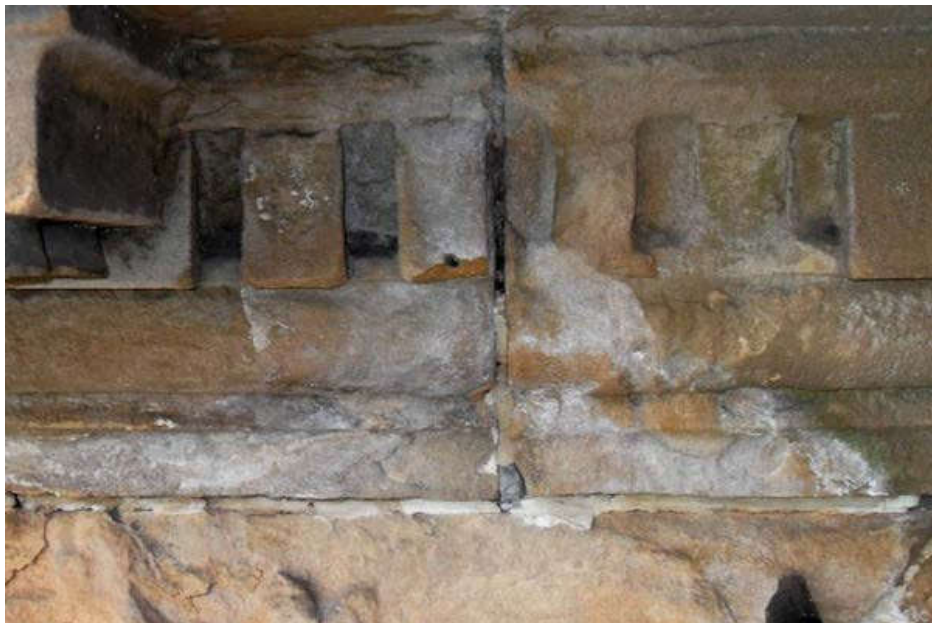
Figure 5. Zone below the cornice showing extensive efflorescence of gypsum and loss of some dentils. The outer cm of the stone contains gypsum (2 wt%, further decreasing with depth).

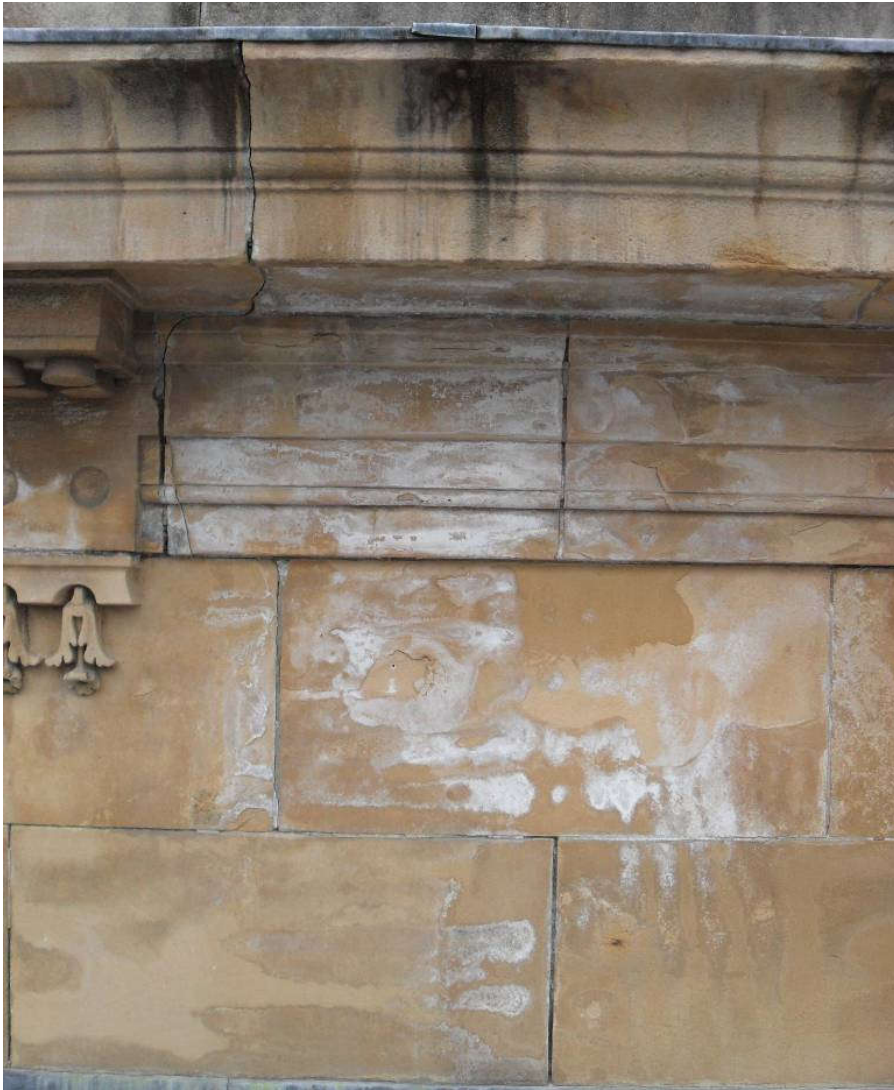
Figure 6. A high amount of gypsum efflorescence is seen, while scarce amounts of salts are detected in the underlying stone.

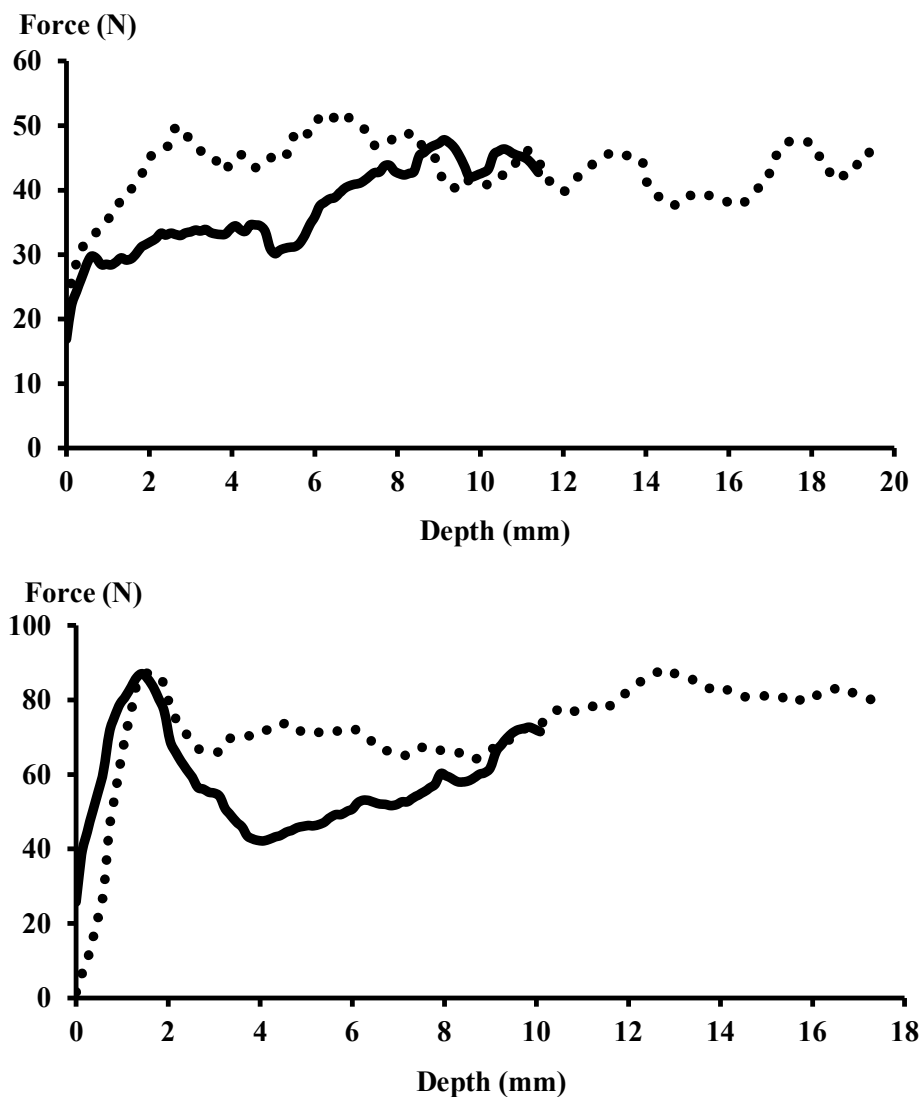
Figure 7. Hardness profiles of Luxembourg sandstone characterized by a weathered zone of 7 mm (upper part) and by a calcinated layer of a few millimeter depth (lower part) before (solid line) and after (dotted line) 3 applications with a 100% solution of TEOS.
