A. Frankl, J. Poesen, J. Moeyersons, and J. Nyssen

In the Tigray highlands, gully development is linked to poverty-driven unsustainable use of the land in a vulnerable semi-arid and mountainous environment, where intense rainfalls challenge the physical integrity of the landscape. Over the last two centuries, three major phases in the hydrological regime of the region could be distinguished. In the first phase, between 1868 (or earlier) and ca. 1965, the relatively stable gully channels showed an oversized morphology inherited from a previous period when external forcing of environmental conditions caused significant channel development. In the second phase (ca. 1965–ca. 2000), increased aridity and a continued vegetation clearance accelerated dynamics of the gully system. A sharp increase in gully headcut retreat rates, network densities and volumes could be quantified for that period. With the widespread implementation of soil and water conservation measures, erosion rates decreased, which announced the start of the third hydrogeomorphic phase since ca. 2000. In 2010, about one-fourth of the gully channels were stabilized. These hydrogeomorphic developments correspond to a gully

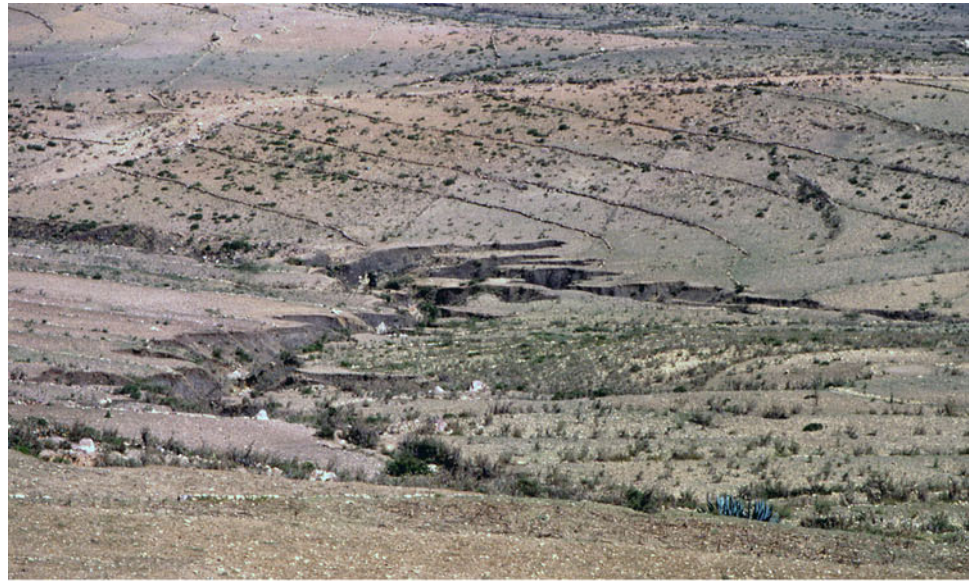
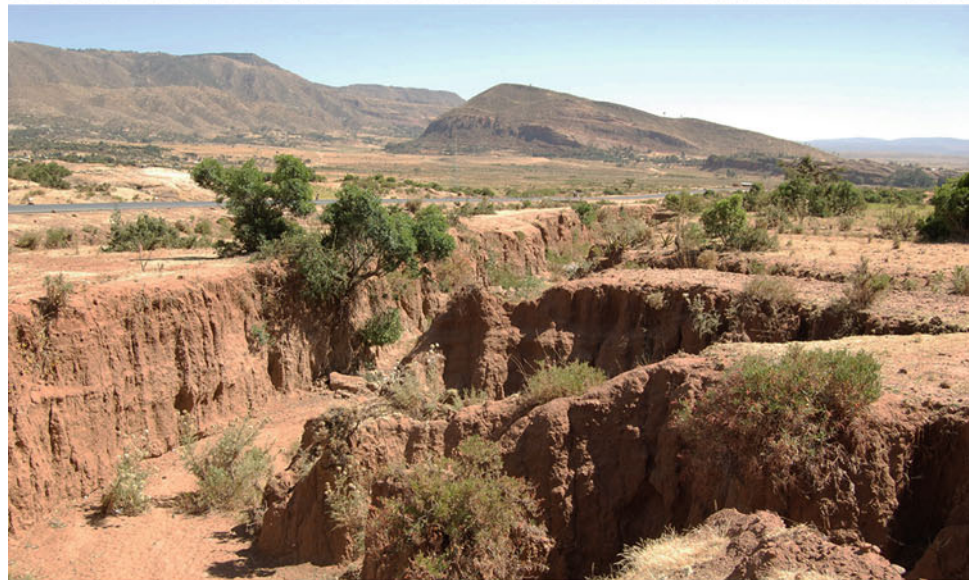
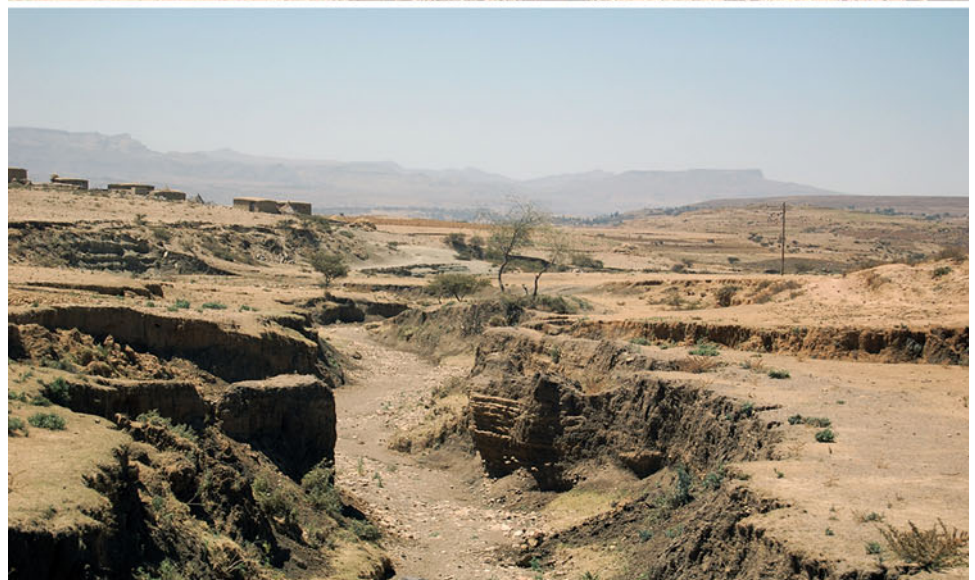
Fig. 10.1 Active gully channel networks in a barren landscape of Tigray highland (*Photographs by Jean Poesen—top, and Piotr Migoń—middle and bottom*)

Several studies reported significant gully erosion in Ethiopia and especially addressed the Tigray highlands (Fig. 10.1; Virgo and Munro 1978; Berakhi and Brancaccio 1993; Nyssen et al. 2000, 2002, 2004, 2006; Billi and Dramis 2003; Munro et al. 2008; Reubens et al. 2009; Frankl et al. 2011, 2012, 2013b, c, d). Among the first, Virgo and Munro (1978) assessed the status of soils and landscapes in northern Ethiopia, documenting numerous cases of severe gully erosion. The importance of gully erosion in Vertisols, which are susceptible to soil piping, was discussed by Nyssen et al. (2000). Berakhi and Brancaccio (1993) and Nyssen et al. (2006) studied the effect of road building on gully erosion risk, and Nyssen et al. (2004) investigated the usefulness of check dams to control gullies. Nyssen et al. (2006) analysed the development of four gully systems in the Tigray highlands by developing a field method which is based on how local people remember the evolution of specific gullies. A similar approach was used by Moges and Holden (2008) who studied gully development in southern Ethiopia. A small gully network in eastern Ethiopia was studied by Daba et al. (2003), using a time series of digital elevation models derived from small-scale aerial photographs. An analysis of the development of gully headcuts, their cross sections, networks and volumes at regional scale in Tigray highlands was carried out by Frankl et al. (2011, 2012, 2013b, c, d). By using repeated terrestrial photography, aerial photographs and satellite images, these authors could define distinct phases in gully erosion development since the late nineteenth century. Nigussie Haregeweyn et al. (2005, 2008) linked the presence of gullies to the rate of reservoir sedimentation (catchment sediment yield).

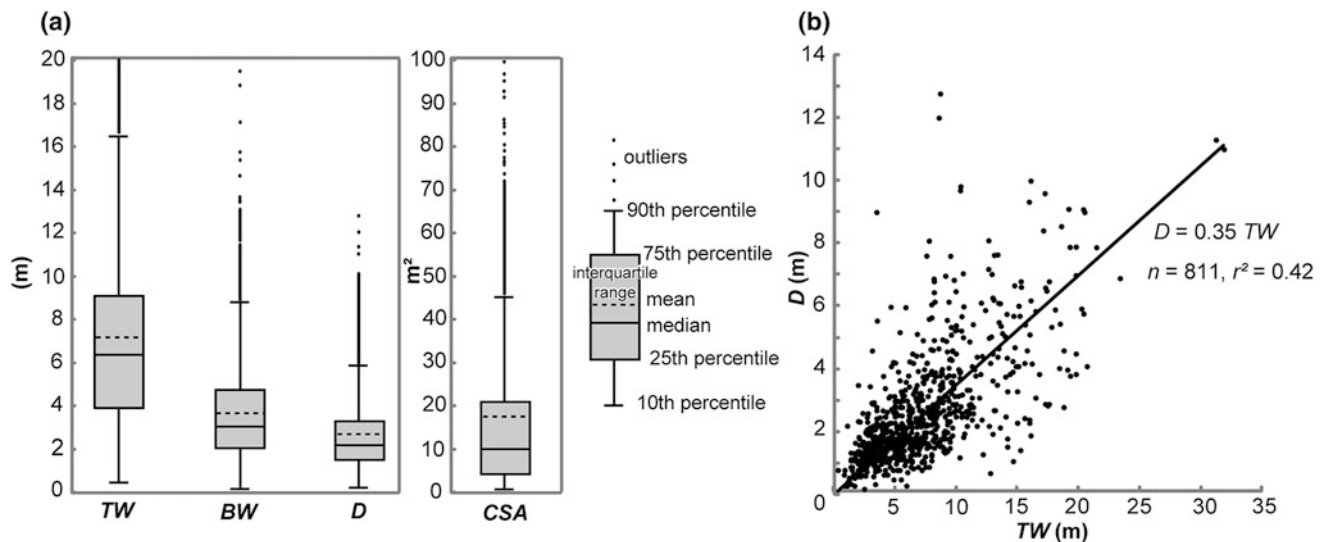
Fig. 10.2 Cross-sectional characteristics of gullies in Tigray highlands (Frankl et al. 2013c). **a** Boxplots for gully top width (TW), bottom width (BW), depth (D) and cross-sectional area (CSA) for 811

sections. Outliers larger than 20 m and 100 m² are not displayed, **b** plotting gully depth (D) over gully top width (TW) shows a linear relation. Based on Frankl et al. (2013c)

Frankl et al. (2013c) characterized gully cross-sectional characteristics in the Tigray highlands by surveying 811 gully cross sections in various environments, reflecting contrasts in lithology, topography, soil, land use and climate. Gully top width (TW) varied between 0.35 and 31.90 m, with a median of 6.34 m. Gully depth (D) varied between 0.20 and 12.77 m, with a median of 2.15 m, and bottom width (BW) ranged between 0.10 and 19.50 m, with a median of 3.00 m. The median cross-sectional area (CSA) was 10.1 m² and ranged between 0.15 and 236.5 m². As the boxplots show (Fig. 10.2a), the distributions are right-skewed and the variability of the observations, as indicated by interquartile range, is higher for TW (5.20) and BW (2.70) than for D (1.79). The median $TW-D$ ratio was 2.7, while the median $BW-TW$ ratio was 0.5. Note that for TW/D and BW/TW , median and mean do not differ much as the distributions are nearly normal. As shown in Fig. 10.2b, plotting D over TW shows wide scatter around a linear relation purged through the origin (0, 0).

Catchment area is the most important factor explaining the variability in TW , D and CSA , as it reflects the volume of water that drains to a certain point in the landscape. However, the large variability in soil management and environmental characteristics causes the gully shape and size to be locally very variable. As shown by Frankl et al. (2013c), besides the catchment area, lithology and the presence of check dams are the most important explanatory factors to account for gully morphology in the Tigray highlands. Gully cross sections in shale-derived deposits are on average 36.7 % larger than those in deposits derived from volcanics. This is mainly related to the higher erodibility of shale-derived materials and to the presence of travertine dams. Degradation and breaching of the latter

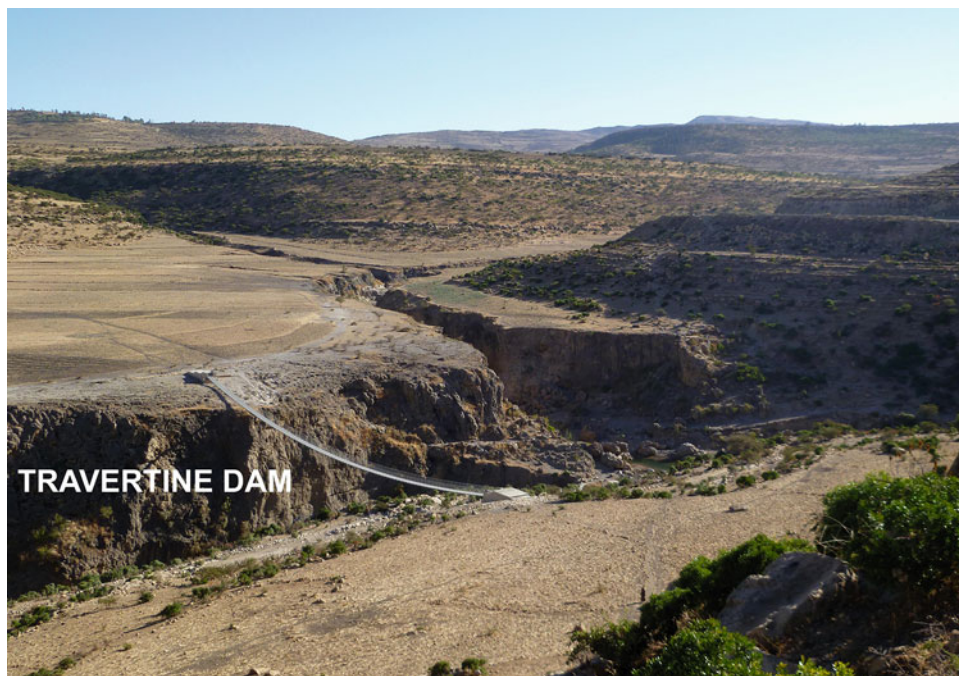
Fig. 10.3 The deeply incised travertine dam at May Mekdan and gully network upslope (Photograph of 2010 by Amaury Frankl; 13.58°N, 39.56°E)

(Moeyersons et al. 2006; Fig. 10.3) triggers regressive erosion and exposure of thick, fine-textured soils locked upslope of the dams. Check dams, which are successfully implemented in low-active gully sections, cause the gully depth to decrease by circa one-third. This makes moderately active gully cross sections with check dams on average 33.5 % smaller than those of very active gullies without check dams.

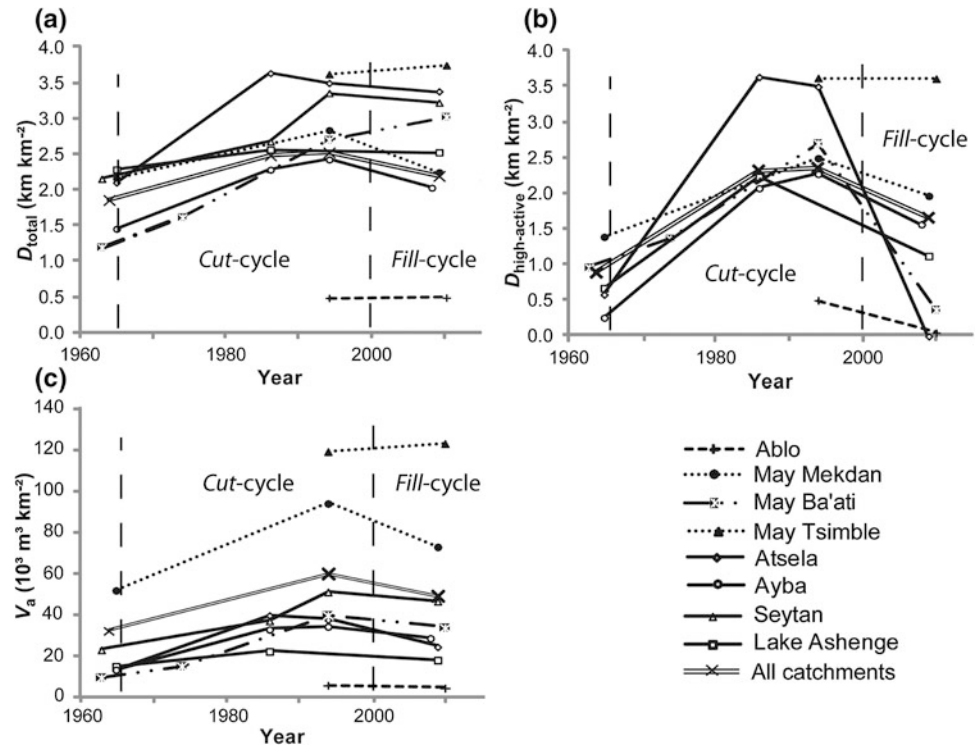
Fig. 10.5 Gully cut-and-fill cycle during the period 1963–2010 as expressed by trends in total drainage density (D_{total}) (a), drainage density of the high-active gullies ($D_{\text{high-active}}$) (b) and area-specific volume development (V_a) (c). Based on Frankl et al. (2013b)

In 1963–1965, gully drainage density (D_{total}) and area-specific gully volume (V_a) were still relatively low, i.e. 1.86 km km^{-2} and $32.23 \times 10^3 \text{ m}^3 \text{ km}^{-2}$, respectively (Fig. 10.5a–c). 48 % of the gully network was high-active. From a largely low-dynamic gully system in the 1960s, network expansion and increased erosion rates in the 1980s and 1990s caused the drainage density and volume to peak in 1994. D_{total} was then 2.52 km km^{-2} and $V_a 60 \times 10^3 \text{ m}^3 \text{ km}^{-2}$, with 93 % of the gully network being highly active (Fig. 10.5a–c). This corresponds to a soil losses by gully erosion (SL_g) of $17.6 \text{ ton ha}^{-1} \text{ year}^{-1}$ over the period 1963–1994. The terrestrial photographs from that period show gullies which were very active, having clear-cut walls and transporting considerable amounts of debris (Fig. 10.1). The average incision rate of gully cross sections was 0.04 m year^{-1} , and maximum incision rates of 0.13 m year^{-1} were observed in Vertisol areas (Frankl et al. 2011). At the upper gully margins, headcuts incised upslope, while at the lower ends, debris fans were deposited and incised subsequently. Long- to medium-term linear headcut retreat rates (R_l) were on average $3.8 \pm 4.7 \text{ m year}^{-1}$ (Frankl et al. 2012). This gully *cut* cycle, that started in the mid-1960s, lasted until ca. 2000, after which a new gully *fill* cycle was initiated.

This gully fill cycle is well evidenced by the analysis of aerial photographs and more recent satellite images (Frankl et al. 2013b). This analysis indicates that average D_{total} and V_a decreased to 2.20 km km^{-2} and $48.96 \times 10^3 \text{ m}^3 \text{ km}^{-2}$, respectively (Fig. 10.5a–c). Even more important is the decrease in average $D_{\text{high-active}}$ to 1.65 km km^{-2} , indicating that 25 % of the gully network had become low-active. These findings are also supported by repeat-photography studies, indicating that in 2006–2009, about 23 % ($n = 8$) of the channel cross sections were stabilized and had cross-sectional characteristics similar to those of the pre-1963 gullies (Frankl et al. 2011). Among the other 31 gullies and river sections studied from repeat photography, 44 % were highly active, whereas 23 % were in a transitional stage. Strong channel degradation can be the result of a clear-water effect, which causes the gullies in the valley bottoms to incise. This can be facilitated by the presence of thick, erodible alluvio-colluvial deposits in valley bottom position.
