# THE CONSERVATION-RESTORATION OF ARCHITECTURAL STATUARY IN ACCORDANCE WITH THE ETHICAL REQUIREMENTS FOR SCULPTURE AND ARCHITECTURE

DE CLERCQ Camille<sup>1</sup>, DE ROY Judy<sup>2</sup>

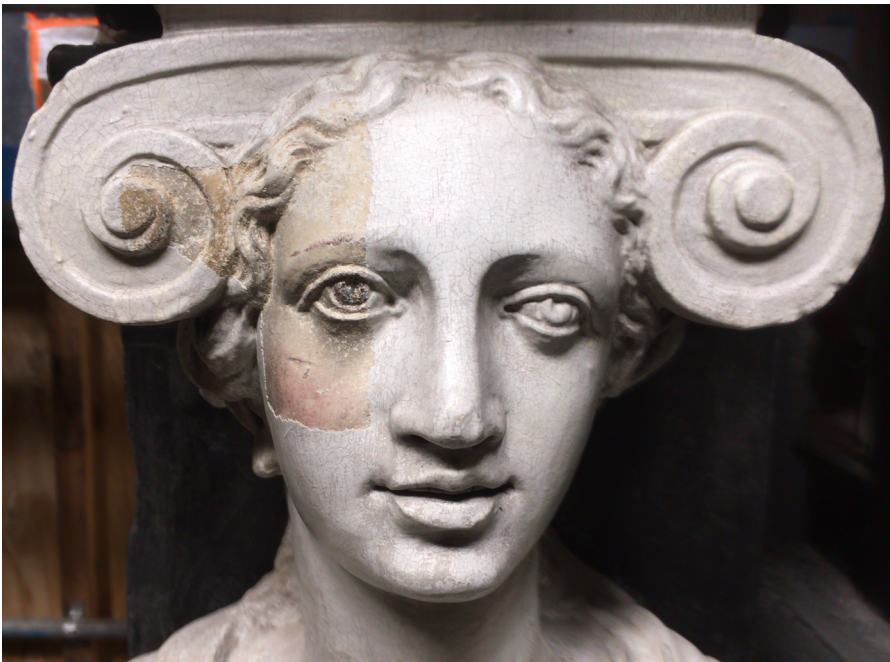
Fig. 1 Eucharistic tower, Hiëronymus Duquesnoy, 1604 (Sint-Martinuskerk, Aalst): detail of a stratigraphic window on the architecture around the sacrarium (southside). Multiple layers of overpaint cover original alabaster imitation (© KIK-IRPA, Brussels, Camille De Clercq)

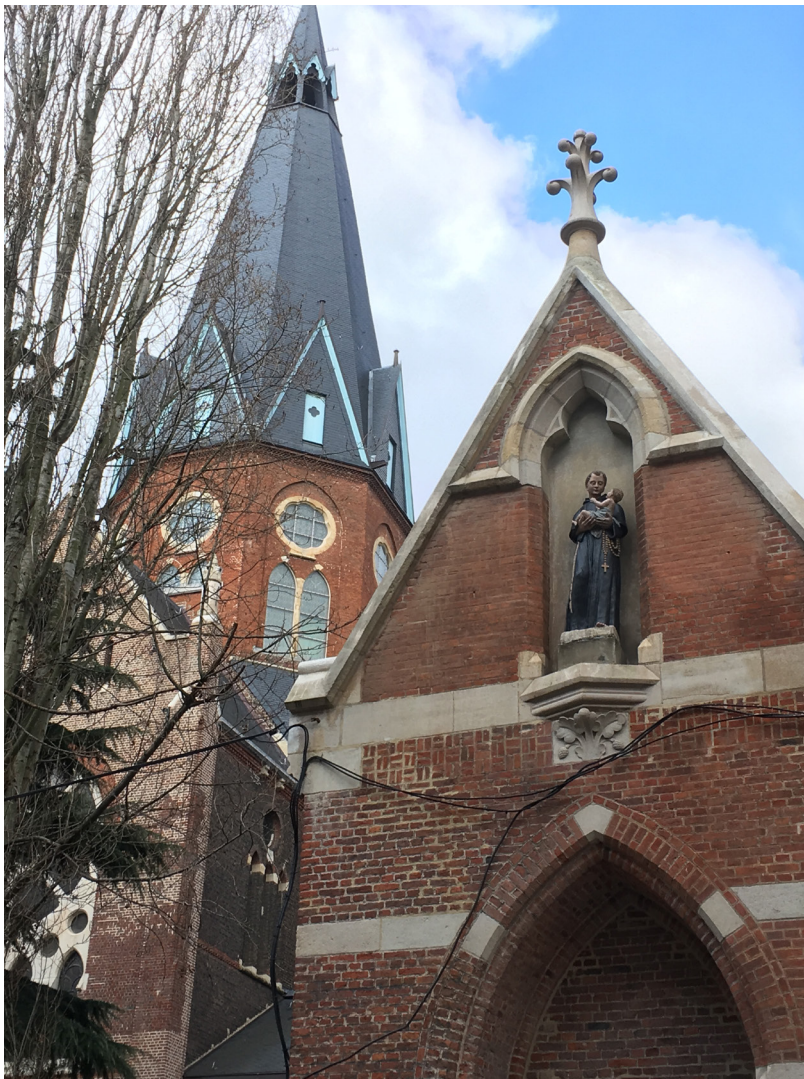
Fig. 2 Statue of Saint Anthony in situ, Georges Houtstont, ca. 1868 (© KIK-IRPA, Brussels, Sam Huysmans). After treatment

The 138-centimetre-tall statue of Saint Anthony is conserved outdoors in its original niche at a height of 8 meters. It makes part of a completely preserved neo-Gothic site in Brussels, consisting of a church and a convent created by architect P.J.H. Cuypers (16 May 1827 – 3 March 1921) in 1868. Saint Anthony, patron of the church community, is represented in a typical way and with his usual attributes. He is wearing the Franciscan habit, with a rope belt and a large rosary hanging from his robe. He holds the Infant Jesus in his hands.

After an outdoor exposure of 150 years, the conservation state of the sculpture was problematic. The most badly weathered parts are situated at the bottom of the right arm and

at the base. Infiltration of rainwater and rising damp in combination with frost action provoked a series of small cracks and delamination resulting in material loss. The terracotta surface of the sculpture was largely unprotected as a large part of the paint layer was missing. Stratigraphic investigation however showed that the sculpture was originally finished with a paint layer. The realistic effect of the statue was emphasized by this elaborate polychromy. The soutane resembled black velvet with a yellow-brown rosary and the Infant Jesus wore a light blue lincloth. The original polychromy is well preserved on the flesh tones but largely disappeared on the robes vestments, especially on the front side. The statue was overpainted twice. First in colours similar to the original polychromy and later with a whitish paint layer. The binding media were not fully identified. However, there is evidence that all the paint layers were bound in an oil medium.

It is obvious that the priority of the conservation treatment is to stabilize the terracotta support. The cracks where rainwater could infiltrate were filled and the statue's partly broken base was consolidated. To keep the intervention to a minimum, broken parts that do not have a supporting function such as the monk's sleeve and the Child's limb have not been restored.

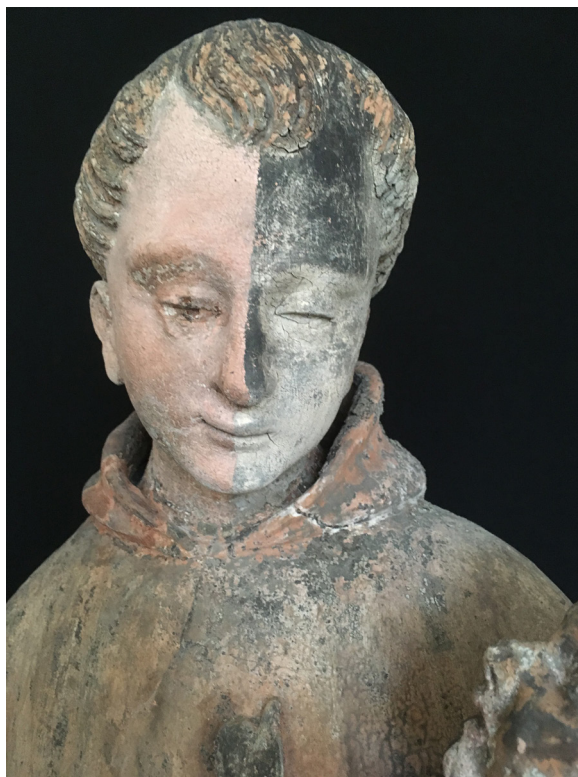
Fig. 3 Statue of Saint Anthony, Georges Houtstont, ca. 1868, polychrome terracotta. The group during the treatment, still covered by greyish overpaint on the right; on the left, the polychromy cleared of the overpaint which weighed down on it (© KIK-IRPA, Brussels, Camille De Clercq)

Since the expression of the face of Saint Anthony was completely lost, we decided to test the possibility of removing the whitish overpaint. The result was aesthetically very satisfying (Fig. 3). Unfortunately, this approach could not be applied on the other parts of the sculpture as the polychromy had largely disappeared. On the front side of Saint Anthony's robe for example, there were hardly any remains of the original paint layer.

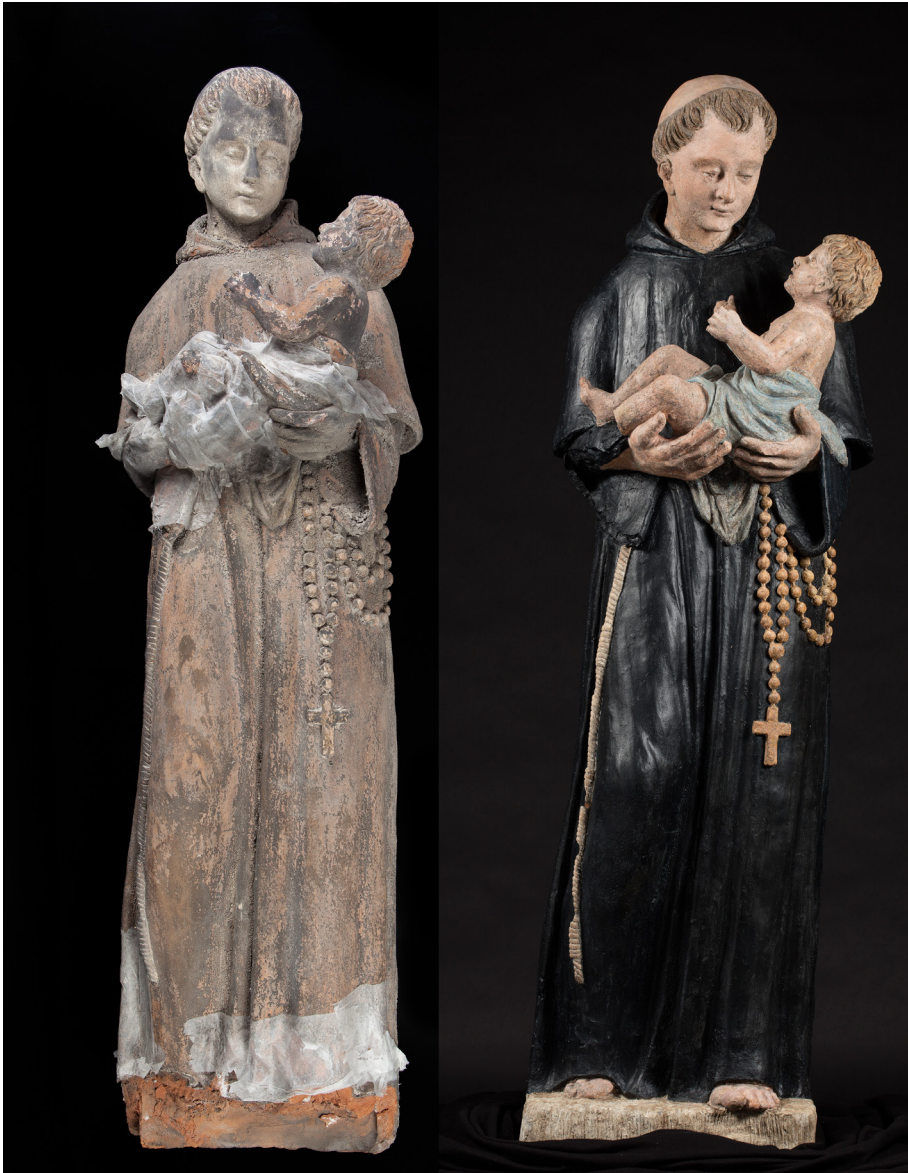
Fig. 4 Statue of Saint Anthony, Georges Houtstont, ca. 1868. Before treatment on the left; on the right after treatment. Partially repainted the statue has, next to an aesthetic and iconographical function, also a very important protective function against the severe weather conditions. (© KIK-IRPA, Brussels)

An important element in the decision-making on the conservation-restoration treatment is the location of the sculpture, as both the owners and the architect were strongly in favour of keeping the sculpture in its original niche. However, because the statue must be replaced outside, a protection of the damaged surface against severe weathering conditions was an absolute necessity. The fragile terracotta support definitely needed a protective coating. Therefore, we decided to remove the whitish overpaint on the flesh tones and recover the vestments with reversible conservation paint products in their original colour scheme (Fig. 4). The remains of the original polychromy were preserved underneath this new layer of paint, as a historical witness. As new painting materials a ground layer ("Gesso", an acrylic coloured ground layer from Golden) and paint (Golden MSA) were used<sup>1</sup>. They have both been tested at the KIK-IRPA during a 10-year period with very good results: good colour, good attachment, no peeling and perfectly reversible.

As a depiction of the patron of the church and the convent, the polychrome statue has a very high religious value. Partially repaint the statue has, next to an aesthetic and iconographical function, also a very important protective function against the severe weather conditions.

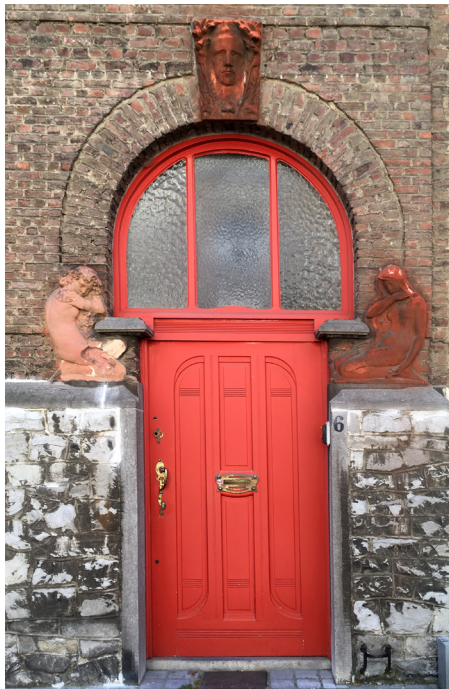
During our inspection, it appeared that only one of the three reliefs from the façade was still the original made out of red baked terracotta. Apparently, the two others were replaced by replicas in a terracotta-coloured mortar. It was only during our study that the landlords informed us about an unexpected and interesting fact: another copy of the central figure was kept in their garden. After our examination it appeared that the 'garden relief' was not a copy, but the original terracotta representing the portrait of the painter (Fig. 6). So instead of three original terracotta reliefs on the façade, there was only one original on the façade,

Fig. 5 Three reliefs, Pieter Braecke, 1902, from the street façade of the private house of the Symbolist painter Emile Fabry in Woluwe-Saint-Pierre. Only one of the three reliefs, the kneeling female on the left, is still the original made out of red baked terracotta. The two others were replaced by replicas in a terracotta-coloured mortar. (Brussels) (© KIK-IRPA, Brussels, Camille De Clercq)

The deterioration of all four of them was advanced. The deterioration pattern of the two terracotta reliefs is mainly determined by the presence of cracks and delamination resulting in material loss on the entire surface. This damage was, as with the statue of Saint Anthony in our first case study, provoked by the combination of water seepage and frost. The thinner parts, such as the flowers in the hair of the left female character seemed to be very sensitive to this process as they were severely damaged. Furthermore, a lot of previous restorations were aesthetically disturbing. Lacunae were filled with gypsum or cement-based mortars. Apart from the colour difference with the terracotta their composition is inadequate for outdoor use or incompatible with the original material. Concerning the two mortar copies we can say that, despite their formal compatibility with the original sculptures, their state of conservation wasn't satisfactory either. The indefinite mortar was damaged by physical and chemical degradation, resulting in an uneven surface. Furthermore, we could observe black crusts.

It was decided that the original reliefs in terracotta were too fragile to be exposed outside in the future. The old mortar copies wouldn't be re-used either because they are also not suited to be exposed in an outdoor situation.

Therefore, we proposed to make three new replicas with a lime-based mortar<sup>2</sup> in a terracotta colour for the decoration of the façade and preserve the original reliefs in a protective environment. At the moment, the discussion concerning the future place of conservation of the originals is still ongoing. In fact, two options have been suggested. Firstly, as the reliefs were especially specifically designed for this house, conserving them inside this house could be a possibility. Another option would be to display the reliefs in a public space. The originals could be exhibited in the town hall of Woluwe-Saint-Pierre or at the museum of the CIVA foundation in Brussels, specialized in architecture.

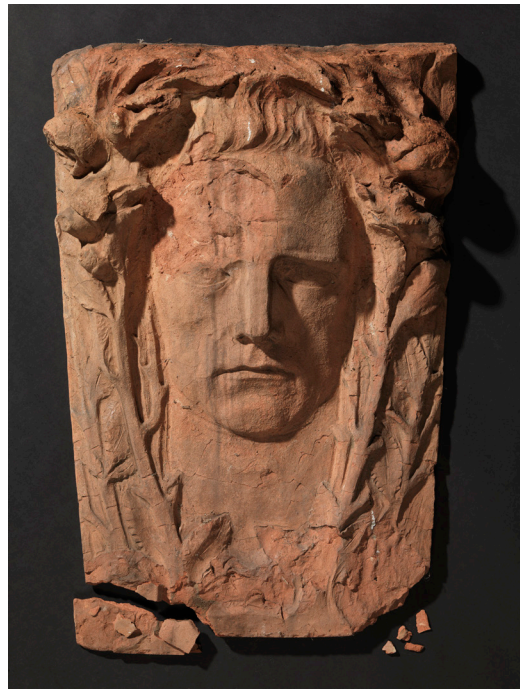
Fig. 6 The original terracotta relief representing the portrait of the painter, for years kept in the garden of the landlords, FIGcliché x108851 (© KIK-IRPA, Brussels)
