How the study of polychromy sheds fresh light on a previously proposed laser treatment

Royal Institute for Cultural Heritage (KIK-IRPA, Brussels)

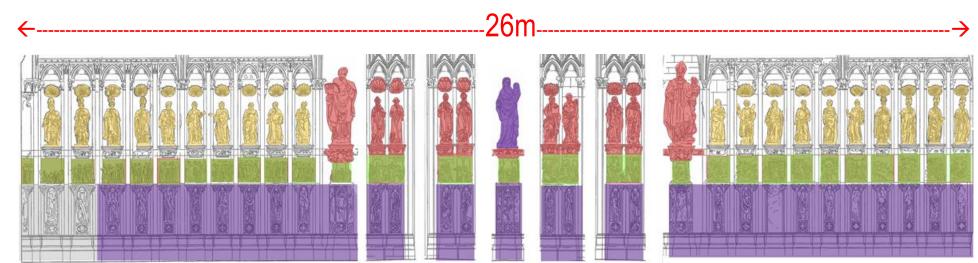
Figure 1

The statuary of the western facade (Fig. 2) of the cathedral of Our Lady of Tournai (Belgium) has been mutilated and transformed throughout its history, resulting in an eclectic combination of Gothic, Renaissance, early Baroque and late Baroque sculpture (Fig. 1). Protected by a sixteenth-century porch, the many reliefs and statues form an ensemble that occupy the entire width of the facade.

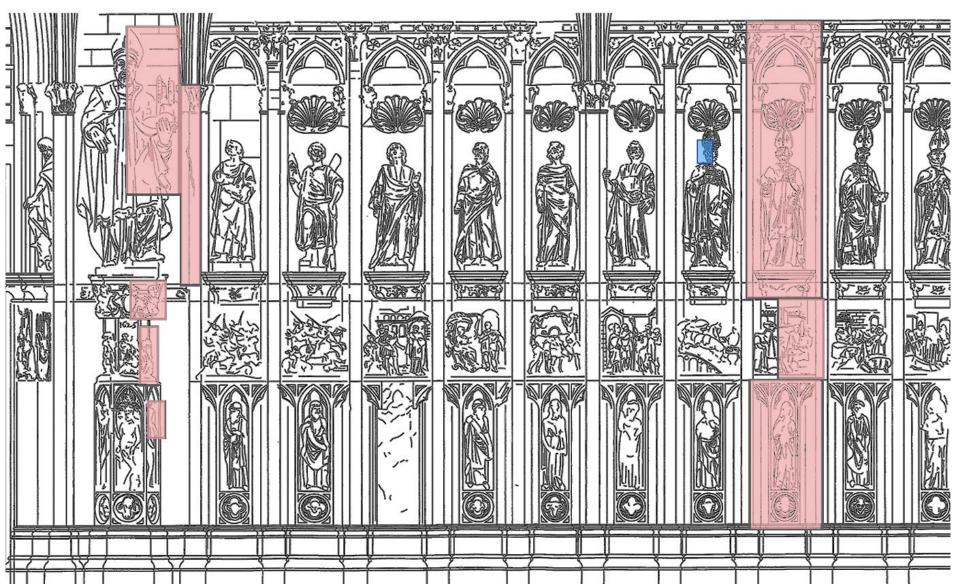
Figure 13

The pilot project included several tests on different large areas (Fig. 13) to evaluate the compatibility and aesthetic result of our newly proposed treatment.

Previous laser cleaning test KIK-IRPA pilot project

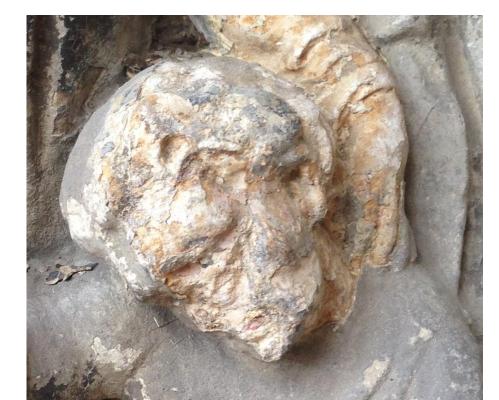
Figure 5

The stratigraphic study revealed that the ensemble was originally completely embellished with polychromy. The colors have completely disappeared on the gothic statuary made of stone of Tournai and largely disappeared on the renaissance elements (Fig. 5). The Baroque statues still contain large polychrome areas underneath the black gypsum crusts, allowing to reconstruct the original color scheme. A striking example is the statue of Saint Eleutherius (Fig. 3). Painted en camaïeu and adorned with gilded details to create highlights, the statue gives a vivid picture of the early baroque color scheme and of the modeling obtained by light and shade.

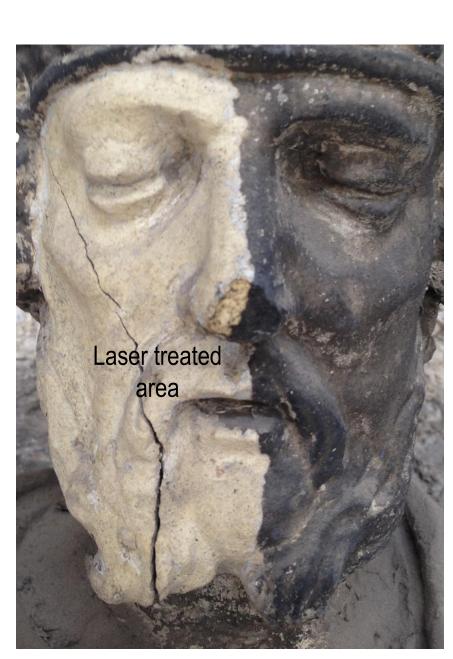
Figure 10

In order to compare the laser cleaning method with mechanical cleaning, a head of a statue in Avender stone with monochrome paint layers adjacent to the statue with the laser test was chosen. The laser cleaning (Fig. 10) is able to remove ingrained crusts and clean fissures on the stone surface. However a yellowish surface remains and results in an unnatural appearance.

A possible explanation for the aspect difference could be the fact that Q-switched laser pulses can cause the temperature to be increased significantly because of the high temperature gradient of IOsK/cm [1] (Cooper [2] estimated that a Q-switched Nd: YAG pulse can induce a temperature rise of – 1500° C to the carbon layer and -170° C to the limestone).

Pilot project

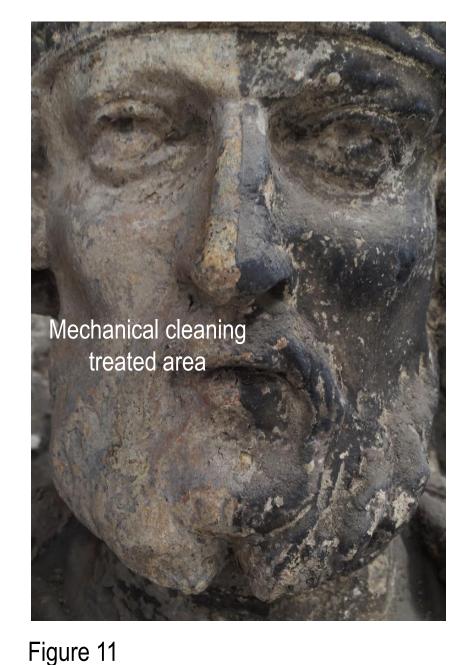
Mechanical cleaning (Fig.11) was executed with brushes, scalpels and an ultrasonic scaler. However, although the area appears dirtier from close-up, it ensures preservation of the monochrome paint without discoloration. Seen from a normal viewing distance the result with mechanical cleaning is very satisfying (Fig. 12). The cleaning rates of the mechanical cleaning can be compared with those of the laser treatment.
