Reconstruction of a flash flood event through a multi-hazard approach: focus on the Rwenzori Mountains, Uganda

Keywords Flash flood · Landslide · Forest fire · Multi-hazard · Equatorial Africa

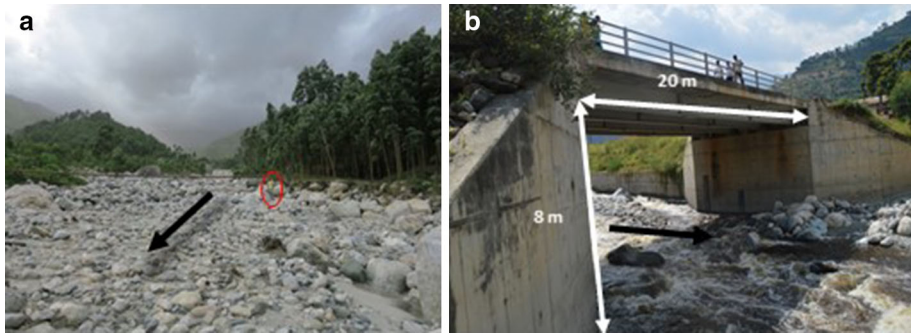
Fig. 4 River cross sections selected for peak flow discharge estimations. **a** River cross section 1, red circle highlights person for scale, photograph taken in October 2014. **b** River cross section 2, photograph taken in September 2015. Black arrows indicate river flow direction

For the reconstruction of the peak flow discharges of the Nyamwamba River, the Manning's equation (Eq. 1) was applied to two river cross sections (Figs. 3, 4) with a

From the comparison of river beds described by Barnes (1967) with the boulder-rich mountainous river (Fig. 4a), the Manning's coefficient was estimated to be between 0.050 and 0.075. This is congruent with the recommendations of Chow (1959). Considering the irregular river bed, variations in the channel cross section, minor obstructions in the river bed by the bridge and the expansion of the river into a eucalyptus forest, the Manning's coefficient was estimated to range between 0.060 and 0.075. The Jarrett's equation (1989) yielded a Manning's coefficient of 0.098 and 0.088 for the first estimation point (cross section 1) and the bridge (cross section 2), respectively.

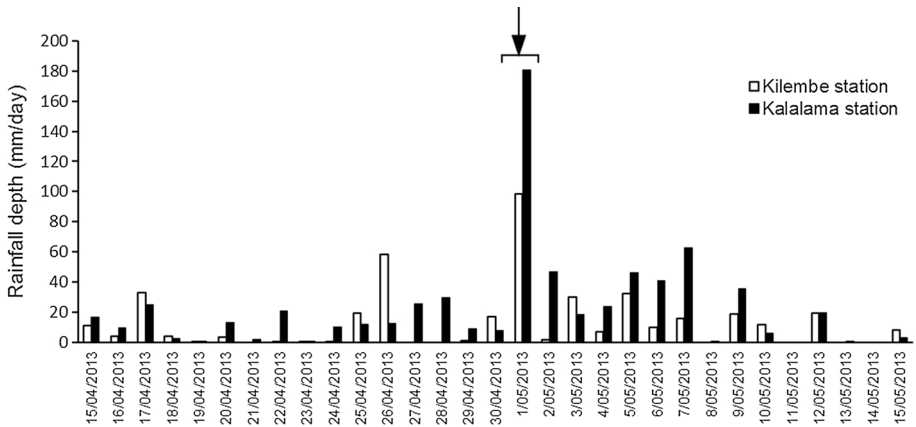
Fig. 5 Daily precipitation at Kalalama and Kilembe rain gauges 2 weeks before and after the flash flood event (indicated with arrow)

On May 1, 2013, 180.6 mm of rainfall was measured at Kalalama camp and 98.3 mm in Kilembe (Fig. 5). The days preceding the event were characterized by variable, but generally moderate to low rainfall depths, except for 58 mm on April 26, 2013, in Kilembe

(Fig. 5). Large differences in rainfall depths between both stations are observed, pointing to a high local variability of precipitation, with generally higher rainfall in the upper catchment. Based on the high-resolution regional climate model results by Thiery et al. (2015), the 24-h precipitation depth of 180.6 mm was exceeded four times at Kalalama camp between 1999 and 2008 and its estimated return period is 2.9 years. From reports on this flash flood (LIDEFO 2013; Reliefweb 2013), the 98-mm rainfall observed on May 1 in Kilembe town was concentrated in ca. 6–8 h. The return periods for this rainfall observed over 6–8 h were calculated and found to range from 6.6 to 5.3 years, respectively. For completeness, the 3-hourly TRMM 3B42 record (TRMM 2015) was checked from April 25, 2013, to May 5, 2013, but no peaks larger than 3 mm/h were detected in that time span, and this can be due to the crude spatial resolution of the satellite product (0.25°) compared to the catchment size.

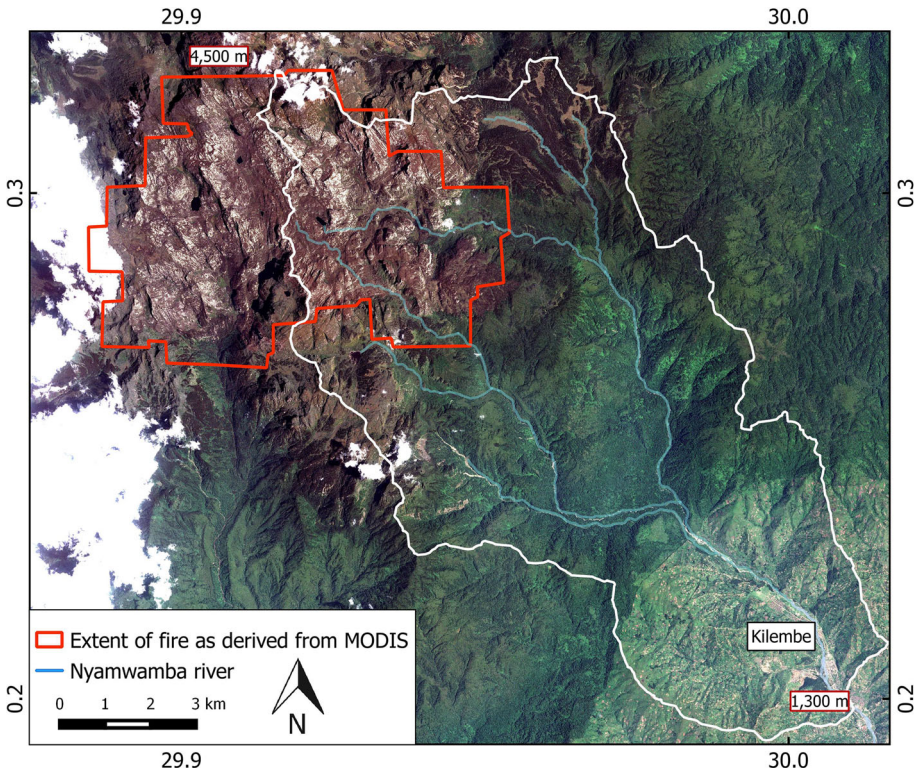
Fig. 6 Extent of the fire determined using MODIS imagery overlain on the SPOT 6 pan-sharpened image acquired in January 2013. MODIS pixels are of 1-km resolution: Hot pixels from multiple scenes are used to outline the maximum extent of the burning area

Using the MODVOLC algorithm, a fire was detected between February 9 and 11, 2012. Based on the MODIS imagery for these dates, an area of 42 km^2 could be delineated as the maximum extent of the fire given that the burning surface may not have occupied the entire area of pixels detected as hotspots (Fig. 6). No pre-fire satellite imagery is to our disposal. However, the delineated fire corresponds well to the occurrence of bare rock visible on the SPOT 6 image taken in January 2013, i.e., almost 1 year after the fire (Fig. 6). A total burned area of 19 km^2 was located within the Nyamwamba catchment, accounting for 18 % of its surface area at the second cross section. Given the absence of pre-fire images, we do not know the initial percentage of bare rock. However, in January 2013, 30 % of the burned area in the catchment still consisted of bare rock. This bare rock was also observed in the field in September 2014 and was found to be due to the destruction of vegetation on shallow soils. The effects of this fire were also still largely visible in the heather zone of the national park where a severe reduction in canopy cover and the occurrence of unrecovered soil covered by bare ash spots were observed (Fig. 7). Indeed, after similar fires in the other highland of Uganda, Mount Elgon, the natural heather vegetation has been reported to have a recovery of several years, with large denudation even 2 years after the fire (Wesche et al. 2000).

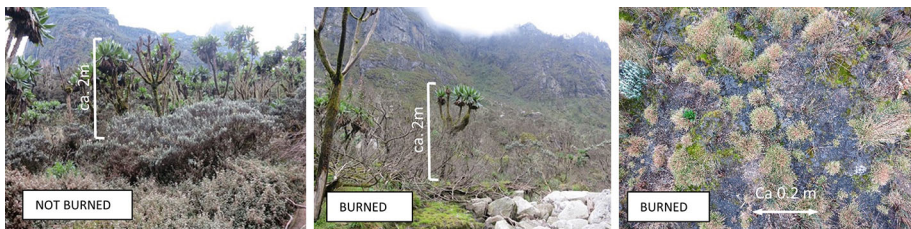
Fig. 7 Photographs taken in the upper Nyamwamba catchment (at ca. 4000 m a.s.l.) in September 2014 illustrating the effect of the fire of February 2012 on the canopy cover (*middle*) and on the ground cover (*right*) in comparison with the intact area (not burned, *left*)

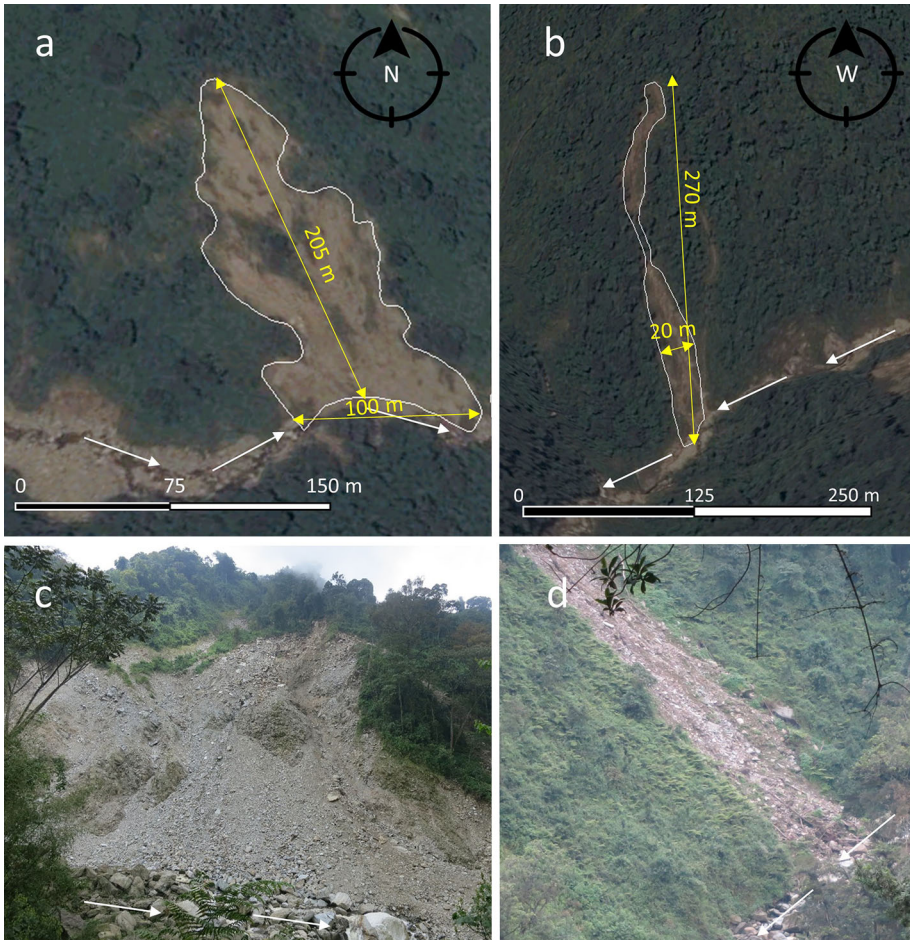
Fig. 8 Illustrations of the two landslide types: **a** and **c** landslides adjacent to the river with large width-to-length ratios. **b** and **d** debris flows with a narrow run-out zone. *Top* landslides observed with GE images, location is given in Fig. 2a, and *bottom* examples observed in the field do not depict the same landslides as **a** and **b**, but serve as illustration. *White arrow* indicates river flow direction

twice the maximal width, hereafter referred to as Type 1 (Fig. 8), and (2) debris flows or slides with typically a narrow run-out zone, not necessarily connected to the river system (length typically larger than three times the maximal width, Type 2; Fig. 8). Based on field observations of deep scour and the typically wide base of the landslides in Type 1, they are interpreted to have been triggered by scour and bank failure at the slide foot. Type 2 landslides are triggered directly by rainfall. This distinction is relevant because of their different triggering mechanisms, and they play a different role in the hazard interactions. Furthermore, the identification of the trigger zone and therefore the analysis of their spatial occurrence strongly depend on this typology. Generally, we consider that Type 2 landslides are not regressive and are triggered at their top, while the Type 1 landslides are triggered close to their base.

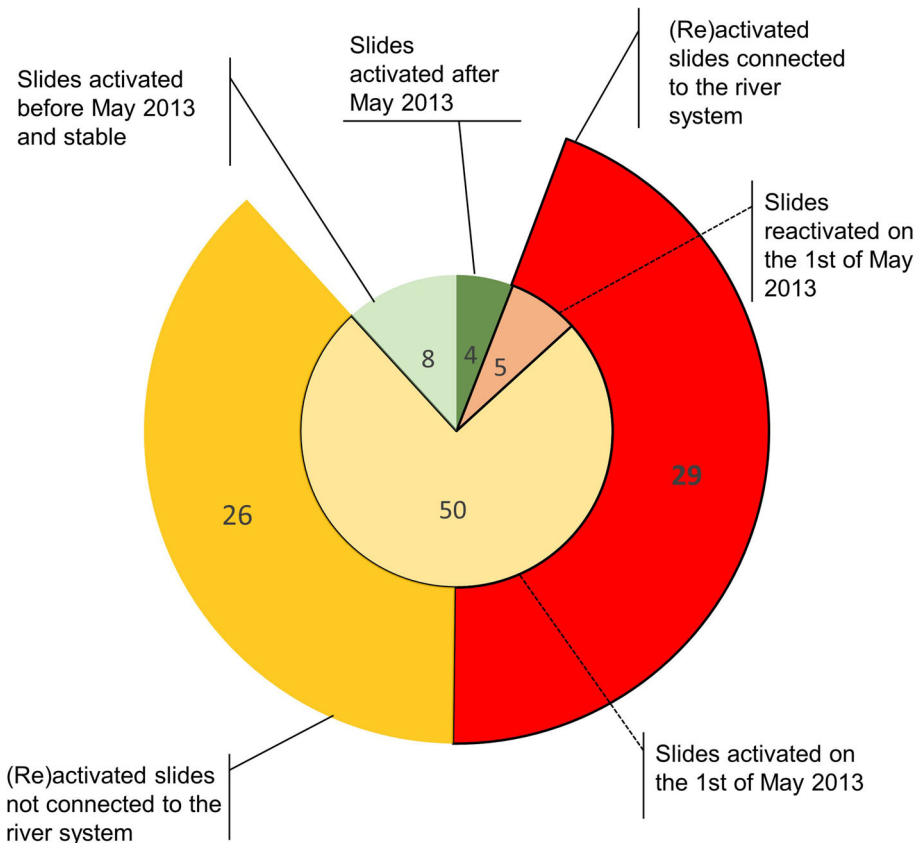
Fig. 9 Summary of the 67 landslides mapped in the Nyamwamba catchment. *Inner circle* all 67 landslides mapped and classified according to their timing of occurrence or reactivation. *Outer circle* subdivision of 55 landslides (re)activated in May 2013 according to their connectivity to the river system

In total, 67 landslides have been mapped covering an area of $207 \times 10^3 \text{ m}^2$ (or 0.2 % of the total catchment area; location: Fig. 2a). Among these, 16 belong to Type 1 (total area of $84,300 \text{ m}^2$), while 45 are Type 2 (total area $119,900 \text{ m}^2$). Six small landslides (length $<50 \text{ m}$, total area 2400 m^2) were not classified. Despite low terrain accessibility, 16 landslides could be validated in the field. Landslides observed on the GE image (2014a) and not on the SPOT 6 image of January 2013 or with a significantly smaller area are assumed to have been (re)activated on May 1, 2013, unless stated otherwise by personal communication with the Rwenzori Trekking service guides. As such, 50 slides were activated and 5 slides reactivated on May 1, 2013 (Fig. 9 inner circle). Of these slides, 15 landslides belong to Type 1 slides, implying that all except 1 of this type of landslide were triggered on May 1, 2013, by high river discharge. These Type 1 slides account for 58 % of the surface of landslide bodies that are candidates for debris supply to the river on May 1, 2013. The remaining slides consist of 34 Type 2 slides and six unclassified slides and are considered to be triggered directly by rainfall. Earthquake activity as a triggering mechanism for these event can be excluded as no major earthquakes occurred early 2013 (USGS 2015). Among the 55 (re)activated slides, 29 are directly connected to the river system and

are considered to be candidates for debris supply (Fig. 9 outer circle). No evidence of river damming was observed in the field; however, a systematic survey of the river channel was not possible due to its poor accessibility. There was also no evidence of landslide damming or lake formation on the satellite images. However, the first post-flood satellite images date from 9 months after the flood (i.e., February 2014), and in contrast to landslides, a build-up and release of a water body behind a landslide dam would not necessarily leave clear spectral signatures 9 months later. Therefore (partial) landslide damming cannot be ruled out with certainty.

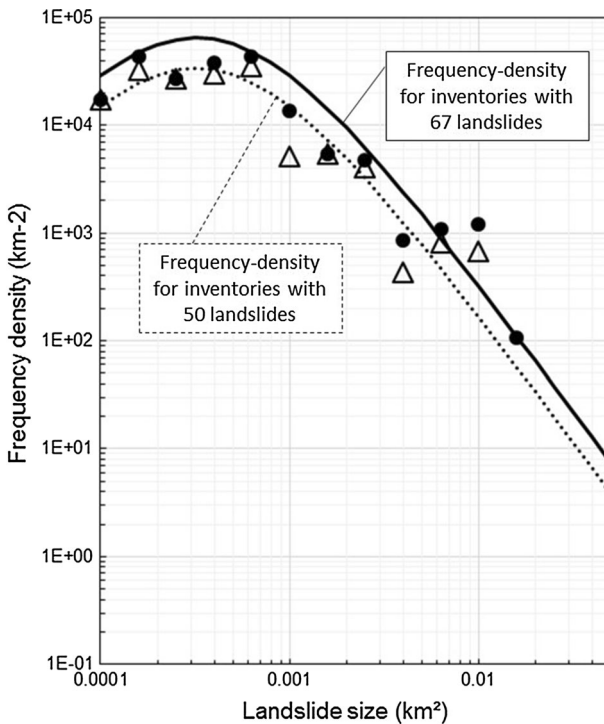
Fig. 10 Frequency density distribution of the entire landslide inventory (*black dots*) and the landslides activated (and not reactivated) on May 1, 2013 (*white triangles*), together with the calibrated theoretical frequency density functions by Malamud et al. (2004) for complete inventories with $n = 50$ landslides [m represents the magnitude of the event and equals $\log(n)$ (Malamud et al. 2004)]

When applying the frequency size distribution by Malamud et al. (2004), we can observe that the landslide distribution of all landslides as well as the distribution of the 50 landslides activated (and not reactivated) on May 1, 2013, follow well the rollover behavior, for theoretical inventories of the same size (i.e., 67 and 50 landslides) (Malamud et al. 2004) (Fig. 10). This theoretical frequency density function holds for complete inventories, but in this case, we only consider the landslides occurring in one catchment. The size distribution function was therefore applied not to demonstrate the completeness of the inventory but to show the general size distribution of the landslides in the Nyamwamba catchment.

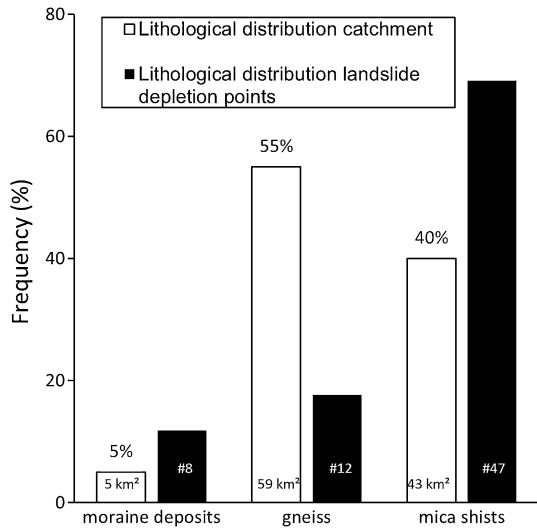
Fig. 11 Distribution (%) of the lithology in the Nyamwamba catchment versus the lithology within the triggering zones of the landslides. #The number of landslides with their triggering zone in a specific lithological class

The material displaced consists mostly of a mixture of rock, debris and large wood. Based on the lithological map (GTK Consortium 2012), Figs. 11 and 2a show that the

landslides are mainly concentrated on the mica schists and moraine deposits (70 and 18 % of the landslides, respectively) even though gneiss is the dominant lithology in the catchment (55 % of the catchment).

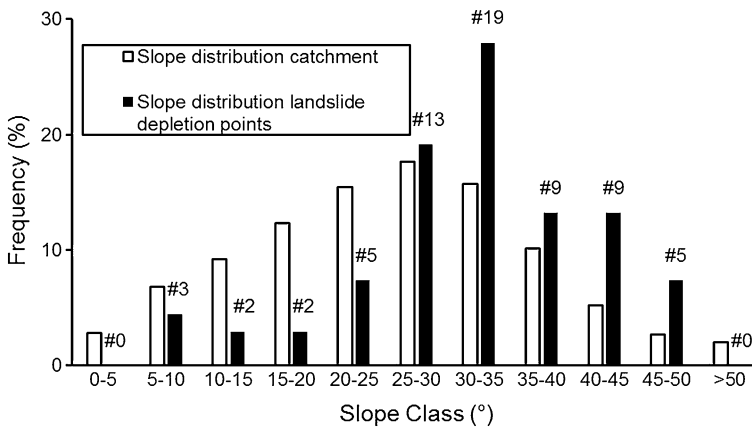
Fig. 12 Distribution of the slope angles in the catchment versus slope angles of the landslide trigger points. Slope angles are derived from the SRTM 1" 30 m (USGS 2014). #The number of landslides with their trigger zone in a specific slope angle class

When looking at the distribution of slope angles of the catchment in comparison with the distribution of slopes where the landslides occur, a concentration of slides on the steeper slopes can be observed with 60 % of the landslides occurring on slopes above 30° (Fig. 12).

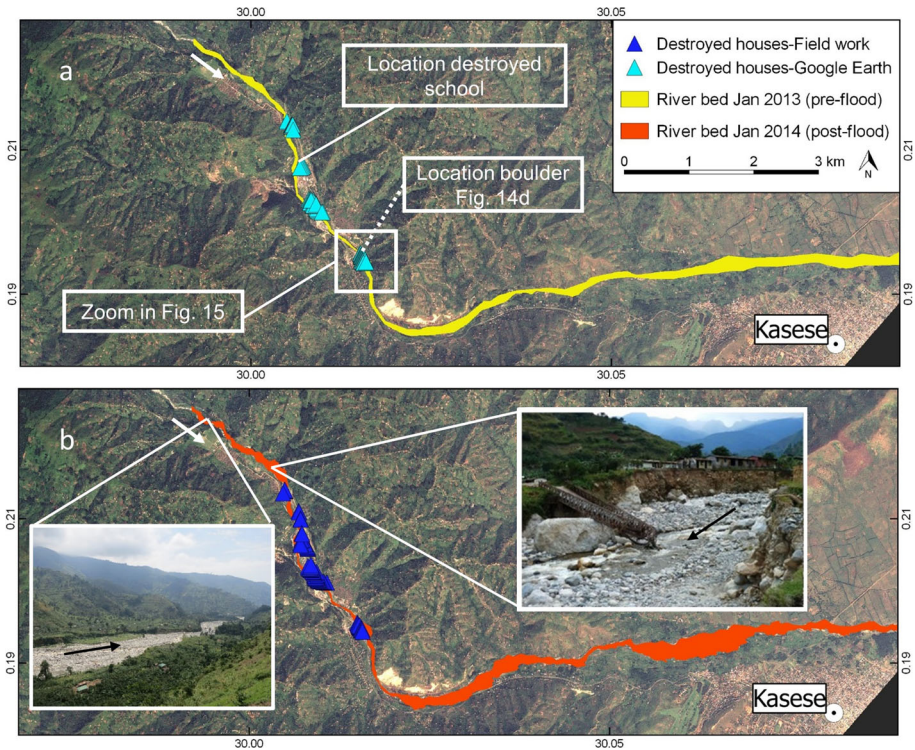
Fig. 13 Lower reach of the Nyamwamba river (SPOT 6 image, 1.5 m) with an indication of the extent of the river bed before (January 2013) and after (January 2014) May 1, 2013, flood combined with locations of the destroyed buildings and photographs illustrating the damage observed in the field. *Black arrows* in pictures and *white arrows* in the maps indicate river flow direction

Number of damaged buildings extracted from GE is based on the analysis described in Sect. 3.4 and illustrated in Figs. 13 and 15

from non-damaged buildings in GE if the roof is intact. According to ActAlliance (2013), five bridges were destroyed, whereas only three bridges were detected with GE. It is possible that some of the five bridges reported by ActAlliance (2013) had already been repaired before January 2014.

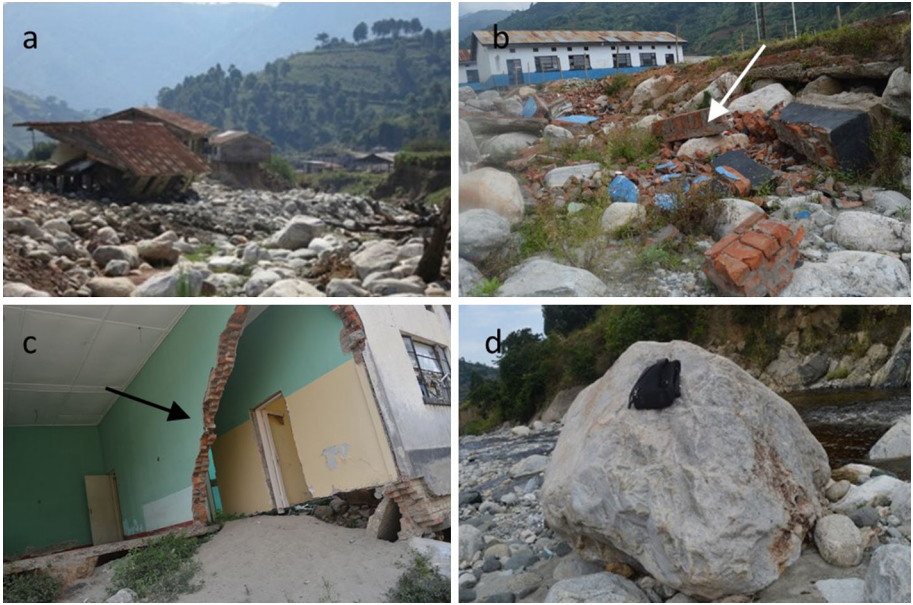
Fig. 14 Examples of damage caused by the flood. **a** River bed and scour, **b** destruction of house foundation (white arrow), **c** destruction of house due to impact from debris (black arrow), **d** illustration of boulder size frequently found in the valley (black bag on the boulder is ca. 40 cm high, location: Fig. 13a)

Only field work allowed to identify the processes by which infrastructure was destroyed. The buildings destroyed or damaged show both signs of water damage and damage through the impact of large boulders (Fig. 14a–c). These transported boulders have a diameter exceeding 1.5 m (Fig. 14d). The foundation of the buildings nearest to the river bed was often completely destroyed (Fig. 14b). Furthermore, the damage to infrastructure and specifically buildings, tarmac roads and bridges can only be explained by the large volume of debris transported by this high-energy torrent. It has also been reported by the external reports that boulders crashed into buildings and destroyed a primary school (ActAlliance 2013; location: Fig. 13). A buffer analysis shows that 54 of the 57 destroyed buildings including the hospital and school lie within 100 m of the pre-flood river bed. An excerpt of the GE inventory is given in Fig. 15, indicating the proximity of destroyed buildings to the river bed. The increase in area covered by debris in the Nyamwamba valley up to Kasese town is $49.7 \times 10^4 \text{ m}^2$, or an incremental increase of 34.4 % compared to the original boulder river bed (Fig. 12). The landslides in the upper catchment and the debris from scouring of the river beds are expected to be the main suppliers of debris.

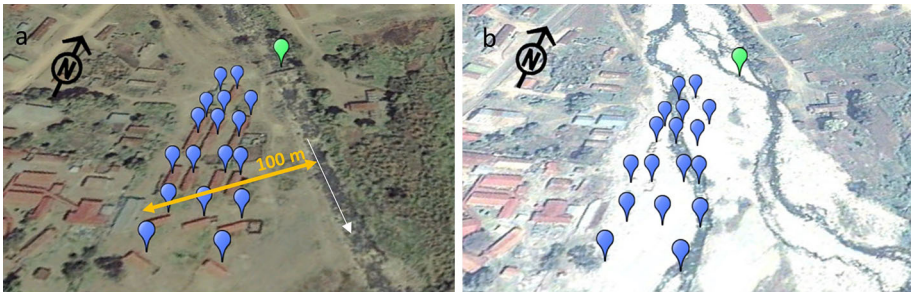
Fig. 15 Zoom of a cluster of destruction in the Nyamwamba valley (location: Fig. 13a). Blue dots are destroyed buildings; green dot is a destroyed bridge. Left pre-flood image GE, March 24, 2006, 0.195°N, 30.02°E. Right post-flood image GE, January 13, 2014, same location. White arrow indicates river flow direction

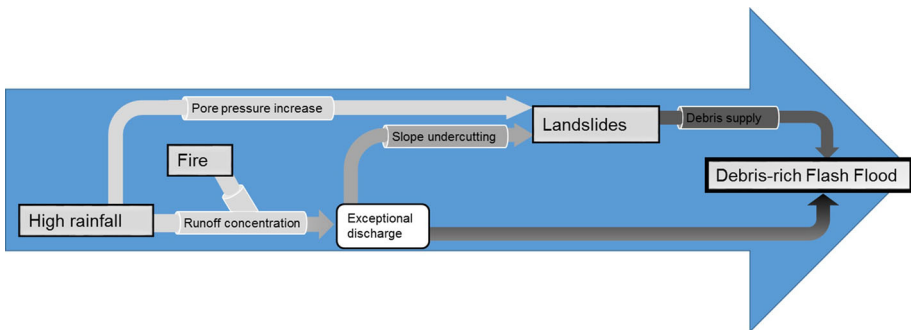
Fig. 16 Hazards (black squares), cascade effects, interactions and processes at play during the Kilembe flood on May 1, 2013
