# Landslides in Belgium—Two Case Studies in the Flemish Ardennes and the Pays de Herve

Olivier Dewitte, Miet Van Den Eeckhaut, Jean Poesen and Alain Demoulin

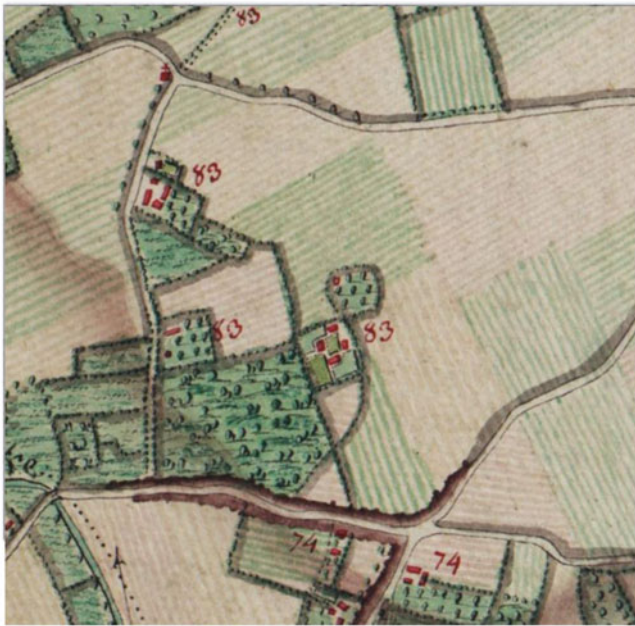
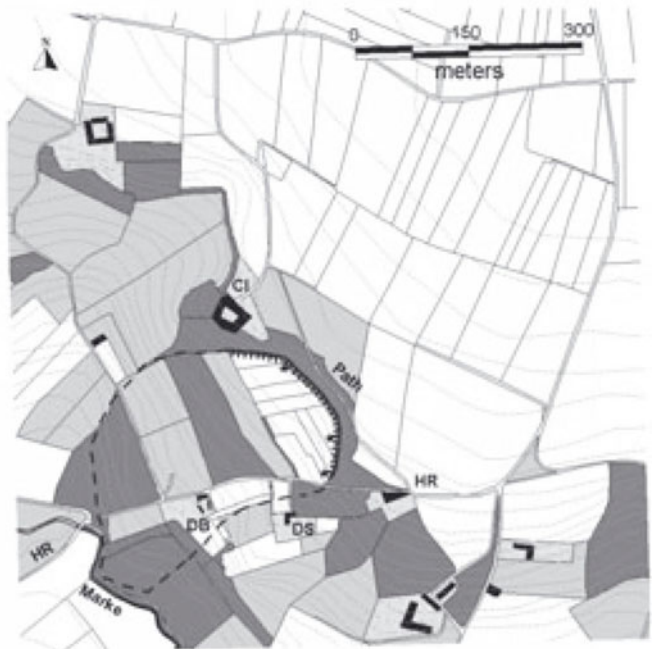
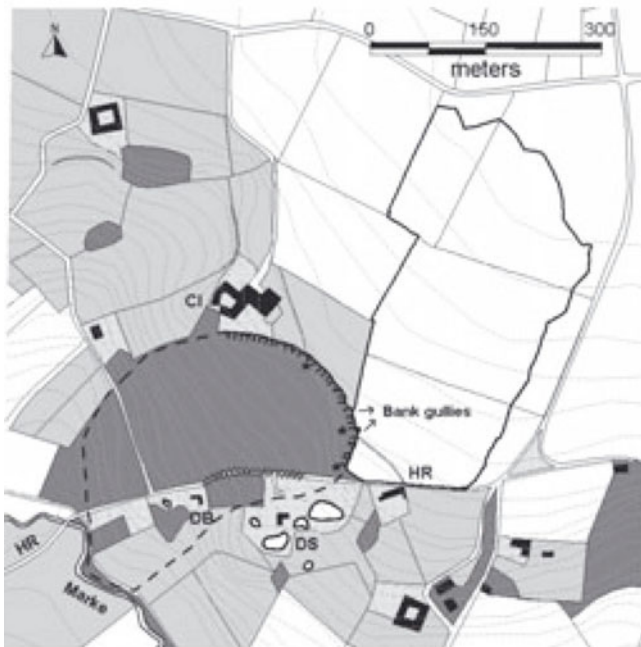
**Fig. 20.5** Evolution of the Hekkebrugstraat landslide site as revealed by old maps. **a** Excerpt of the Ferraris map (1771–1777). **b** Situation around 1952 based on aerial photograph interpretation. **c** Situation

around 1996 based on aerial photograph interpretation. **d** Topography around 2001–2002 shown on a LIDAR-derived hillshade map (DEM of Flanders 2007) (from Van Den Eeckhaut et al. 2007a)

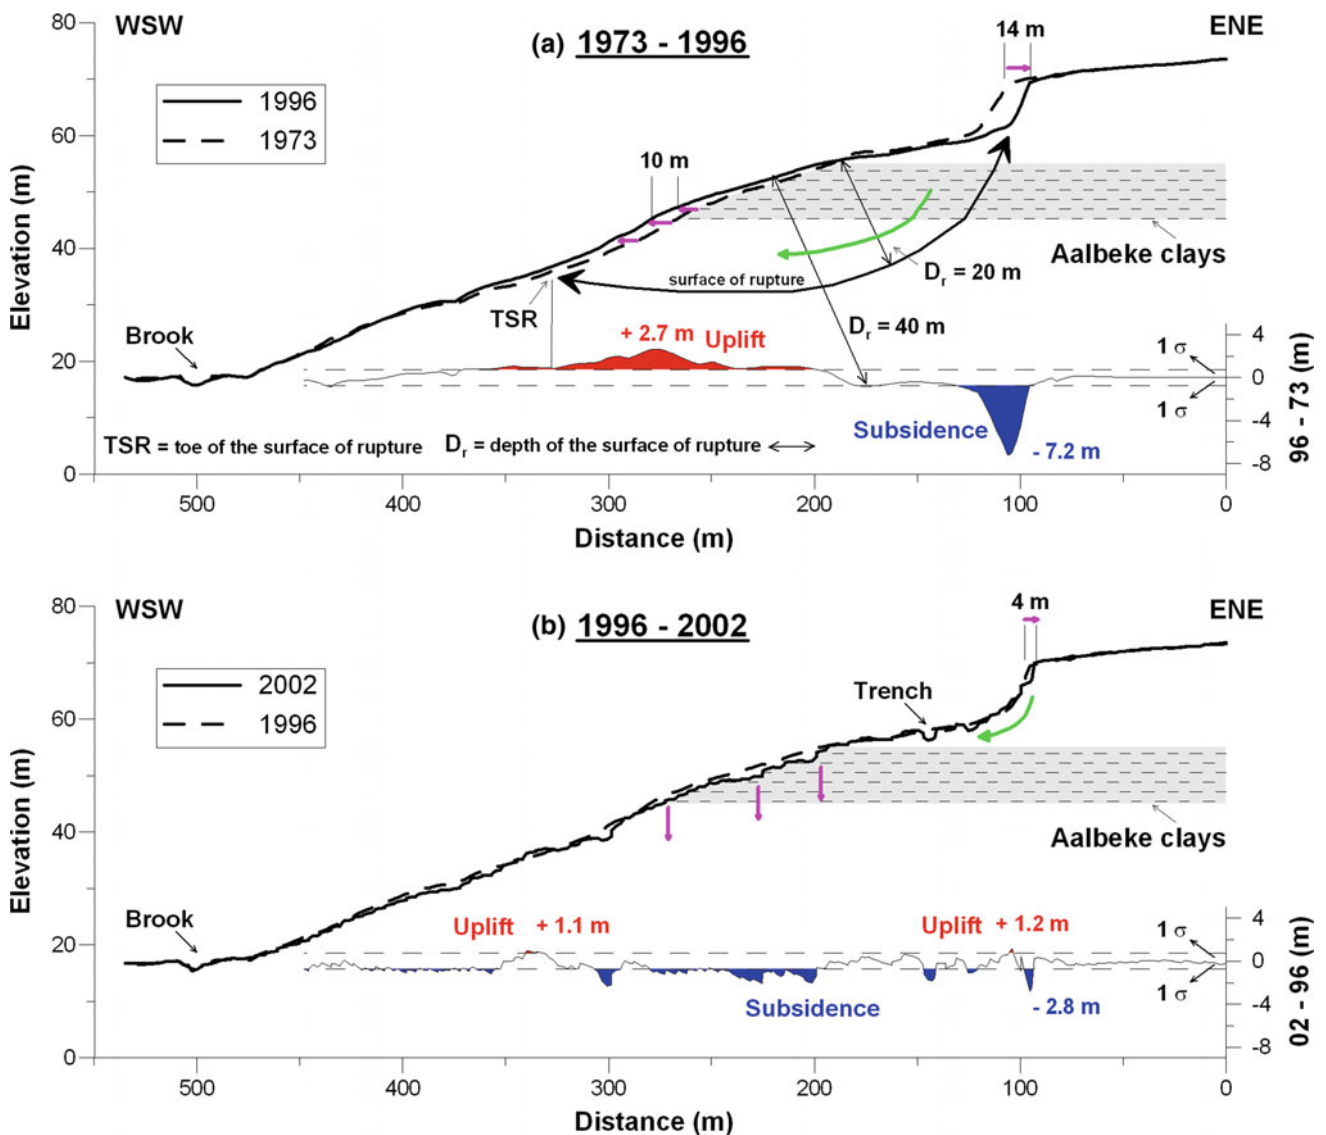
**Fig. 20.9** DTM cross-sections of the Hekkebrugstraat landslide (landslide 1 in Fig. 20.4) compared with vertical displacement profiles (see location in Fig. 20.8). **a** Ground displacements between 1973 and 1996. **b** Ground displacements between 1996 and 2002. Lateral and vertical motions of the main scarps and ridges are represented by

horizontal and vertical purple arrows, rotational motions by curved green arrows. In blue and red, associated profiles of the  $>1\sigma$  ( $0.75\text{ m}$ ) vertical displacements obtained by DTM subtraction. Delimiting the collapsed and uplifted areas. Maximum and minimum vertical displacements are also provided (from Dewitte et al. 2008)

Topographic profiles are very illustrative of the combination of vertical and horizontal displacements (Fig. 20.9). Figure 20.9a shows that the main scarp retreat, amounting to 14 m in this profile, is clearly associated with the zone of the highest subsidence at the landslide head. According to the conceptual model developed by Casson et al. (2005) for rotational landslides, the distribution of the topographic variations between 1973 and 1996 corresponds to a large rotation angle dividing the landslide into three areas

(depletion–transfer–accumulation). The distribution of elevation changes within the profile 1973–1996, the shape of the visible part of the surface of rupture at the landslide head, and the alternation of subhorizontal clayey sand and clay layers suggest that the  $\sim 220\text{-m}$ -long surface of rupture of the February 1995 reactivation is situated at a depth of  $\sim 20\text{ m}$  (Fig. 20.9a), in contact with the Aalbeke clays. The uplift in the zone of accumulation is not a true vertical surface movement, but mainly the effect of the downslope lateral displacement of the slipped mass along the curved rupture surface (Fig. 20.9a). Likewise, the transfer area where no vertical displacement of the surface is observed

between the collapsed and uplifted parts of the landslide corresponds to a zone of mainly horizontal motion. This model agrees with the values of lateral displacement measured at walls (Fig. 20.8b). The small uplifts measured in the landslide toe, downslope of the intersection between the lower part of the surface of rupture and the original ground surface (Fig. 20.9a), correspond with several small earthflows subsequent to the main reactivation (Van Den Eeckhaut et al. 2007a).

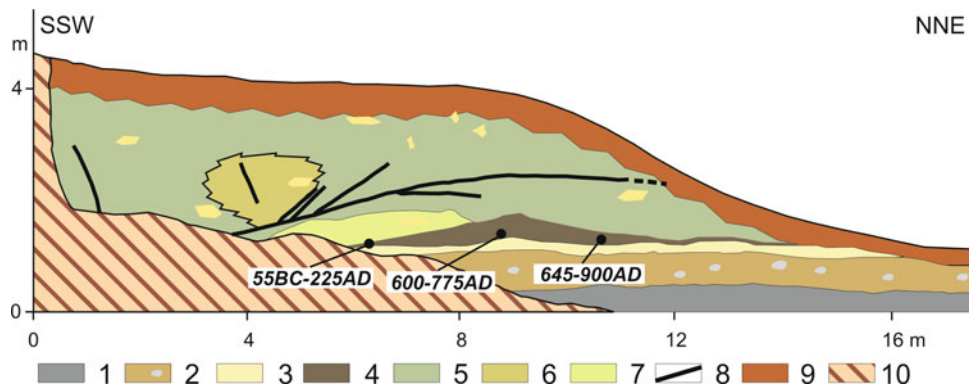
**Fig. 20.13** Section across the toe of the Croix Polinard landslide on the north-looking side of the Battice ridge (see location on Fig. 20.10). 1 Paleozoic shales weathered to clay; 2 clay-with flint pre-landslide colluvium; 3, 4 eluvial and humic horizons, respectively, of a podzolic soil developed in a silt of mainly eolian origin; note the bulging of the

humic horizon in the centre of the section, with location of the <sup>14</sup>C-dated samples (calibrated 2σ ranges); 5, 6, 7 slipped masses, chiefly made of reworked Vaals clays with sparse sandstone blocks; 8 major shear surfaces; 9 present-day soil; 10 waste hiding the base of the section

A 20-m-long trench dug in the landslide toe, parallel to the slide direction, provided a detailed view of how the displaced material moved to accumulate and form the toe scarp. A second trench in another nearby landslide, shown in Fig. 20.13 with the  $^{14}\text{C}$  ages obtained for three charcoal pieces, revealed a similar structure. At Sérezé, the original ground surface is identified by a podzolic soil developed on colluviated silts of mainly eolian origin. Superposing a grey humic horizon, a bleached eluviated horizon and a variegated illuvial horizon, this soil is  $\sim 0.6$ -m-thick under the distal part of the toe scarp, then displays local bulging and thickening to  $>1$  m before wedging and rapidly disappearing inward. The silts rest on 1 to 2-m-thick colluviated green glauconiferous Vaals clays that shallow auger borings showed lying over a thin ( $\sim 0.3$  m) bed of water-saturated purple sands of the Aachen Formation and Paleozoic schists weathered to black clay. Covering the soil and the colluviated material, the slipped masses are mainly made of light grey-brown clays with few flints and a subordinate silt component, a mixture of all sediments cropping out upslope. In contrast with the somewhat blurred contact surface between the undisturbed soil and the overlying slipped clays, an undulating sharp shear surface separates the latter in two distinct bodies, from which the lower one shows lumps of soil especially in its upper part. This exposed section suggests that, before leaving the soil on which it slid intact at the far end of its toe, the landslide, which had started several tens of metres upslope, partly scraped it, stacking broken soil

pieces in a final bulge (Fig. 20.13). However, no positive field observation can resolve whether the two slipped bodies were emplaced simultaneously or during different slip episodes, except maybe that the lower one is, as a whole, strikingly more rubefied than the other.

landslide, north of the ridge (Fig. 20.13). Multiple  $^{14}\text{C}$  ages obtained in the two trenches have brought consistent insight into a common oldest time of landslide probable initiation between 50 and 250 AD, followed by several reactivation episodes in one or the other place around 400, 700, and 1250 AD (Fig. 20.14). In particular, these dates demonstrate that the upper body in the Sérezé landslide toe moved onto the lower one during a reactivation event in the thirteenth century.
