## Assessing the physical-mechanical properties of ferruginous sandstone

R. Hayen, L. Fontaine & H. De Clercq

**ABSTRACT:** A dark-brown glauconite-rich sand cemented by iron oxides characterizes the landscape and the typical architecture of the Hageland: the so-called ferruginous sandstone of the Diest Formation.

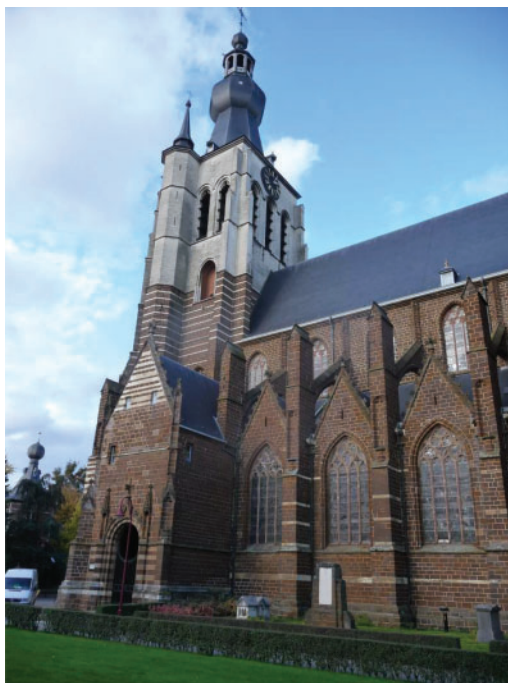
Figure 1. Typical example of the local architecture found along the Demer river: Our Lady's Church of Aarschot. Ferruginous sandstone is alternated with layers of the light-coloured sandy limestone of Gobertange (Brussels Formation).

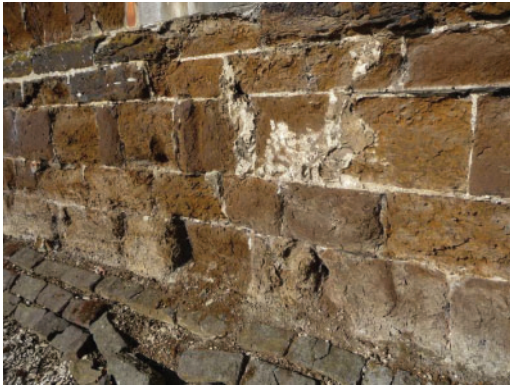
Figure 2. A typical example of damage to the ferruginous sandstone at the St. Catherine's Church of Kortrijk-Dutsel.

Ferruginous sandstone is well known as a heterogeneous construction material, sensitive to erosion and often leading to a very heterogeneous damage pattern, which makes the selection of suitable materials and intervention techniques for restoration difficult (Figure 2). Some stone blocks may exhibit at first sight practically no damage, while neighboring blocks may have lost their internal cohesion and exhibit material loss over several centimeters depth. Such variations can appear even within a single block of ferruginous

sandstone, where softer zones may have disappeared to quite an extent while more solid limonite layers or concretions still outline the original surface of the stone. The cause of damage can be very diverse, being related for instance to the effect of frost, salts or wind erosion. Nevertheless it always comes down to the loss of cohesion of the stone opposed to the initial degree of lithification of the sand. In general, it is considered a rather weak building material, especially in comparison with other typical local building materials such as Gobertange, Lede or Tournai stones. Typical values for the compressive strength ( $f_c$ ) found in the literature are reported in Table 1.

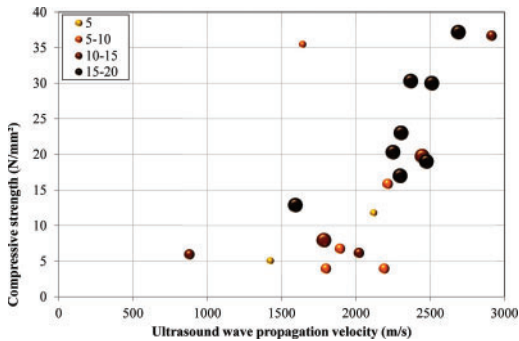
Figure 6. Comparison of the average ultrasound wave propagation velocity (m/s), the compressive strength (N/mm<sup>2</sup>) and the characteristics of the limonite cement (the colour refers to the amount of limonite cement, while the size to its distribution properties with small = isolated islands of limonite cement and large = continuous limonite cement).

When comparing the mechanical strength of ferruginous sandstone with the degree of lithification based on the amount and distribution of the limonite cement, determined from petrographic analysis, a positive correlation is noticed (Figure 6). A strong lithification, characterized by a dense continuous deposit of limonite, corresponds with a compressive strength of at least 15 N/mm<sup>2</sup>.
