## The origin and control of mega-gullies in Kinshasa (D.R. Congo)

This study aims to investigate the relation between mega-gully (>5 m width) distribution and urbanization in Kinshasa (D.R. Congo), to establish what governs mega-gully location and plan form and to illustrate the concepts behind mega-gully treatment. For this purpose, the diachronic distribution of mega-gullies has been mapped in Kinshasa. All mega-gullies have been reported in ArcGis 9.3 on the orthorectified SPOT 2007 image. A newly elaborated DEM enables the mega-gullies to be placed in their natural topographical context. The GIS inventory on the SPOT 2006/2007 anaglyph indicates the mega-gully situation in the high town of Kinshasa 5 years ago: 308 mega-gullies with a cumulated length of 94.7 km, a mean drainage density of 0.4 km km<sup>-2</sup> and an average width and depth of 17 m and 6 m respectively. On the WorldView 1 (WV1) coverage, the number of mega-gullies has more than doubled between 2007 and 2010 from 160 to 334. The study shows that mega-gullies only develop within the urbanized perimeter of the high town of Kinshasa and only 5 to 10 years after incipient urbanization. The study also indicates t

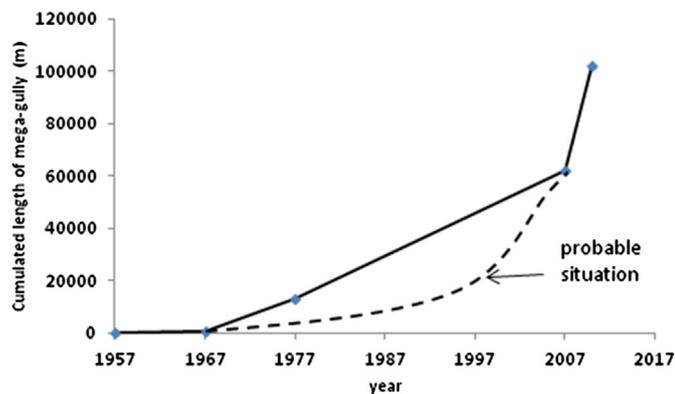
**Fig. 2.** Cumulated length of mega-gullies in the sector of the town covered by WV1 image. The 1977 value, on the base of Van Caillie (1988) is too high because gullies smaller than 5 m are included. The dashed line gives a better interpretation.

But the diachronic mega-gully evolution shows that the mega-gully situation in the high town of Kinshasa is still quickly deteriorating and therefore, extremely serious. The comparison of the mega-gully characteristics between 2007 (SPOT anaglyph) and 2010 (WV1) suggests a dramatic evolution (Table 6) in the area, covered by the WV1 satellite image. Within these 3 years, the approximate mega-gully volume of this area covered by the WV1 has doubled and their average volume has increased by 20% (Table 6). The evolution of the accumulated mega-gully length in this area from 1957 to 2010 is spectacular over the last years (Fig. 2). It is remarkable that the increase of the cumulated length of mega-gullies (width > 5 m) between 2007 and 2010 from 62,092 m to 102,076 m is essentially due to the development of new mega-gullies. In 2007, the area covered by WV1 accounts for 160 mega-gullies and in 2010 the number rises to 334.

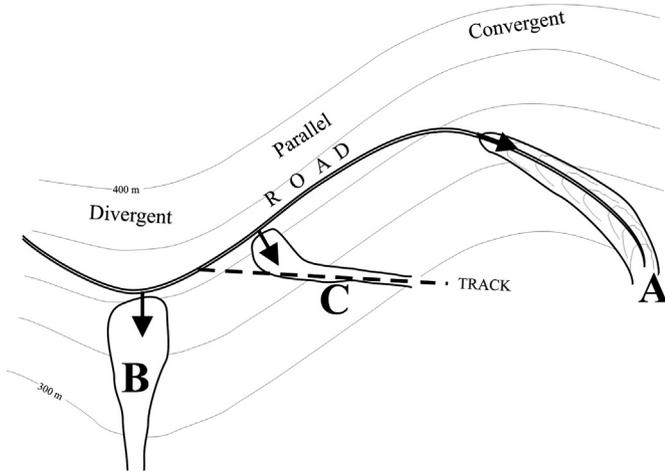
**Fig. 3.** A: axial oblique mega-gully on convergent slope; B: not oblique leak mega-gully on divergent slope; C: oblique leak mega-gully on parallel slope. Arrows indicate alimentation of mega-gully. More explanation in text.

of both types of mega-gullies can finally obliterate the different origin of both mega-gully sections (Fig. 3 and 4). Table 7 shows that the majority of leak mega-gullies occur in topographical hollows. The influence of urban structures is best expressed by the obliquity of the leak mega-gullies. Twenty-seven of the 157 leak mega-gullies are not oblique, but 3 of these 27 are located on a diverging spur slope. This topographical situation on a spur instead of in a topographical hollow evidences their artificial origin.

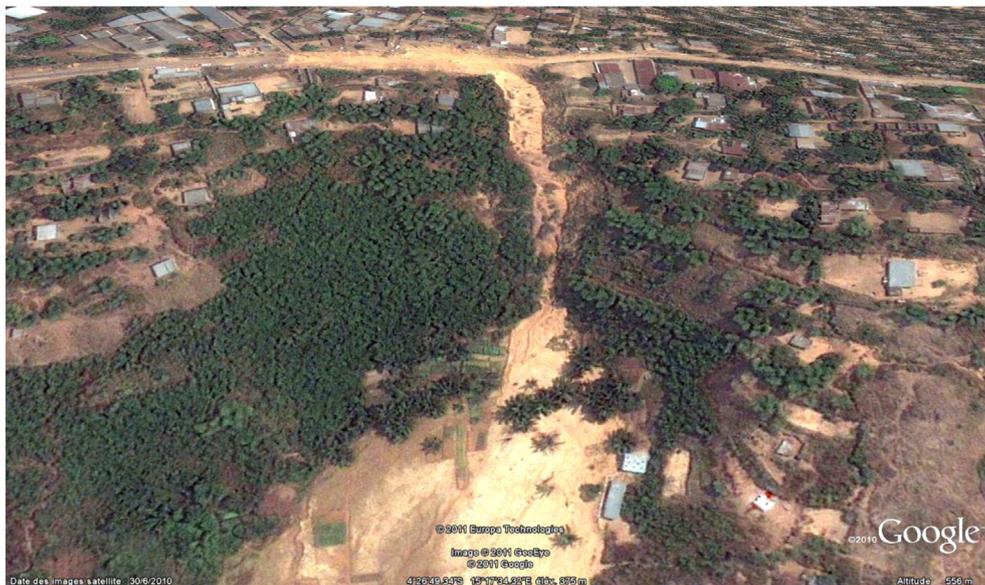
**Fig. 4.** New quickly developing leak mega-gully along the road of Kimwenza, 4 km south of UNIKIN (Fig. 1). Progressive erosion from the side of the road with already pronounced gully head. Regressive erosion on the road. GoogleEarth, 30/06/2010. The gully complex is only a few months old at the moment when the picture was taken.

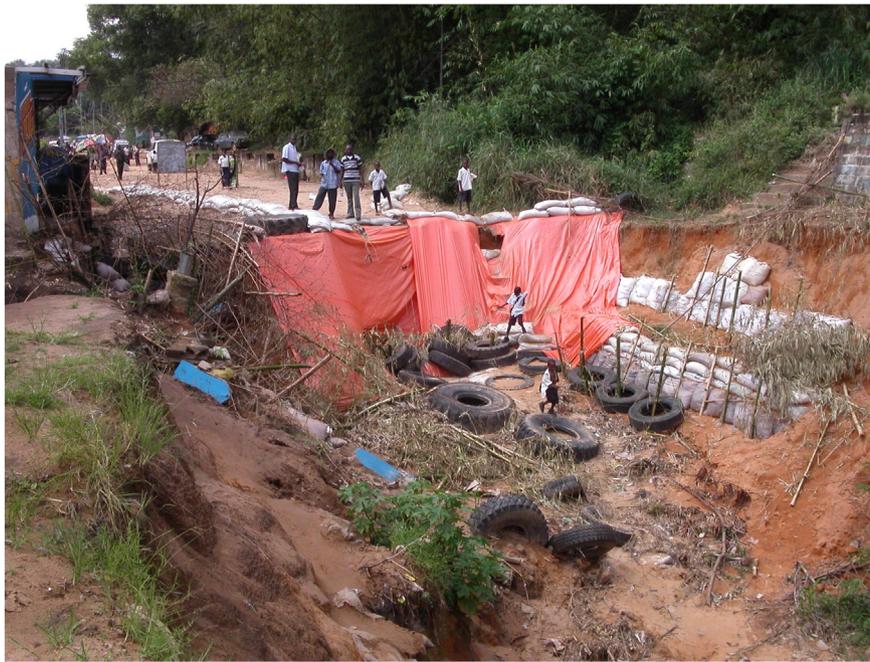
**Fig. 5.** Tyres, sand bags, canvas, fences of wooden sticks, auto parts and rubbish, to protect the axial mega-gully on the road of Kimwenza, 3 km south of the UNIKIN campus, 2009. The axial mega-gully developed from the plunge pool head of a progressive leak mega-gully behind the back of the photographer. Finally, in 2010, a Chinese contractor has filled up the axial part of the mega-gully and repaired the road. The plunge pool head has been stabilized by a huge massive retaining wall with a concrete gutter to assure a safe outlet of the water in the future.

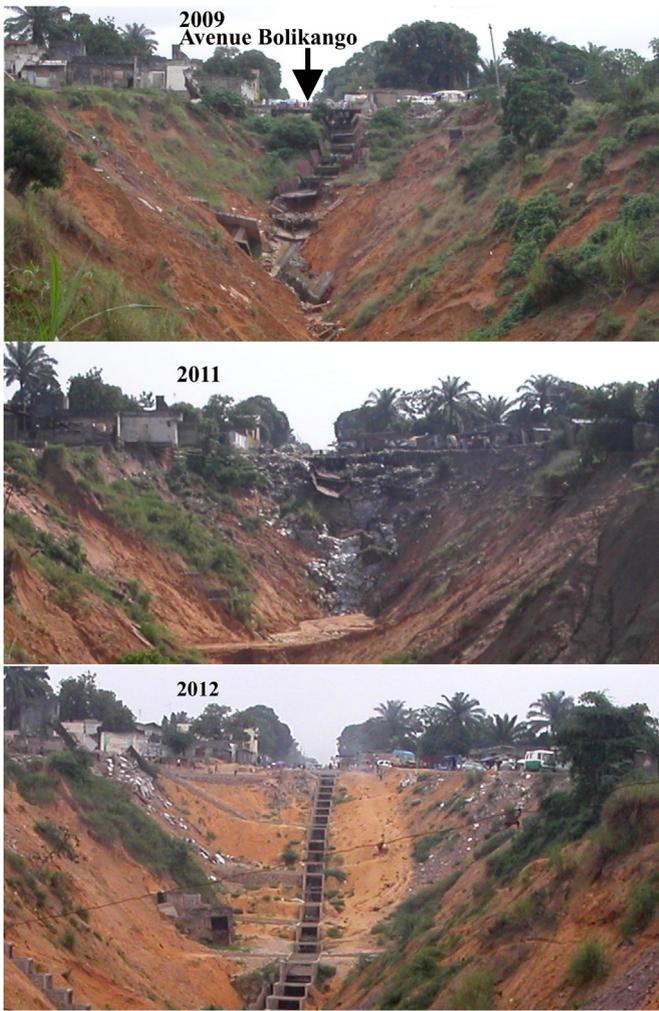
**Fig. 6.** Axial mega-gully head of Laloux gauche. A construction of metallic sheets, intended to protect the mega-gully head against further vertical incision and head retreat by runoff from Bolikango Street (Laloux gauche, Fig. 1) is destabilized from below. The 2011 picture shows that an insufficient amount of sand bags has been put in the mega-gully head to replace the metallic construction which has partially gone. In the foreground the top of a sand dam, is visible. This dam causes temporary sedimentation in the mega-gully bottom. Finally in 2012 the metallic sheets were all gone and a huge staircase-like gutter has been constructed.

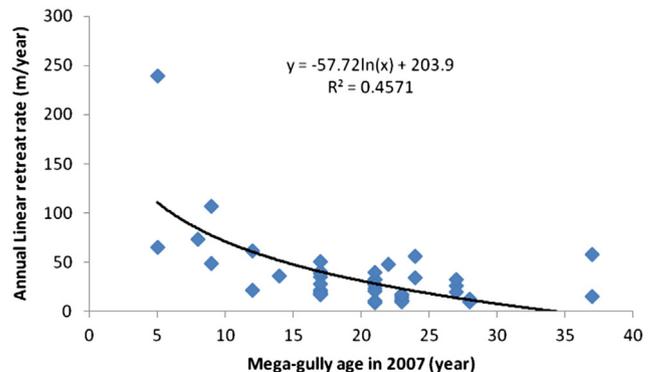
**Fig. 7.** The annual retreat of 45 mega-gullies, as based on field information. A decrease in annual retreat with mega-gully age is obvious.
