Deterioration mechanisms of the compact clay-bearing limestone of Tournai used in the Romanesque portals of the Tournai Cathedral (Belgium)

Laurent Fontaine¹ · Roel Hendrickx¹ · Hilde De Clercq¹

Received: 6 November 2014 / Accepted: 26 March 2015 / Published online: 7 April 2015
© Springer-Verlag Berlin Heidelberg 2015

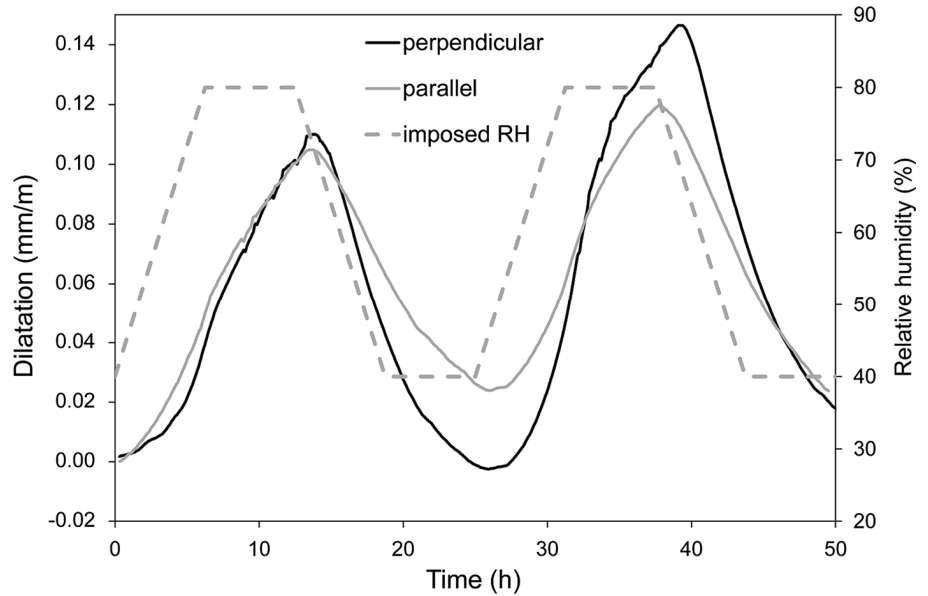
Figure 11 presents the average dilatation results during RH cycles. It appears that the response of the stone towards changes in RH is delayed by 5 h during the absorption phase, while it is much shorter in the desorption phase. The amplitude is higher in the perpendicular direction and further increases from the first to the second cycle.

Fig. 11 Dilatation during RH cycles of 40 and 80 % at constant temperature of 20 °C. Average curves of 2 measurements for each bedding direction © KIK-IRPA (Monuments Laboratory)

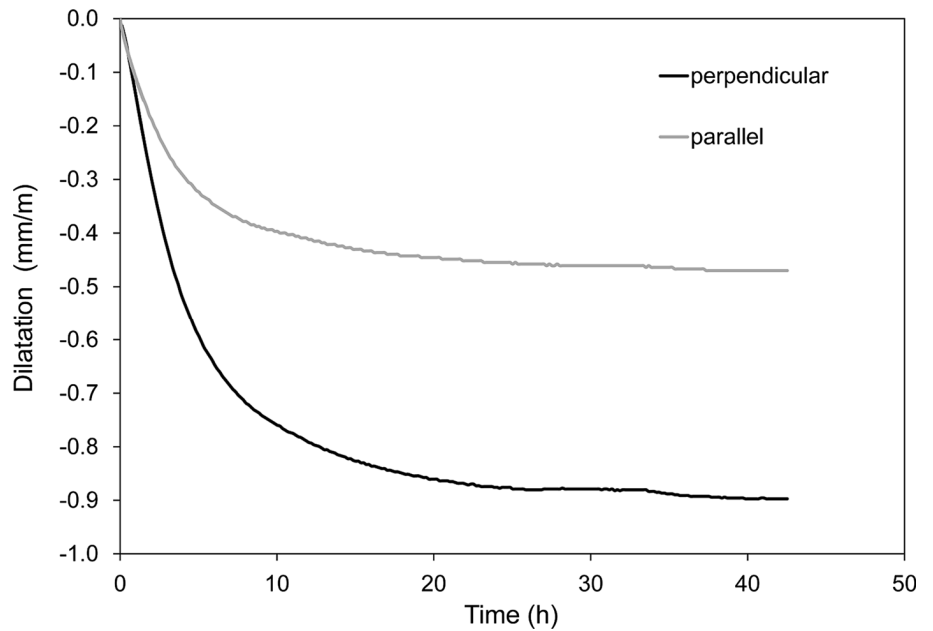
Results obtained in case of a hygric shock (from 95 to 40 % RH, at 20 °C) are presented in Fig. 12. Shrinkage in the perpendicular direction ($n = 2$) is much higher than in the parallel direction ($n = 1$). Despite the low number of tests, the findings are in good agreement with the results determined by Lubelli and Nijland (2014) for fresh stone (max ± 0.10 %) and, therefore, can be considered as plausible.

Fig. 12 Hygric shrinkage induced by a hygric shock from 95 to 40 % RH (20 °C). The black curve is an average of 2 measurements; the grey curve is the result of a single measurement © KIK-IRPA (Monuments Laboratory)

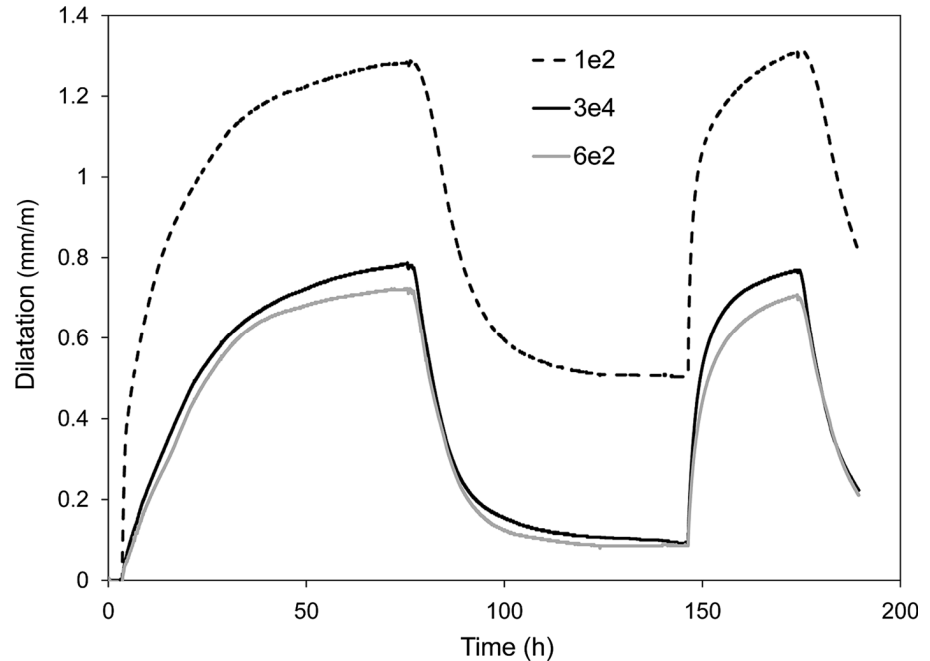
Fig. 13 Dilatation perpendicular to the bedding of 3 samples submitted to hydric cycles. Sample 1e2 cracked during the first water uptake phase © KIK-IRPA (Monuments Laboratory)

Figure 13 shows dilatation results of some samples submitted to 2 cycles, consisting of a wetting phase by immersion ($t = 0$ h) and a drying one in laboratory conditions. The curves illustrate the slowness of the process (3 days are necessary to reach a quasi-equilibrium) and that the deformation is largely reversible, except for sample 1e2. In this particular case, the appearance of a micro-crack at the beginning of the test provoked an irreversible deformation. A similar micro-cracking process induced by water absorption has been observed on other samples. This demonstrates the impact of hydric dilatation on the deterioration process of Tournai stone.
