# Paper 4: Mechanical Properties of Bricks of the Coudenberg Archaeological Site in View of a Proper Conservation Strategy

HILDE DE CLERCQ, LAURENT FONTAINE, ROALD HAYEN,  
and SEBASTIAAN GODTS

*Royal Institute for Cultural Heritage (KIK-IRPA), Belgium*

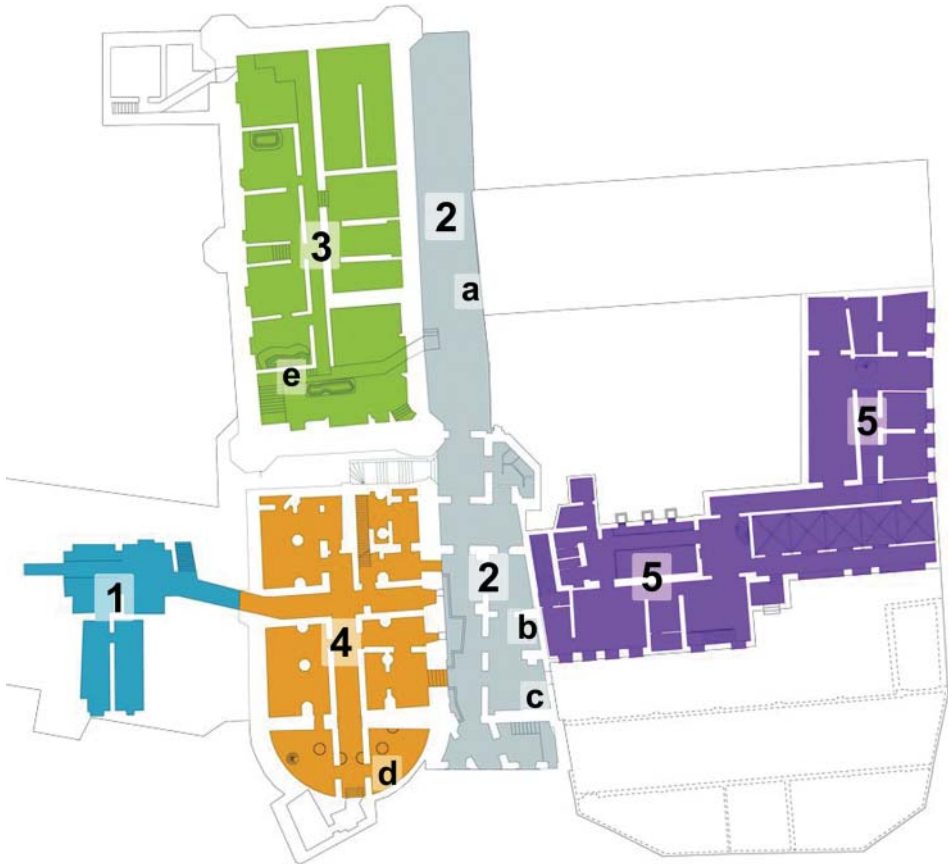
Figure 1 presents the areas submitted to the investigation of the mechanical properties and which are subject of the discussion in this paper. The first area is a part of the wall in brickwork masonry of the *Isabella Street* (Figures 2 and 3: zone a in Figure 1). This wall is quite dry and shows local damage in the form of powdering

FIGURE 1 Floor plan of the archaeological site of Coudenberg with identification of the zones submitted to the investigation of the mechanical properties (1. main building; 2. Rue Isabella (Isabella Street); 3. Aula Magna; 4. Chapel; 5. Hôtel Hoogstraeten (Hoogstraeten House)).

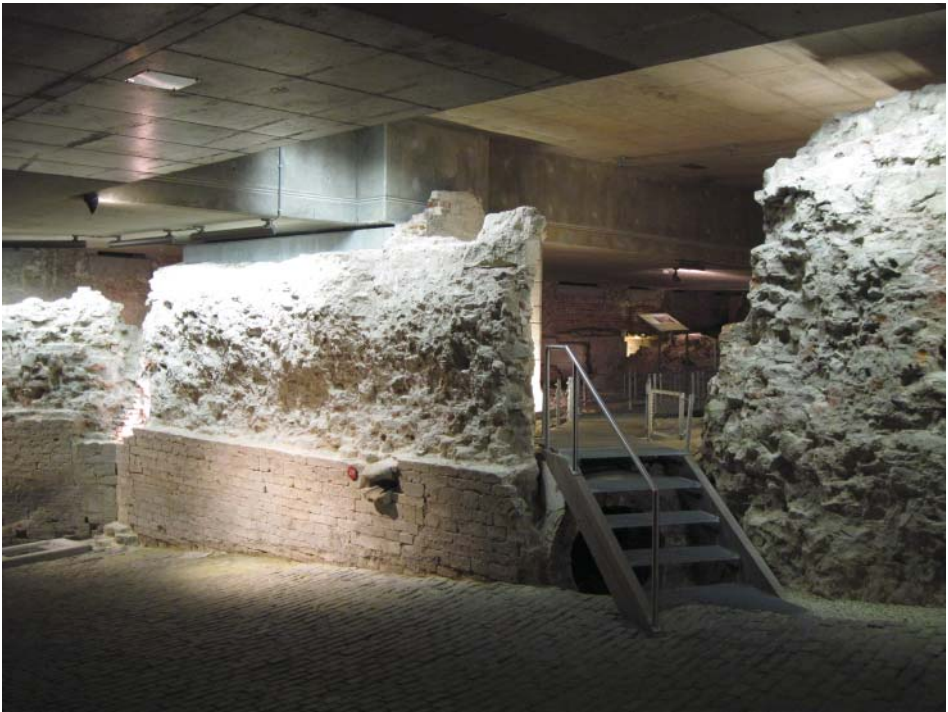
What remains of the Aula Magna (Figure 9), the previous palace's banqueting hall, are cellars located directly underneath the Royal Square. This level housed kitchens and storage rooms of the fifteenth-century palace. The bricks of the Aula Magna (zone e) are generally characterized by a complex fissure pattern (Figure 10). The presence of several fissures leads to an irregular hardness profile (Figure 11). Fissures are detected at a depth of at least 2 cm.

From a detailed visual monitoring on site, it was noticed that the process of fissure formation was still active. The microscopic investigation of thin sections of the brick revealed a general heterogeneous composition and that the clay was not fully mixed prior to the firing of the brick (see Paper 6, this issue). Hence a low quality of the brick used for the construction of the Aula Magna, and this right from the beginning, is concluded. Despite the low quality of the brick being identified, the phenomena activating the process of fissuration remained unknown. Within this investigation, following possible mechanisms were examined:

FIGURE 9 Isabelle Street, upper part, showing the steps at the entrance to the Aula Magna.
