# DIGITAL MAPPING AS A TOOL FOR ASSESSING THE CONSERVATION STATE OF THE ROMANESQUE PORTALS OF THE CATHEDRAL OF OUR LADY IN TOURNAI, BELGIUM

J. De Roy<sup>1\*</sup>, S. Huysmans<sup>1</sup>, L. Hoornaert<sup>1</sup>, L. Fontaine<sup>2</sup> and N. Verhulst<sup>1</sup>

In the framework of the conservation of the Cathedral of Our Lady in Tournai (Belgium), the Royal Institute for Cultural Heritage (KIK-IRPA, Brussels) was called upon in 2012 to carry out a preliminary study of two Romanesque portals called the *Mantile* and *Capitole* portals. The aim of this study was to understand the deterioration mechanisms of the stone and to propose a conservation strategy. Both portals are constructed from the local black Tournai stone, with the exception of the 19th century restoration in Belgian bluestone. Due to the strongly deteriorated state and the large size of the portals, a detailed visual inspection survey of each stone block was necessary to obtain an overview of the actual state of conservation and to develop an adapted conservation strategy. The deterioration patterns were digitally mapped with the Metigo *MAP* software (fokus GmbH), using rectified photographs as a template. The

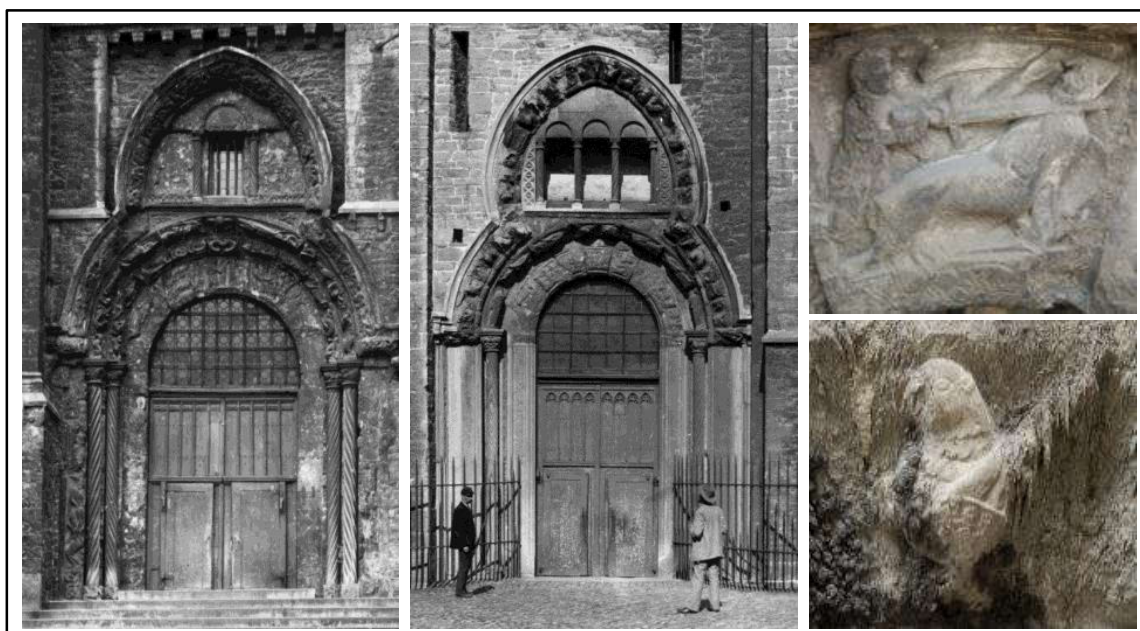
*Fig. 1: Mantile portal Mantile portal (left), picture dating from 1899 © KIK-IRPA, Brussels, B3188. Capitoile portal (centre) © KIK-IRPA, Brussels, A126815. Relief of inner arch of Mantile portal (upper-right) © KIK-IRPA, Brussels, X049701. Relief of trefoil arch of Capitoile portal (bottom-right) © KIK-IRPA, Brussels, X057496.*
