ICOM-CC 19th Triennial Conference 2021 Beijing

SCULPTURE, POLYCHROMY, AND ARCHITECTURAL DECORATION Cyclododecane as protection for water-sensitive polychromy during water bath desalination of limestone sculptures: The case study of a mid-15th-century wall-mounted memorial from the Burgundian Netherlands

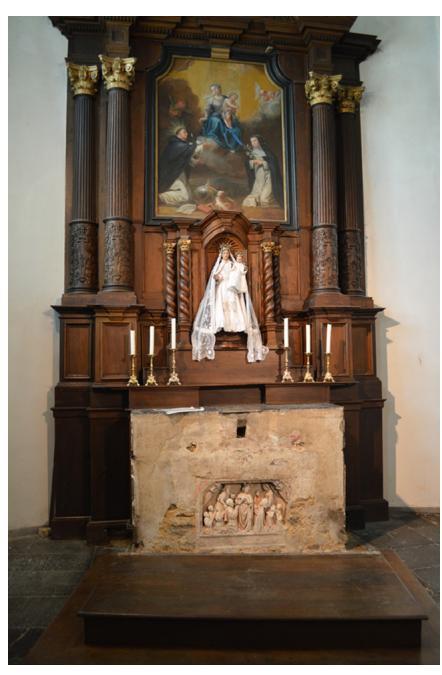
Figure 1. Memorial enshrined in the masonry of the altar dedicated to our Lady of the Rosary

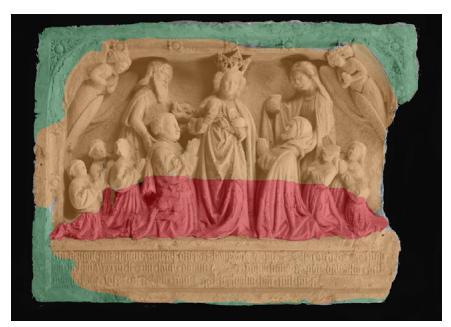
Figure 3. The surface can be divided into three zones: the most weathered zone (red zone), where the salt damage was resulting in the loss of sculpted parts; a mid-weathered zone, with slightly flaky and powdery areas; and a less weathered zone with visible efflorescence

Having been enshrined in the masonry, the tablet was exposed to constant rising damp and fluctuating climatic conditions. This had caused salts to accumulate at the drying front near the surface and frequent crystallisation cycles within the pore structure, leading to subsequent damage to the object. Figure 3 shows the specific distribution of the damage at the sculpted surface (Figure 3), which could be divided into three zones: the most weathered zone (red zone) where the salt damage was leading to the loss of sculpted parts; a mid-weathered zone with slightly flaky and powdery areas; and a less weathered surface with visible efflorescence.

After drying, consolidation was performed with ethyl silicate on restricted weakened areas (red zone, Figure 5) and followed by several other conservation procedures, such as filling and retouching.

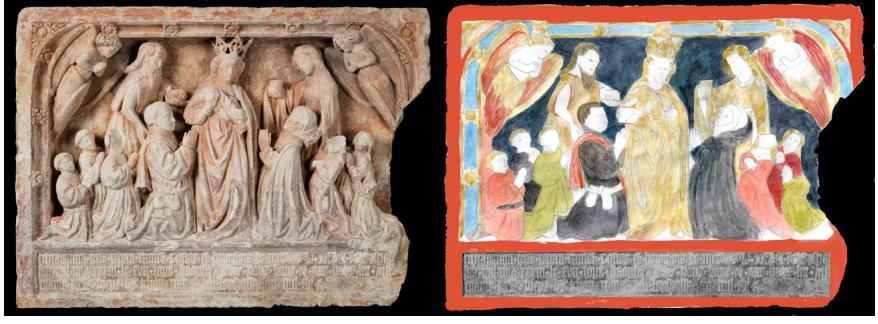
The tablet is carved in stone from Avesnes-le-Sec (Avenderstone), a white limestone with tiny black or greenish spots – glauconite – often grouped in clouds. The northern French limestone permitted the figures to be carved almost in the round. As usually seen on similar sculptures from this period, the stone relief was entirely painted (Brine 2015). Because most of the final polychrome finish had been lost, the ground layer was mainly visible. The literature discussing the polychromy on wall-mounted memorials from the 15th century in the Low Countries (Nys 2001, Serck-Dewaide 2018) states that underlayers were generally made with earth (iron oxide-based) pigments and with little binder. Nevertheless, a thorough microscopic examination made it possible to reconstruct most of the colour palette (Figure 2).

Figure 2. Left: memorial after treatment, Merbes-le-Château (1443); right: reconstruction of the polychromy

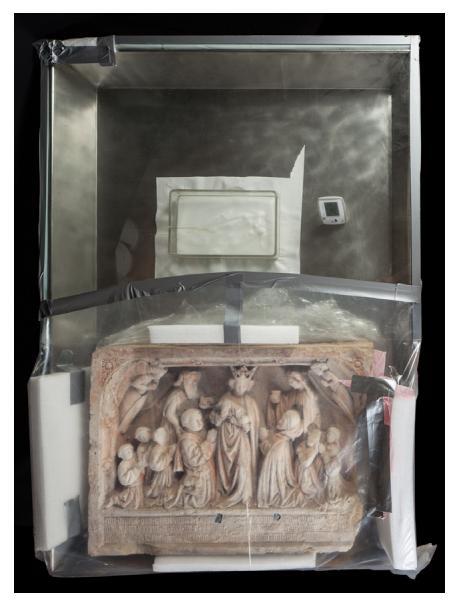
Figure 4. Memorial conditioned in a closed box with a saturated solution of sodium chloride

Based on the state of preservation and the preliminary investigation, it was considered necessary to remove the memorial from the masonry and carry out a desalination treatment by immersion in water. After removing the memorial and pending testing on the samples, the object had to be stored in a stable environment to prevent crystallisation cycles from occurring. While the memorial remained in the workshop, it was conditioned in a closed box with a saturated solution of sodium chloride (Figure 4). Maintaining a relative humidity (RH) of ca. 75%, all of the salts, excluding gypsum, remained in the solution.

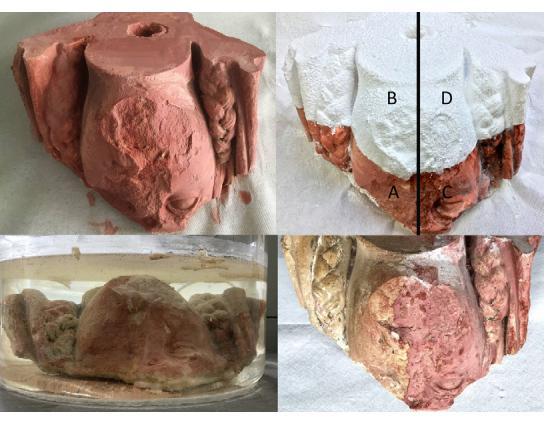
Figure 5. Test

For the following experiment, a CDD melt and CDD aerosol spray, each separately and as two layers on top of each other, were chosen to test the level of protection compared to a non-protected zone. A sculpted stone figure covered with red bole was divided into four separate zones: (A) unprotected; (B) protected with CDD aerosol spray; (C) protected with melted CDD; and (D) protected with melted CDD and aerosol spray (Figure 5).

The bole almost completely dissolved under water where it was uncoated (zone A) or coated with CDD aerosol spray (zone B).

In zone C, the CDD melt film was very effective at protecting the bole during immersion over 50 days (Table 1). However, at the boundary between the coated and uncoated parts, the bole turned a darker colour.

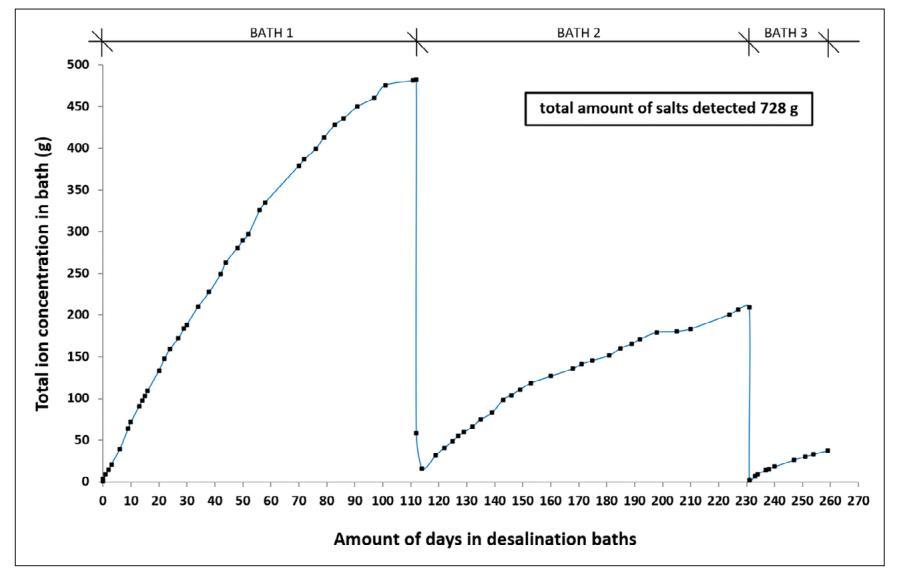
The monitoring consisted of daily to weekly measurements of the ion concentration in the bath water (IC, Metrohm). After mixing the water in the bath thoroughly, 10 or 20 mL of water was removed for each measurement. The total ion content in the bath rose over time to approximately 4 g every day over a period of 111 days. On day 112, the increase slowed significantly to 1 g. The water was changed twice following the results of the IC measurements.

Desalination was completed after a total of three baths and 260 immersion days, reaching a total of 728 g of salts in the bath water. The results of the quantitative salt analysis are presented in Figure 6 as the total salt concentration in the bath (g over time, where the drops in weight represent a change of water). Details on the individual ions detected over time are described in Godts and De Clercq (2020).

Figure 6. The total ion content in the baths over time (days) presented as the amount in weight (g)

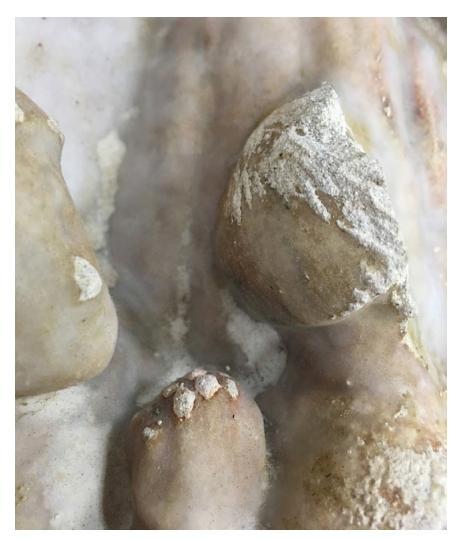
Figure 7. White crust formed on the surface immediately after the sublimation of the CDD

During the CDD sublimation that started during the drying process, an unexpected phenomenon occurred: on the Gothic text below the sculpted scene and on protruding parts, such as heads and hands, a white crust formed on the surface immediately after CDD sublimation (Figure 7). The white crust was later identified by micro-Raman spectroscopy (Renishaw) as gypsum. Given the high content of calcium sulfate detected in the first centimetre of the sculpture and the long-term desalination procedure, most of the gypsum had dissolved and diffused into the bath water. However, a small amount of calcium sulfate had remained in the solution just under the surface. When the CDD evaporated, the salt solution migrated rapidly to the surface through the porous polychrome layers and crystallised as efflorescence outside the pore structure and on top of the polychromy.

The white gypsum crust was found to be quite hard and, as the underlying polychromy is water sensitive, the crust was mechanically removed by scalpel and an ultrasonic scaler. After this process, the sculpted forms and their polychromy became visible again.

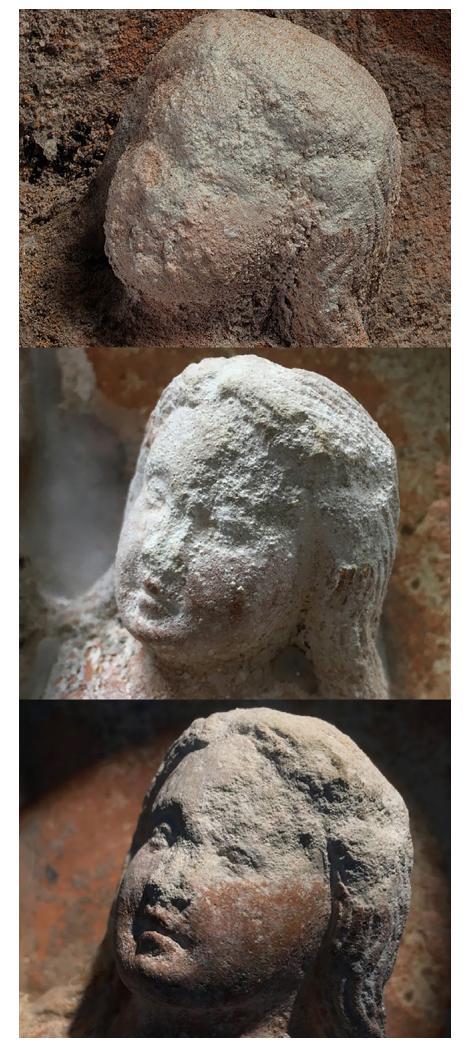
Figure 8. Detail of the memorial: before treatment (left); after treatment (right)

The forms appeared clearer after desalination (Figure 8).
